| Item | Page No. |
|--|---|
| Fire and Life Safety Assessments of Whistler Carpark and Library | 16 |

Building Code of Australia Assessment of Manly Library Manly
fire isolated. 25

Building Code of Australia Assessment Whistler Street Carpark Manly

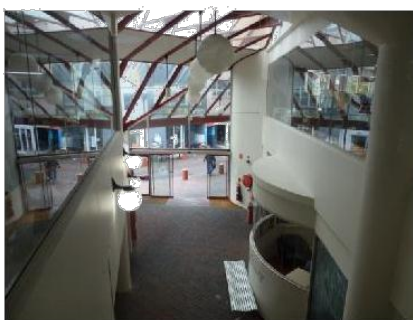
ES Photograph One

There seems a general absence of exits signs and emergency lighting to a standard we would consider acceptable. As an example the main entrance has not been provided with an exit sign that is visible from the stairs.

Visually there appears to be an insufficient number of emergency lights on each storey and external paths of travel. There should be a suitably qualified person to plot the location of the

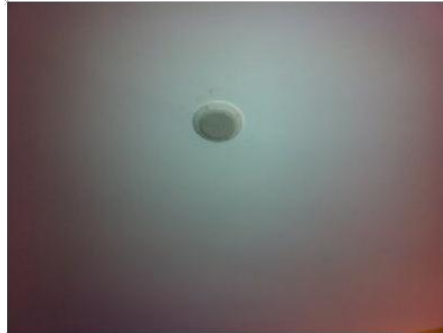
ES Photograph Two

The building and evacuation plan refers to "evacuation alarm" although the plans are silent on their location. Examining the ceiling we found what could be part of an alarm system(BOW) (although they could also be part of a local PA system) which is as shown in the following photograph.

The BOW needs to be activated by another system such as a smoke detection or sprinkler system. There is no sprinkler system and we can see no evidence of a smoke detection system although we note that:

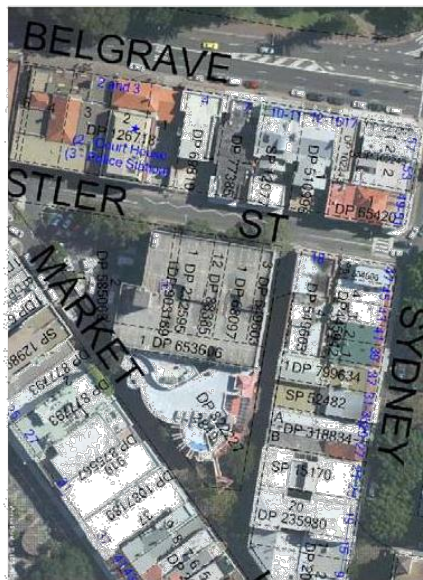
Photograph One

The aerial view suggests that the protruding triangular exit from the library stands outside the boundaries of the property although this has no life safety consequences. Each storey is provided with 2 exits having a minimum width of 1m. The ground floor exits are the main entry doors and the fire isolated circular stair. The first floor is served by a fire isolated stair and a non fire isolated stair that discharges into the front lobby 14m from the main entry doors. The third storey is served by the fire isolated stairs and an external stair that appears to be "an external stair in lieu of a fire isolated stair". The stairs are sufficient to service a maximum population at each storey of 200 persons.

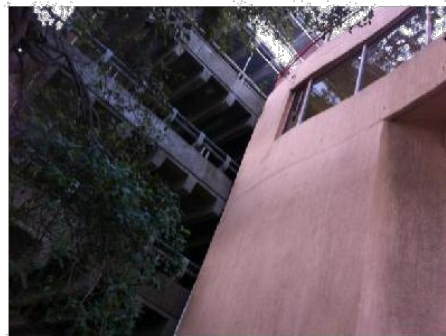
Photograph Three

There are three doors that join the carpark at all three levels. The doors at ground level and first level are tagged as fire doors¹³ however the door at level 3 is a fire door that is untagged possibly because it has unapproved penetration in it in the form of a "peep hole". This door also requires to be replaced with a required fire door. There is a window within 3m of the side boundary fire source feature which needs protection with an external sprinkler (See Photograph Three).

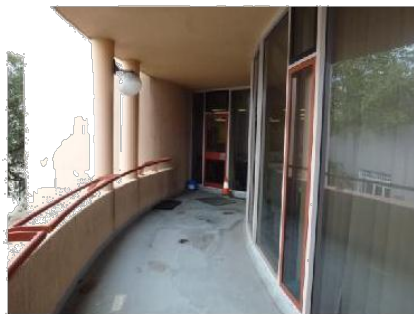
Exit travel distances generally comply with the BCA other than for the external walkway at level 3 which does not have access to an exit or a point of choice to an exit within 20m. The door shown in Photograph Nine is locked and denies access back into the building.

The door latch should be placed on a door striker activated by a fire alarm such as a sprinkler or smoke detection system.

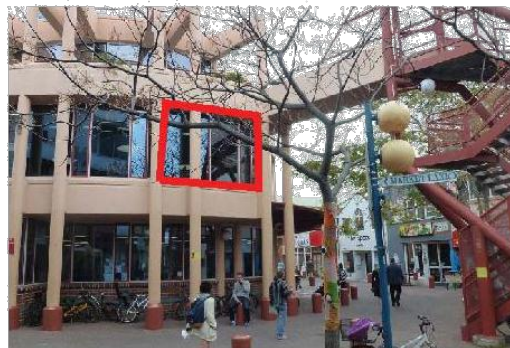
Photograph Eleven

The external stair is required to comply with these DTS requirements as the building is not sprinkler protected. Subclause (c)(i)(C) require that openings that are between 3m- 6m from the stair requires protection in accordance with C3.4 which includes internal sprinklers over the windows (see area indicated in red in Photograph Eleven).

NB: By site measurement and checking with engineering details we get a setback of approximately 5.8m to the windows marked in red.

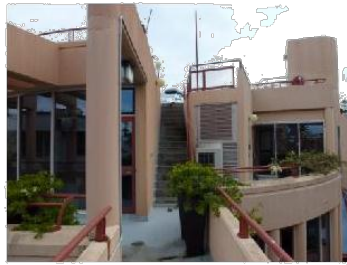
Photograph Twelve

D1.9 *Travel by non fire-isolated stairways or ramps* Non compliance
The stair from the carpark is defined as an exit and therefore must continue to a road or open space by its own flights and risers. In this case the exit is discontinuous and persons need to travel across the clock tower bridge to the external stair.

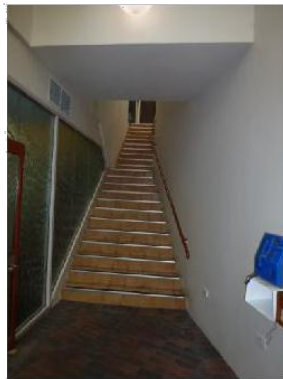
Photograph Sixteen

Must be not less than 1 m wide between handrails. The width of the above stairs at their narrowest point was 960mm and therefore non compliant.

Non compliance

Options should be examined to see if the handrail can be modified to achieve compliance.

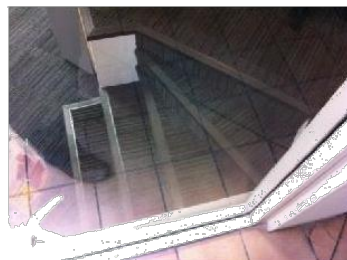
Photograph Seventeen

Not checked in detail although the stair from level 1 to the stairs that connect to level 4 carpark contain winders and are obviously non compliant and not made available for public use until rectified.

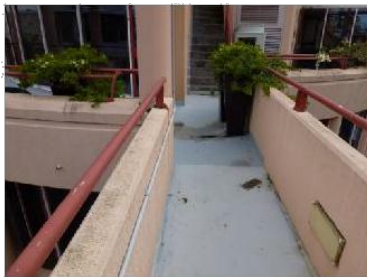
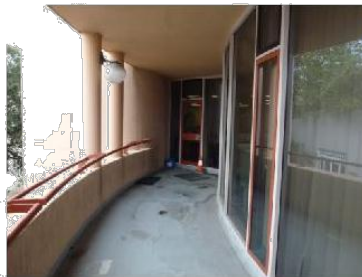
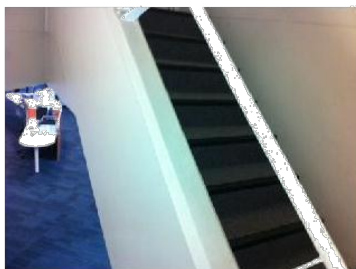
The balustrades are generally non compliant throughout the building. The gaps between openings frequently exceed 125mm¹⁴. These nature of issues do not necessarily reduce levels of safety in the event of fire and are more related to general personal safety. It depends on the level of risk Council and its insurers are prepared to assume. We have no choice other than to recommend they be brought into compliance.

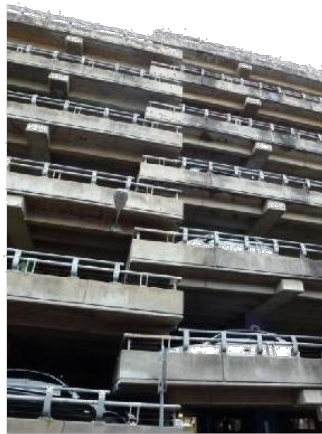
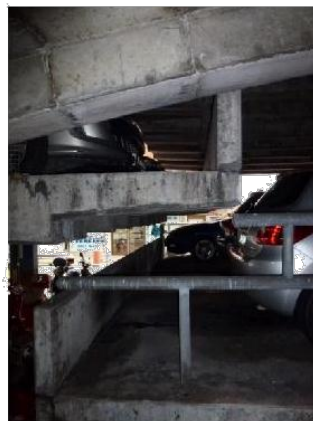
Photograph below details a small overlap which technically constitutes a storey as there is an intermediate floor and ceiling as shown in Photographs One and Two.

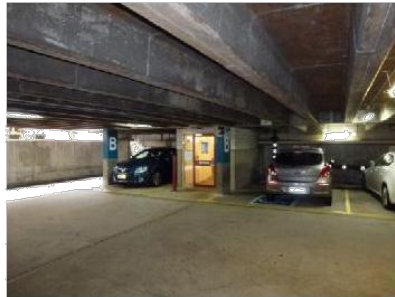
Photograph Ten

We note that current spaces for the disabled are directed to the basement storey although this is the one storey without the required lift access. Access via another building (the library) is not compliant with the BCA Provisions as buildings need to be self compliant.

The toilets should have both a complying toilet for the disabled and an ambulant toilet.

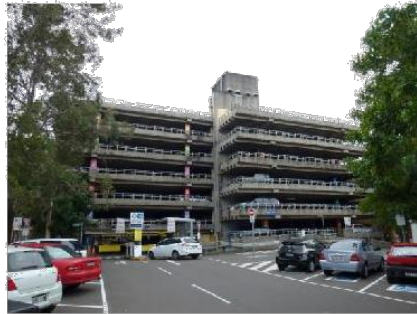
Photograph Twelve

Council has some obligation to provide covered carparking spaces in conjunction with the carpark – albeit they may be adjacent and to what is currently the main entry and require the upgrading of the existing spaces currently designated as disabled (See Photograph Twelve).

The design of the existing car spaces for the disabled do not comply with current requirements. Gradient, carpark sizes and clear spaces beside carparking spaces appear non compliant. That is, the three spaces below should be reduced to two spaces with a clear space between the two outside carparks. (See Figure 2.3 AS1428.1-2009).

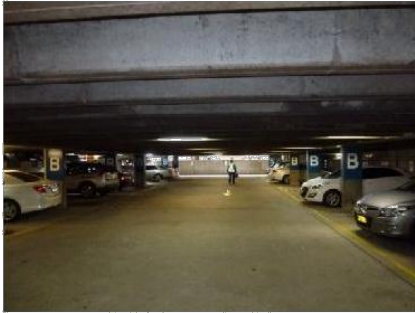
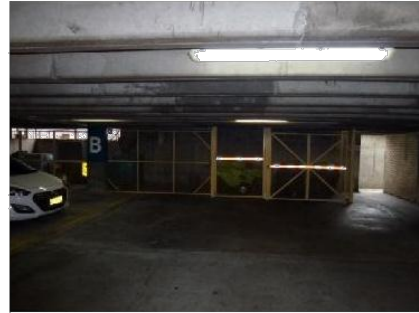
Consequently, it is evident that the building does not comply with the open deck carpark provisions and therefore to retain the reduced FRLs for an open deck carpark it is required to be sprinkler protected.

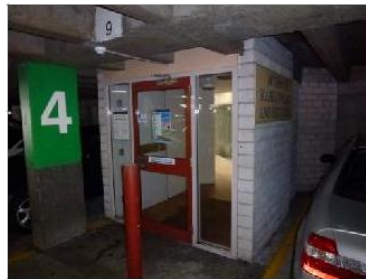
The common wall with the library has two openings that connect the carpark to the library namely at level B and level 4. Further, levels 8-10 have no fire rated walls on the boundary to mitigate the risks of fire spread to the subject premises. When the carpark was originally constructed there were no building code requirements to protect the external walls. The BCA amended this requirement some years ago and now only exempts ramps. There has always been requirement to protect the openings in the library walls that are within 3m of the side boundary. In this regard we note that the openings appear to be protected from just the library side of the lobby and not the carpark side.

The BCA requirements are now that the openings should be protected on both sides of the boundary and at the boundary line rather than on an adjoining property unless there is an easement or formal binding legal agreement between parties. The reason being is that adjoining buildings are frequently under separate ownership and as such may be demolished thereby compromising the levels of protection.

The protection on either side is consistent with the fundamental basis of the BCA whereby each property cannot rely on an adjoining property to supplement fire and life safety measures as the adjoining property has no obligations to maintain the fire safety measures that take account of adjoining properties. Consequently, we recommend that protection be provided on both side of the door opening in accordance with C3.4 of the BCA.
