Identification of Coastal Hazard Risk Areas to Projected Sea Level Rise for the Manly Local Government Area

WRL Technical Report 2011/19
May 2012

Water Research Laboratory
University of New South Wales
School of Civil and Environmental Engineering

by
A Mariani, J T Carley, D B Lord and T D Shand

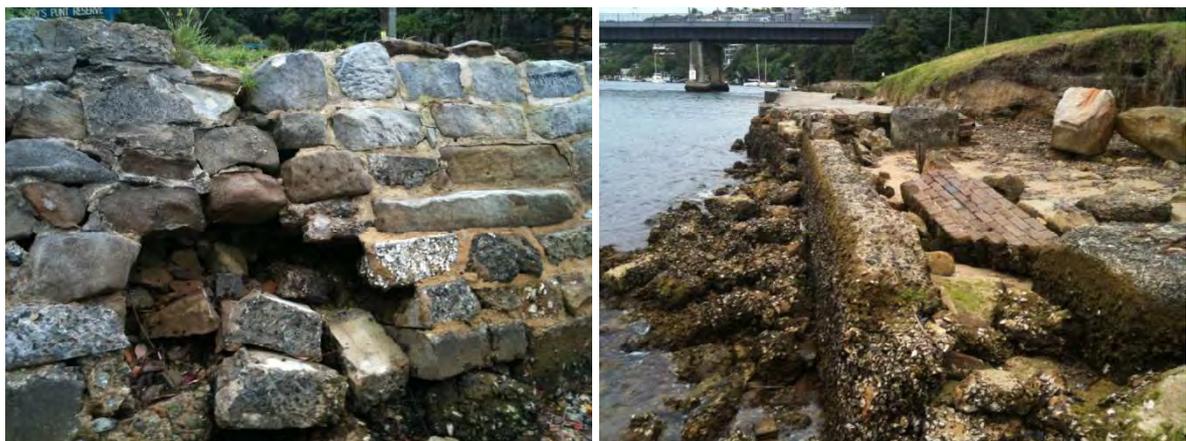
Figure 3.2 Ellery's Punt Reserve Photos of Present Condition

The seawall presents serious erosion of the mortar with several pockets of erosion where the sandstone blocks are detached from the seawall (see Figure 3.2). Moreover, serious undermining of the toe was observed along this seawall.

A 40 metre long seawall connects the eastern end of the punt platform to the western rocky end of the reserve. The seawall is made of sandstone blocks with minimal grouting and concrete (and basalt) capping. A 10 metre section of the seawall is made of concrete construction and is backed by a grassed embankment. The concrete is in poor condition and the leeward embankment suffers from erosion which is probably caused by wave overtopping of the seawall (see Figure 3.2). This area is also subject to high volumes of boat traffic therefore boat wakes. Several sandstone boulders of approximately 1 tonne have been placed at this location to protect the embankment from erosion. The crest levels of the seawalls vary between 1 m AHD and 1.5 m AHD.

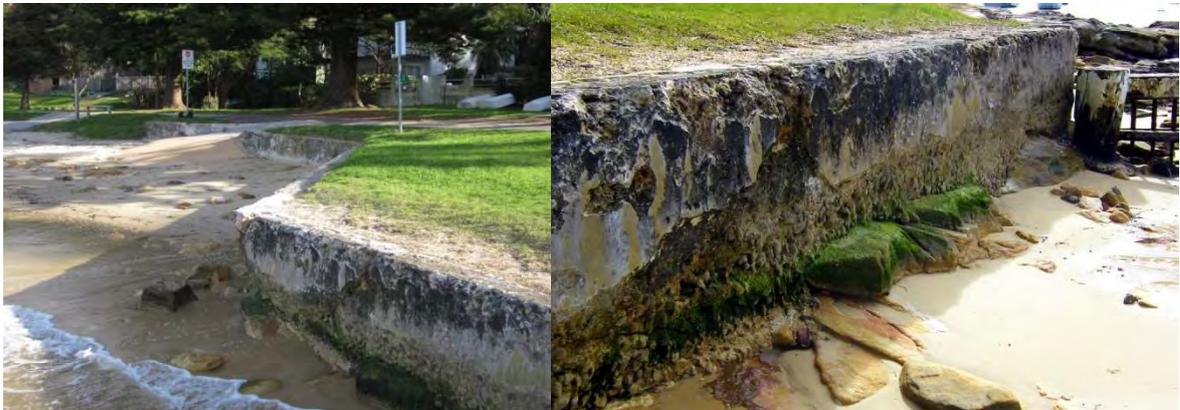
Figure 3.3 Forty Baskets Seawall Photos of Present Condition

Forty Baskets beach is on the northern side of the Sydney Harbour National Park and is accessed by a pathway from Beatty Street. The beach is approximately 250 metres in length and oriented to the north-east. The south-eastern section of the beach comprises a rocky shoreline and the north-western end, which is approximately 160 metres long, is sandy. The northern 70 metres of the beach is backed by a vertical concrete seawall. At the northern end is a netted swimming enclosure. The beach is backed by a grassy reserve with residential development set back approximately 20 metres from the back of the beach, on the steeply rising slopes of the headland.

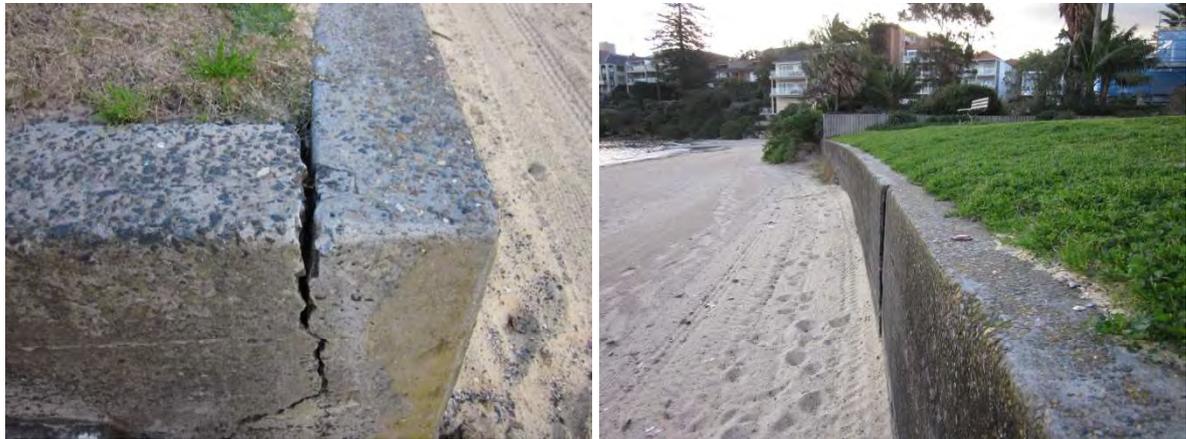
Figure 3.4 Little Manly Seawall Photos of Present Condition

Little Manly Beach is located on the harbour side of North Head. It is a short, sandy beach 150 metres in length deeply embayed between bedrock headlands and oriented to the west-south-west. There is a boat launching ramp at the western end of the beach and a netted swimming enclosure at the eastern end. The beach is backed by a low concrete retaining wall and there is some development immediately adjacent to the retaining wall.

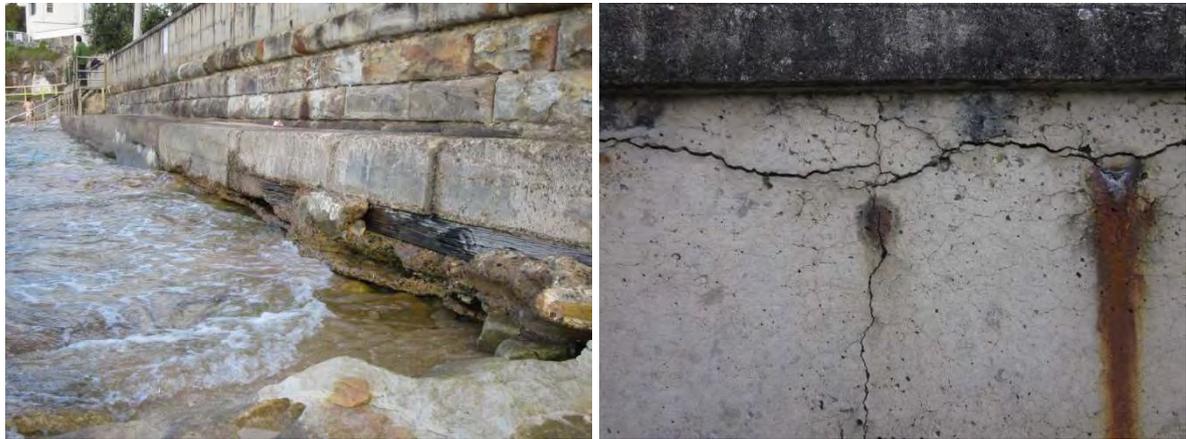
Figure 3.5 Fairy Bower Seawall Photos of Present Condition

Fairy Bower is located on the northern rocky headland of North Head, between South Steyne to the west and Shelley Beach to the east. Fairy Bower is the 140 metre length of low lying rock shelf immediately to the west of the ocean pool. This beach used to be covered with a veneer of sand, the last of which was eroded during the May-June 1974 storms. It has not been replaced, leaving a low, rock shelf shoreline with a protective seawall above. The base of the seawall contains the sewer and stormwater lines servicing the development on the headland behind and to the east. At the lowest section adjacent to Bower Lane, the private development is located within a few metres of the seawall crest which is regularly overtopped during storms at present.

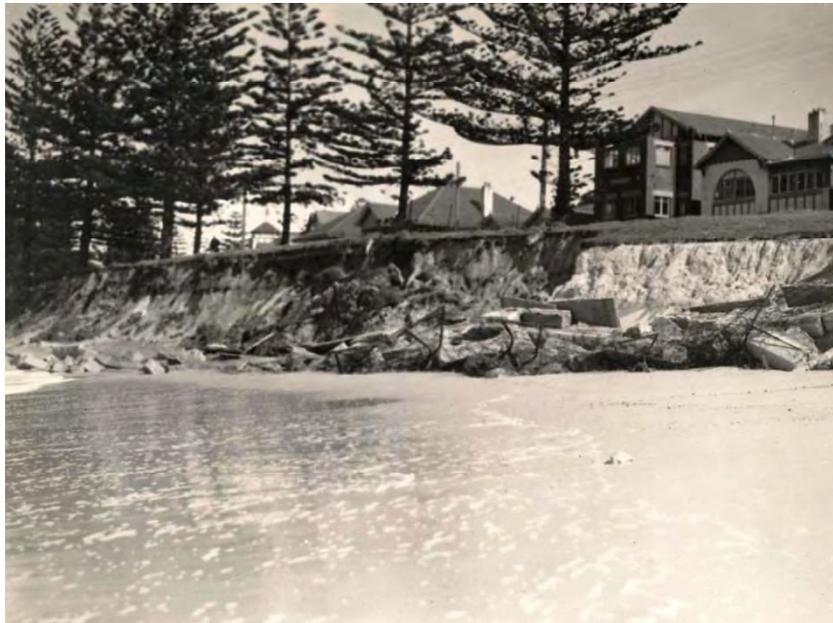
The majority of beaches within the Manly coastline are backed by seawalls. During storm events, waves frequently impact these seawalls and overtopping of the crests occurs in the form of bores of water being discharged inland or splashes of water being projected upwards and eventually transported inland by onshore winds. Wave overtopping can cause serious structural damage to the seawall crest and to properties immediately behind the seawall. Figure 4.5 shows a photo of the North Steyne seawall collapsed in front of Pacific Street due to wave overtopping.

Figure 4.5 North Steyne Seawall Collapsed in front of Pacific Street (25/05/1943)

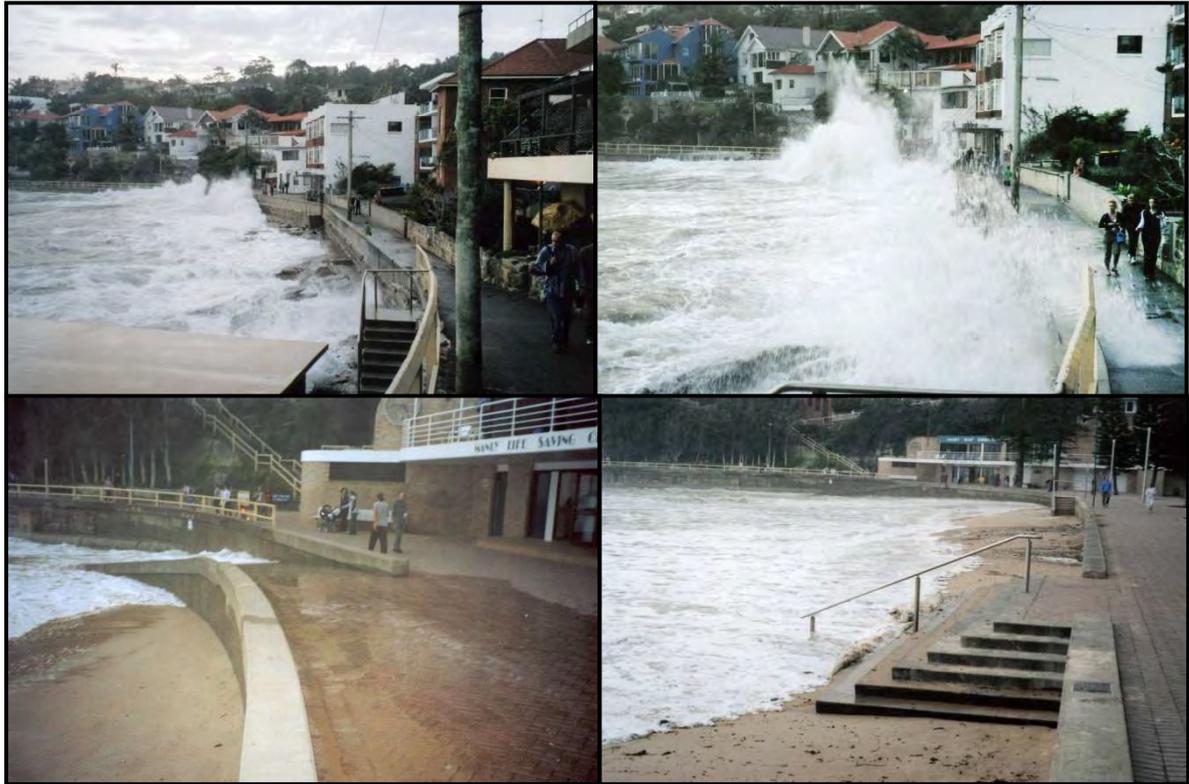
Figure 4.6 Top: Wave Overtopping at Fairy Bower; Bottom: Wave Runup at Manly LSC Boat Ramp and Manly Beach Stairs at Victoria Parade (26/06/2003. Photos James Carley, WRL)

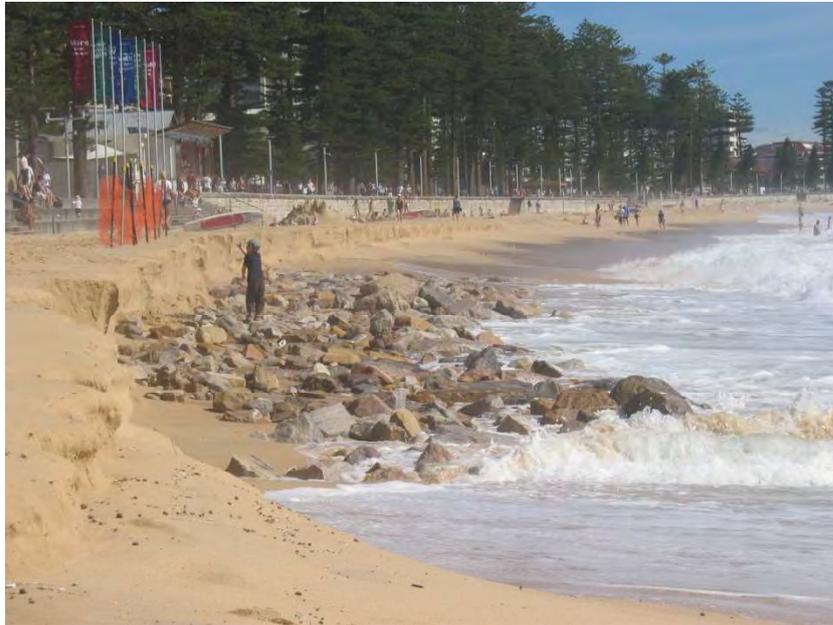
The beach erosion process relates to the erosion of the beach by a single extreme storm event or from several storm events in close succession (DECCW, 2010). The amount of sand (above 0 m AHD) transported offshore by wave action is referred to as "storm demand" and expressed as a volume of sand per metre length of beach (m^3/m). Figure 4.7 shows a photo of the eroded beach after a storm in front of the Manly LSC when the seawall rock apron was left exposed.

Figure 4.7 Photo of Eroded Beach near Manly LSC (06/02/2008)

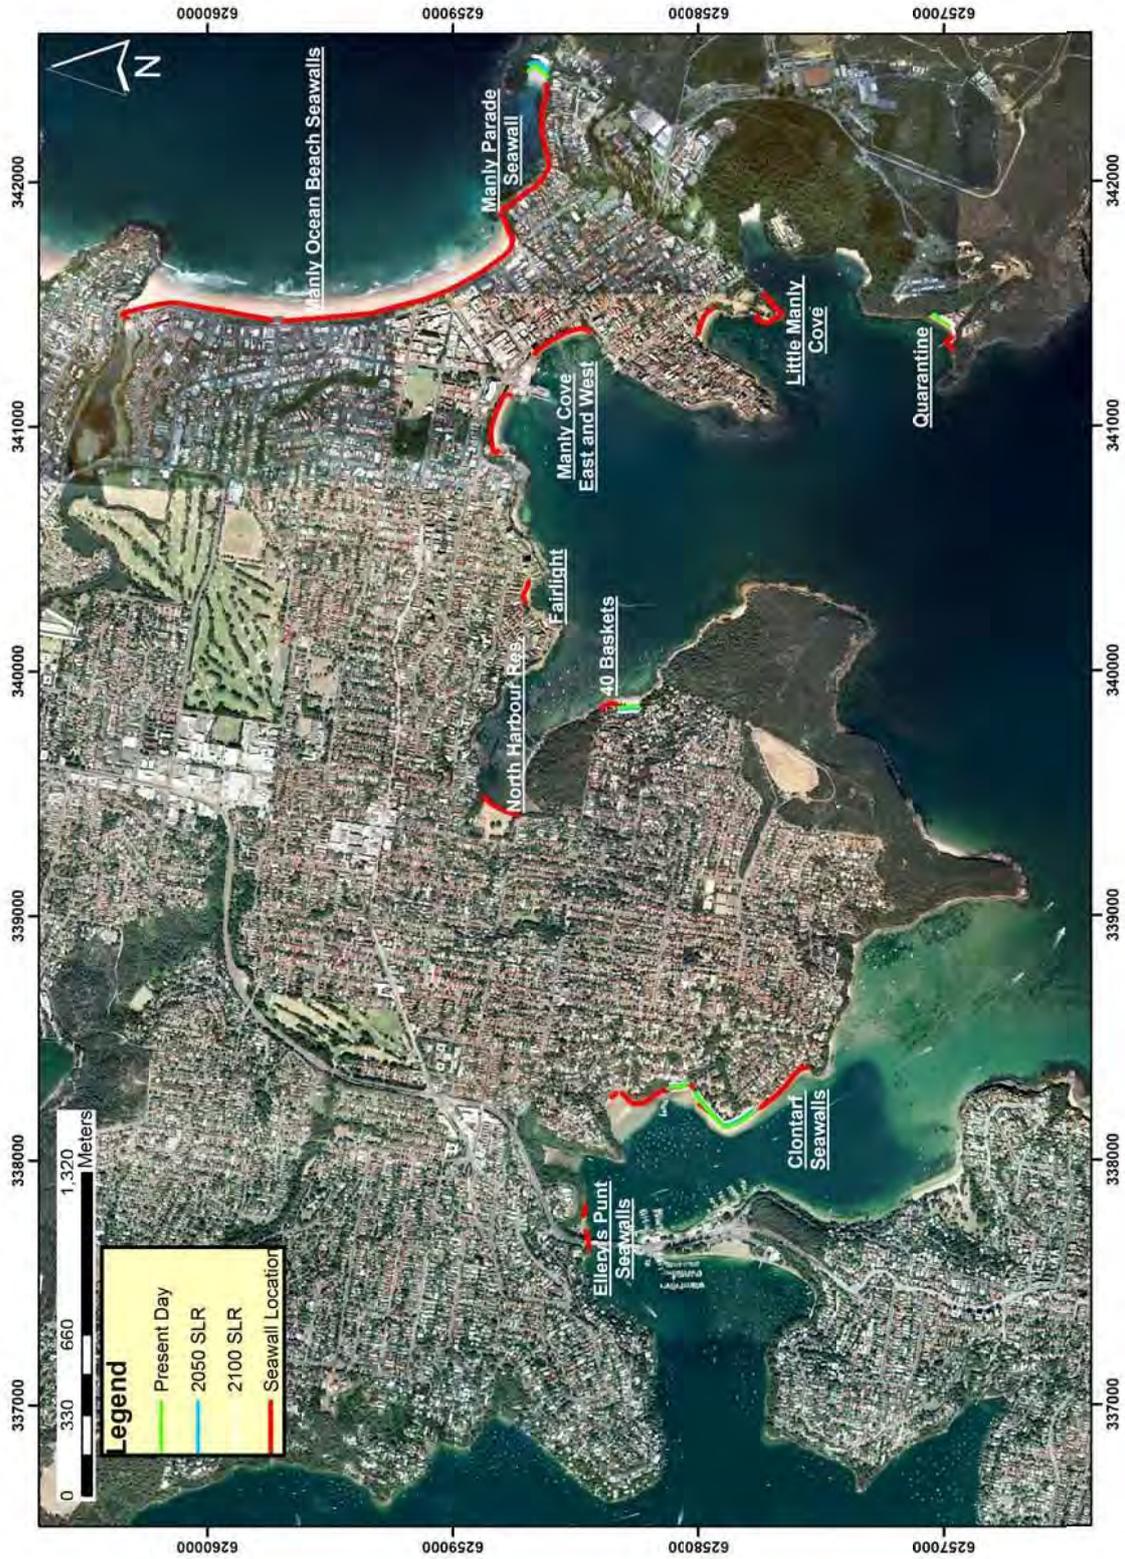
Coastal erosion hazard lines with the seawall in place are shown for every beach within the Manly LGA in Appendix C Figures C.1 to C.12. In the event of seawall failure, erosion will progress inland and allowances for this scenario were calculated and shown for each location in Appendix C Figures C.13 to C.21. Overall maps showing erosion hazard lines and seawall locations are presented in Figure 5.2 and Figure 5.3 respectively in the event of seawall in place and seawall failure. Figure 5.4 shows a photo of North Steyne seawall collapsed and progression of erosion beyond the seawall position. Figure 5.5 presents estimated erosion hazards lines for North Steyne in case of seawall failure.

Figure 5.2 Overall Map of Coastal Erosion Hazard Lines (Seawalls in place)

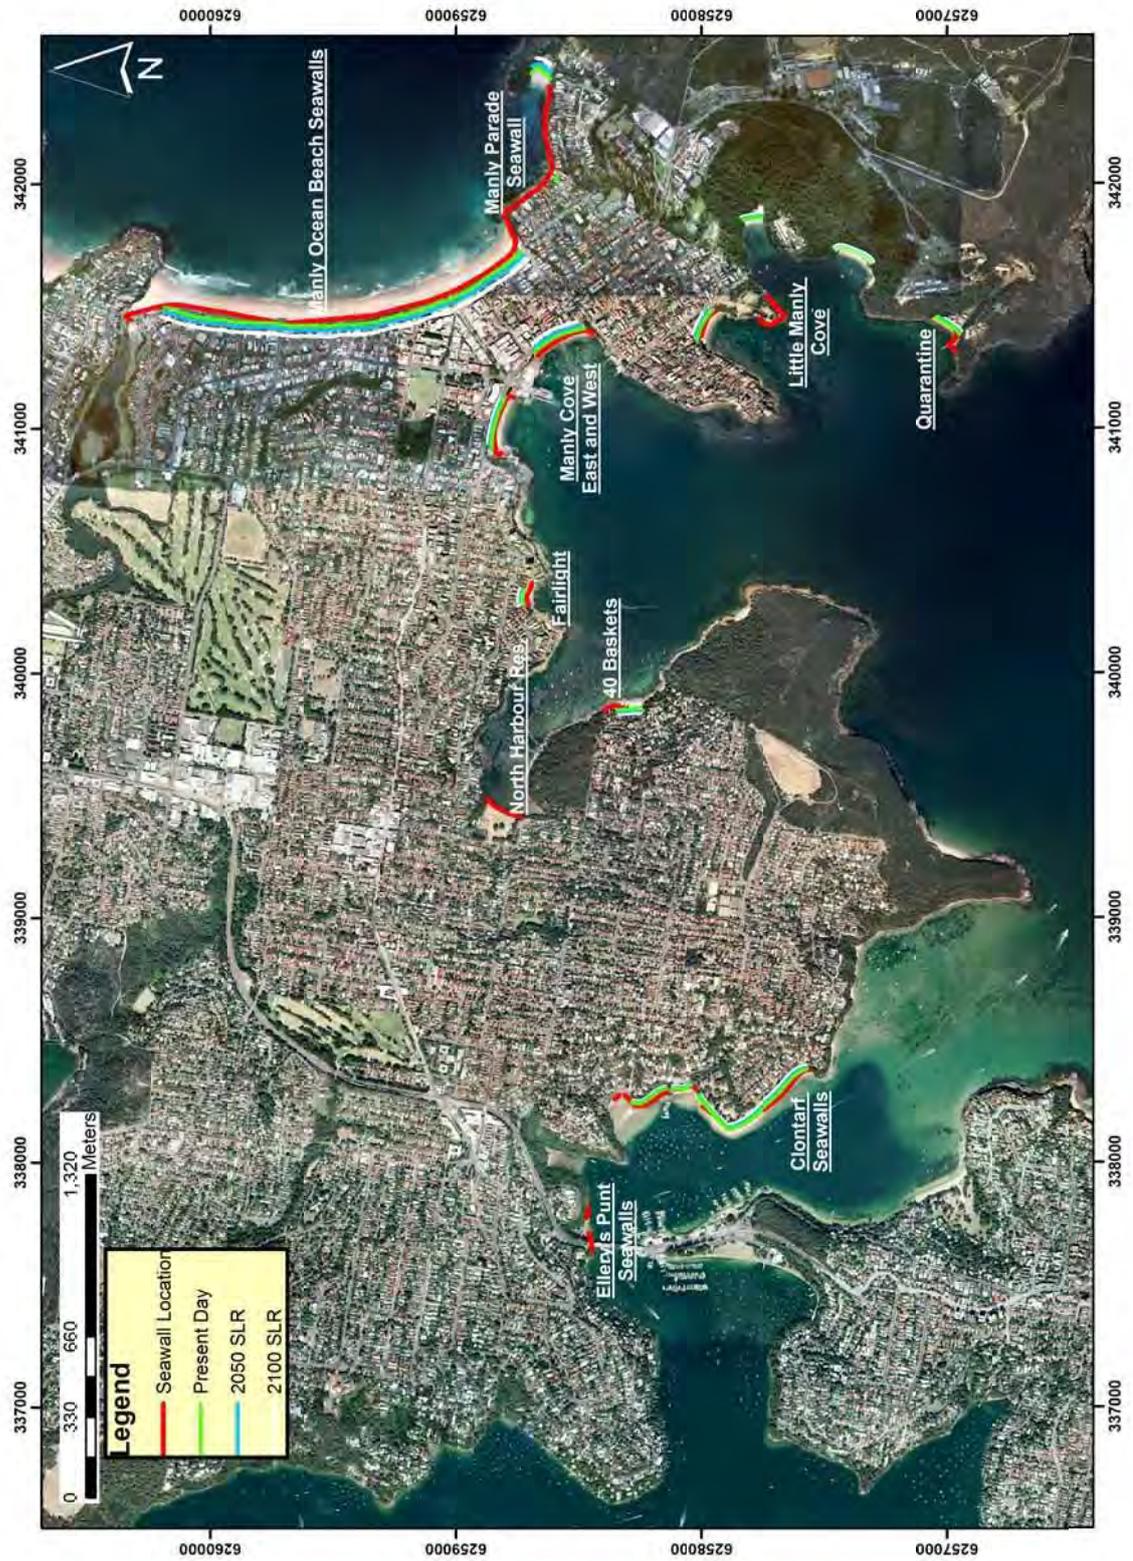
Figure 5.3 Overall Map of Coastal Erosion Hazard Lines in the Event of Seawall Failure
