Pittwater Natural Areas Plan of Management

Part 2 of 2 - Reserve Chapters

Prepared under the Crown Lands Act, 1989 & Local Government Act, 1993
Adopted by Council 6 April 2010

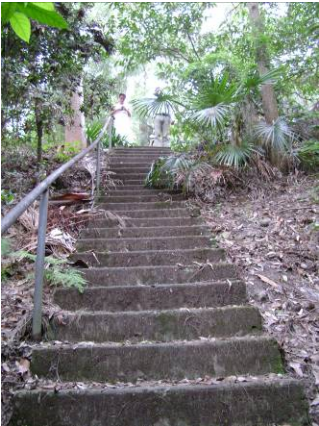
Access steps

- 2 Salt Pan Cove Entrance**
Replace Steps and handrails.
- 3 Creekline**
Plant sedges and erect natural barriers to dissipate water velocity to reduce scouring.

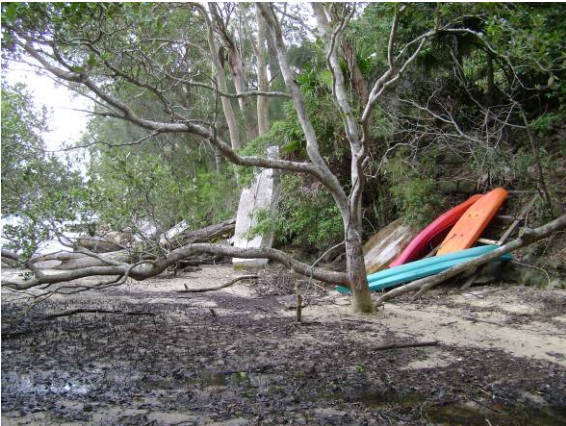
Current boat storage

- 6 Dinghy Storage**
Consider dinghy storage racks for limited boat storage for immediate neighbourhood use (Refer Council Policy 25). Location to be determined.

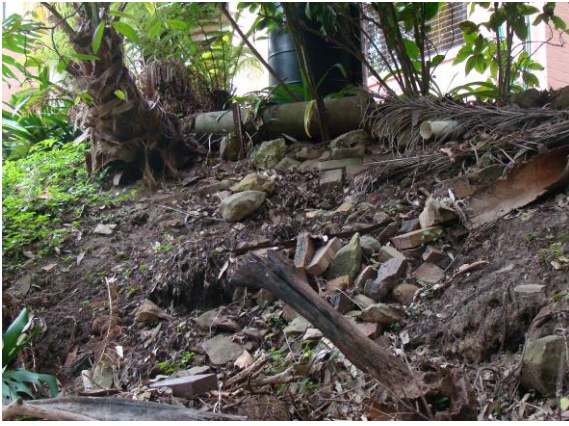
Disturbed soil, debris and erosion

- 7 Stormwater Runoff**
Investigate stormwater runoff to prevent loss of top soil. A water dissipater or equivalent is to be connected to all stormwater pipes that discharge into the reserve.

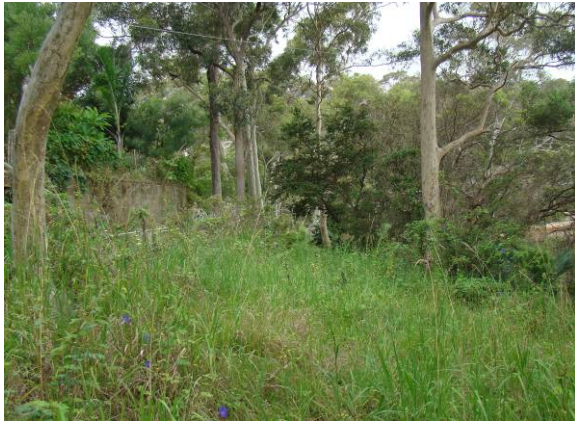
Weeds

- 14 Encroachments - Weeds**
Weeds occur adjacent to residential boundaries, where plantings, mowing and dumping has promoted weed growth. Active bush regeneration to slowly lessen weeds.
Remove all non-native plantings. Re-plant heavily disturbed areas with local native species. Regenerate all mown areas.

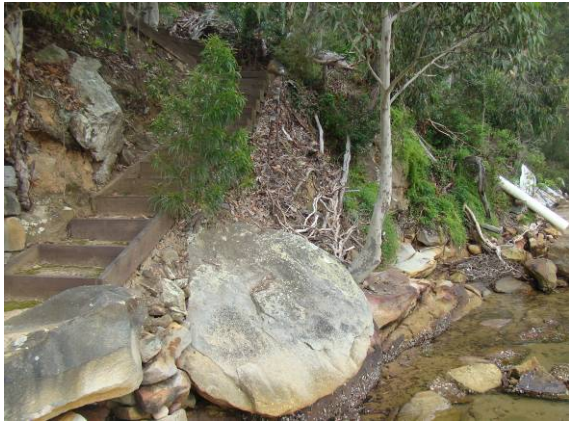
Encroachment- stairs

- 9 Encroachments - Built Structures and Landscaping**
Owners of adjoining properties are to remove exotic plantings and built structures including paths and steps from the reserve. Aim to remove encroachments prior to construction of walking track 2 - 3 metres from the rear of the property boundaries (encroachments may not comply with 'Australian Standards').

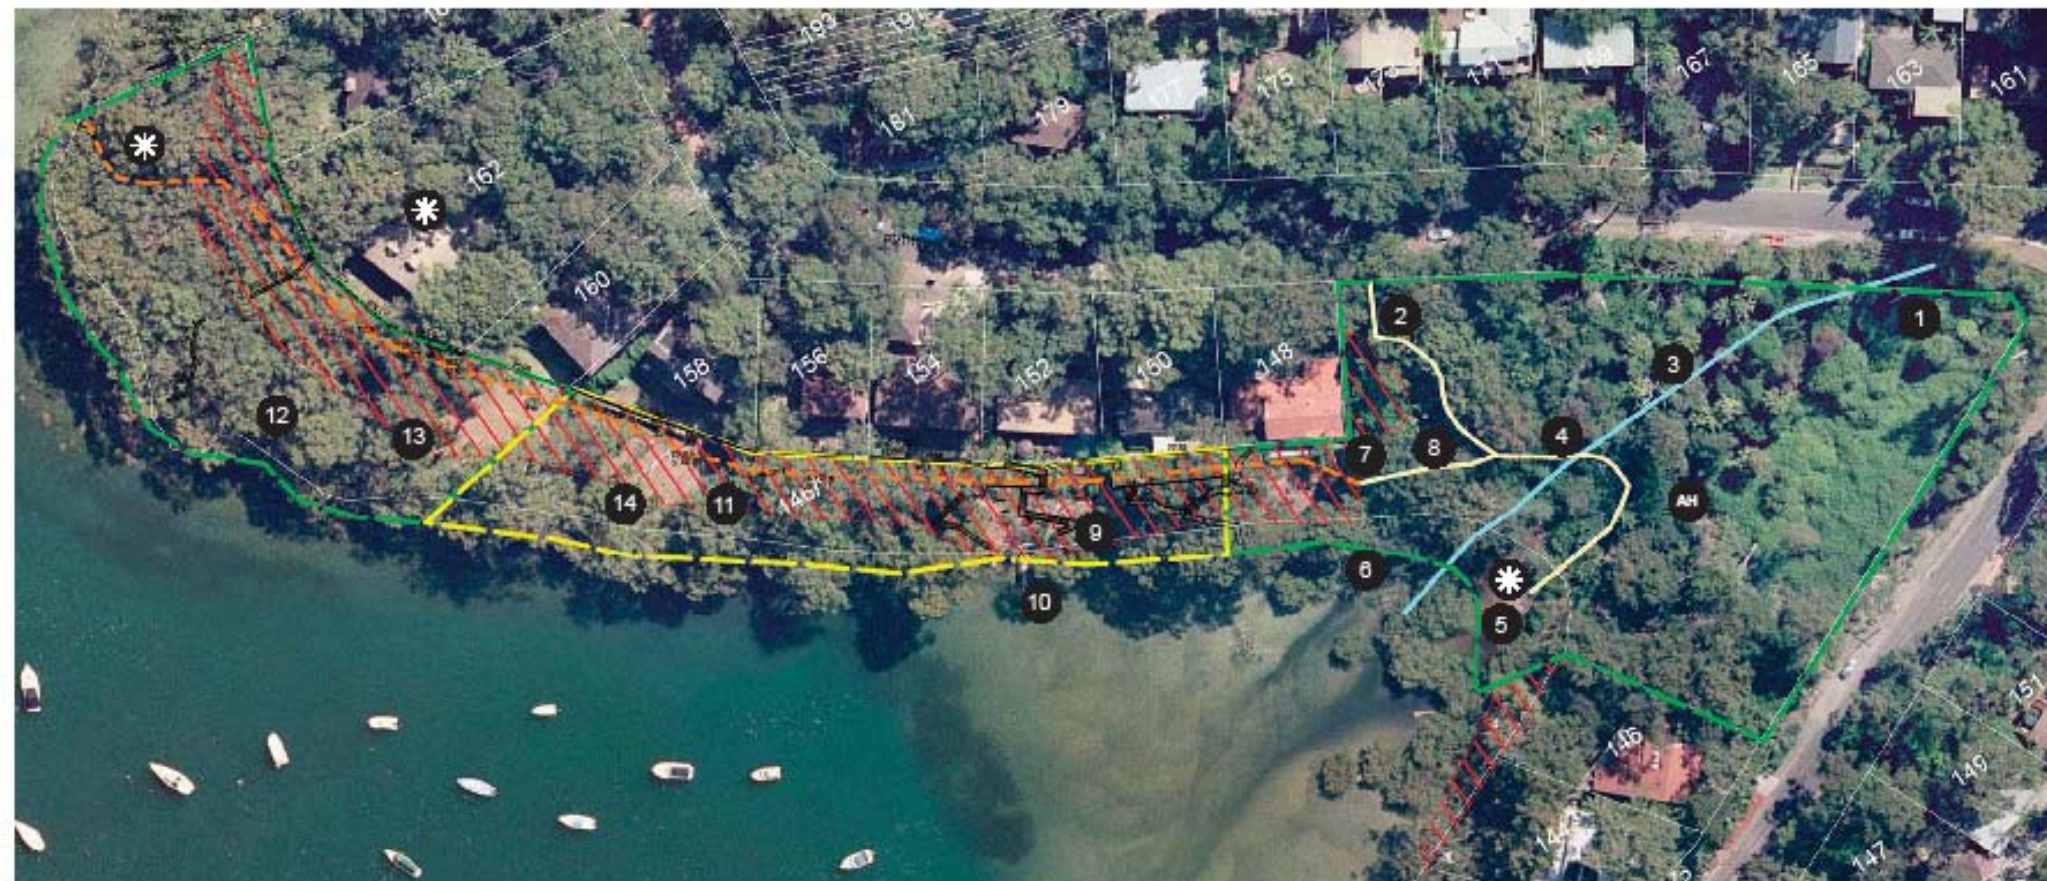
master plan

- Contract bush regeneration area
- Volunteer bush regeneration area
- Private land encroaching onto C
- Watercourse
- Existing walking track
- Unofficial walking track
- Illegal structures

- 1 Stormwater and Urban Runoff**
Install a GPT (or equivalent) and dissipator at the stormwater outlet at the top of the reserve (off Prince Alfred Pde) to reduce rubbish from entering reserve and decline in water quality.

- 4 Boardwalk**
Construct a boardwalk (or similar) where the track meets the creekline (boggy area).
- 5 Beach Area**
Remove rubbish from the creek and beach. Remove encroachments. Protect and restore mangroves and saltmarsh. Consider a rubbish bin, TAngler bin and bench.

- 8 Track Maintenance**
Maintain the path having regard to public safety issues. Repair path and steps to prevent trip hazards, clean out and/or reconstruct cross-fall drains as required.
