**Subject:** Additional Information for Deferred Item 4.2 – NBLPP Meeting 15 December 2021

At the meeting of the Local Planning Panel (NBLPP) on 15 December 2021, the NBLPP resolved to defer Item 4.2, DA2020/1756 for the Construction of a Shop top Housing Development at 351-353 Barrenjoey Road, Newport.

*1. Acid Sulphate Soils Assessment, dated 28 January 2022 prepared by Alliance Geotechnical Pty Ltd.*

**2. Acid Sulphate Soils Management Plan, dated 2 February 2022 prepared by Alliance Geotechnical Pty Ltd.**

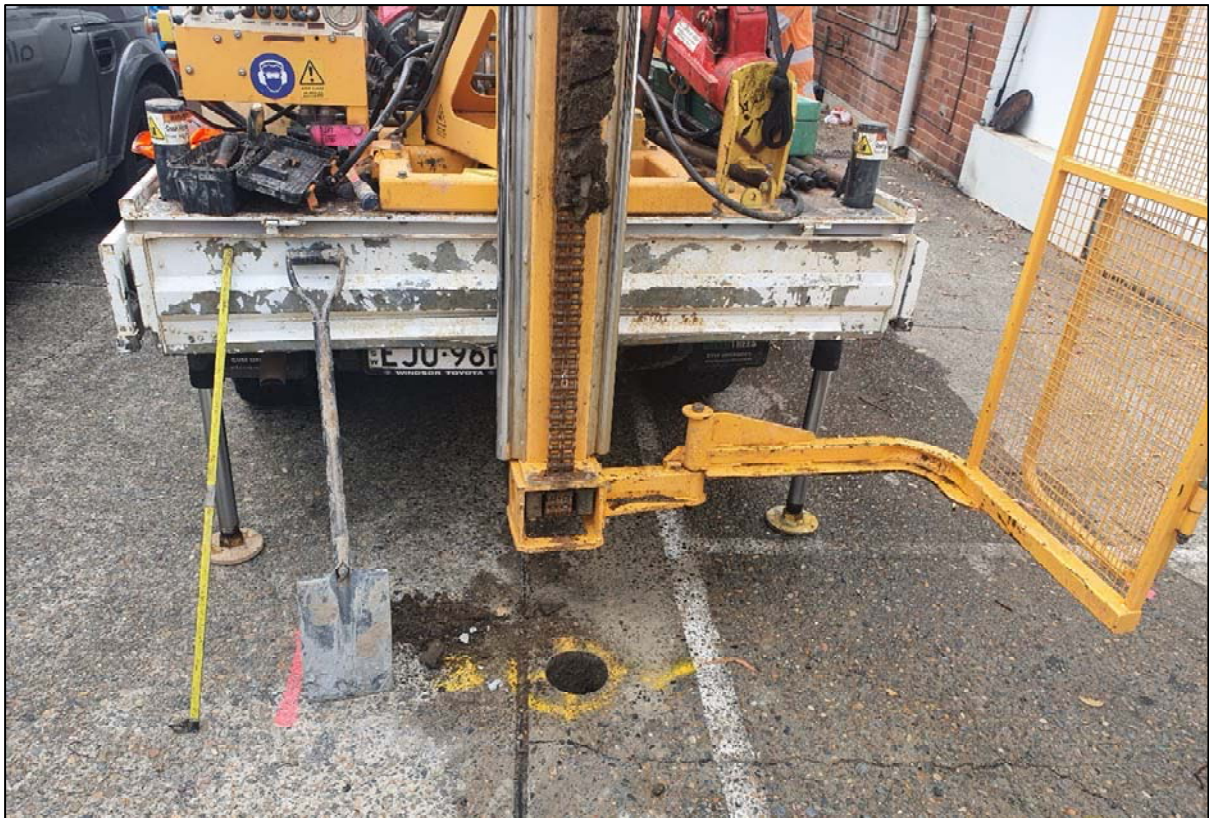
**Image 1 View of borehole BH02**

- 0.0–0.5 m bgl – (FILL) Sandy CLAY, firm, brown, moist;
- 0.5– 4.5 m bgl – (NAT) Sandy CLAY, very stiff, pale brown/red, moist;
- 4.5– 6.0 m bgl – (NAT) Sandy CLAY / CLAY, grey, very wet / saturated; and

During sample collection, visual indicators of actual acid sulfate soils (AASS) (i.e. soils containing pale yellow deposits / coatings of jarosite) were not observed. Indicators of potential acid sulfate soils (PASS), including shell fragments and waterlogged sands, were not observed in soils examined.

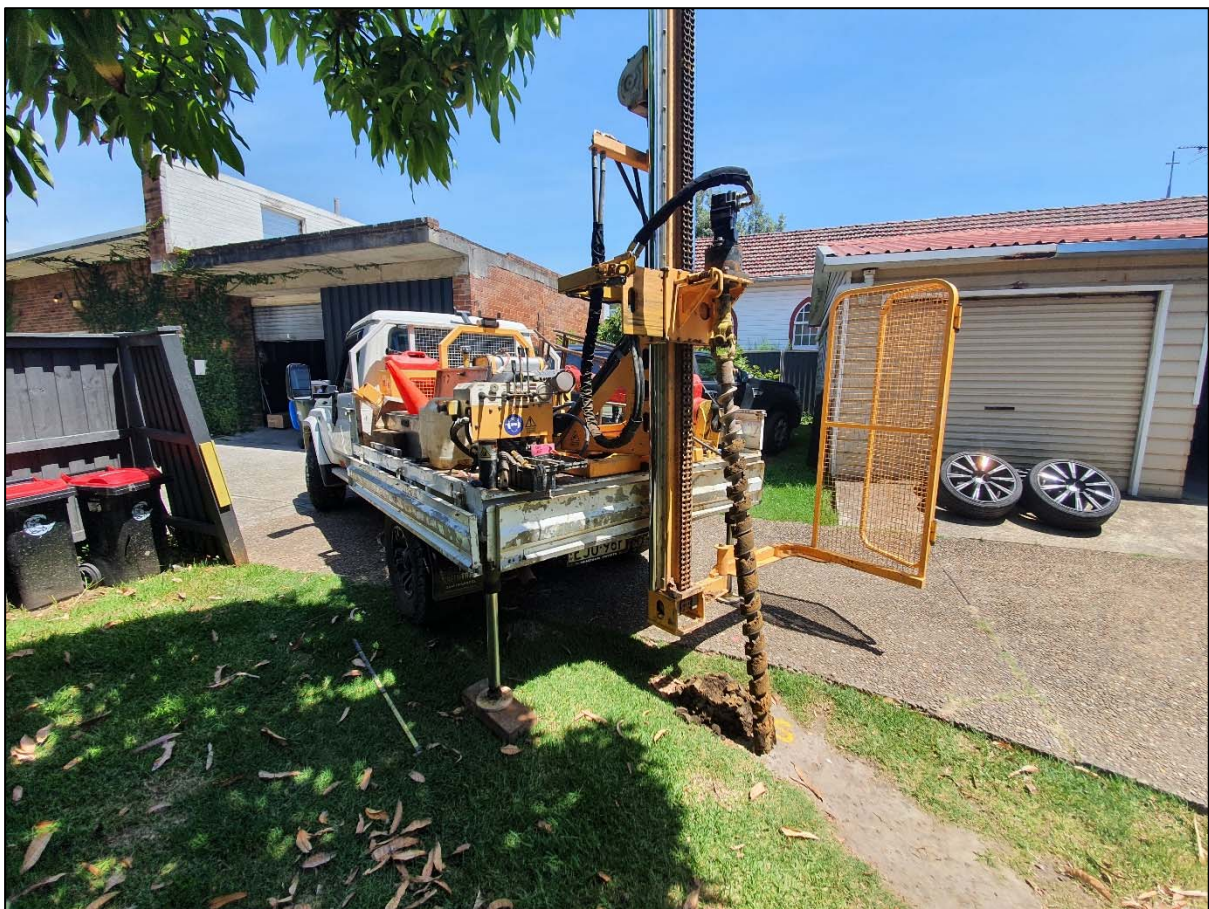
**Image 2 View of soil from BH04**

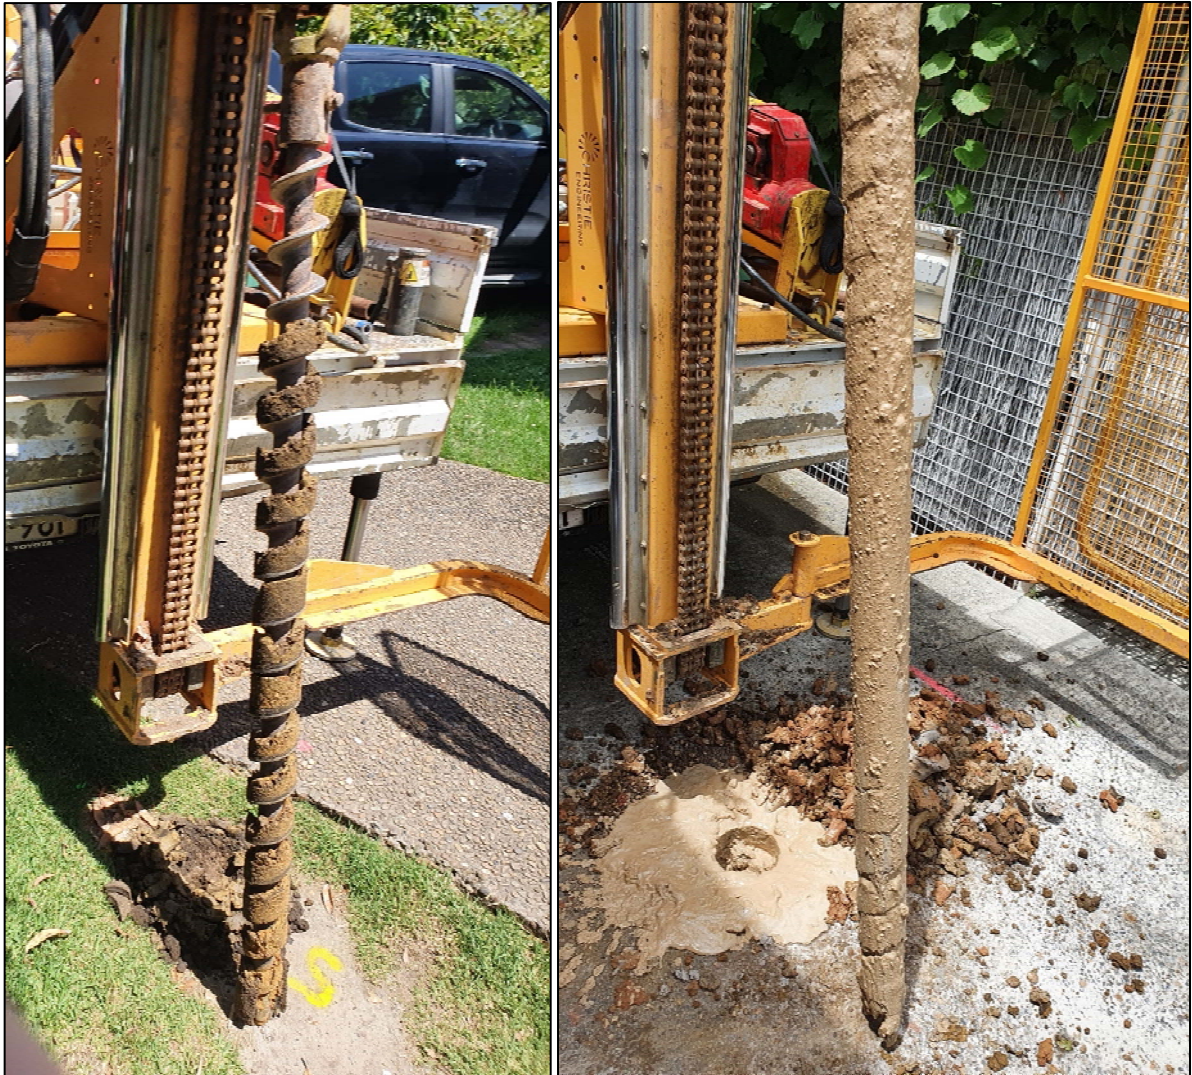
**Image 3 View of retrieved soils from borehole BH04 (left) & BH01 (right).**
