## MANLY BEACH, WHARF AND TOWN CENTRE PEDESTRIAN ACCESS & MANAGEMENT PLAN DRAFT

NORTHERN BEACHES COUNCIL

Project No: P2934

Issue date: 7 June 2017

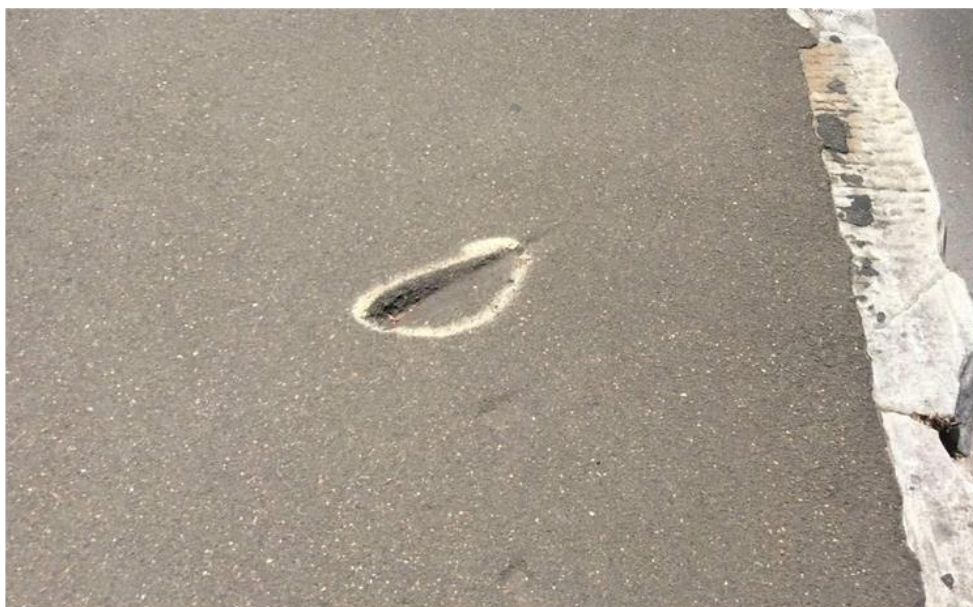
Reference: N108 North of Carlton Street

Figure 4.3 shows an example of a trip hazard, which is a foot-sized hole in the pavement. This hazard and other similar may lead to injury.

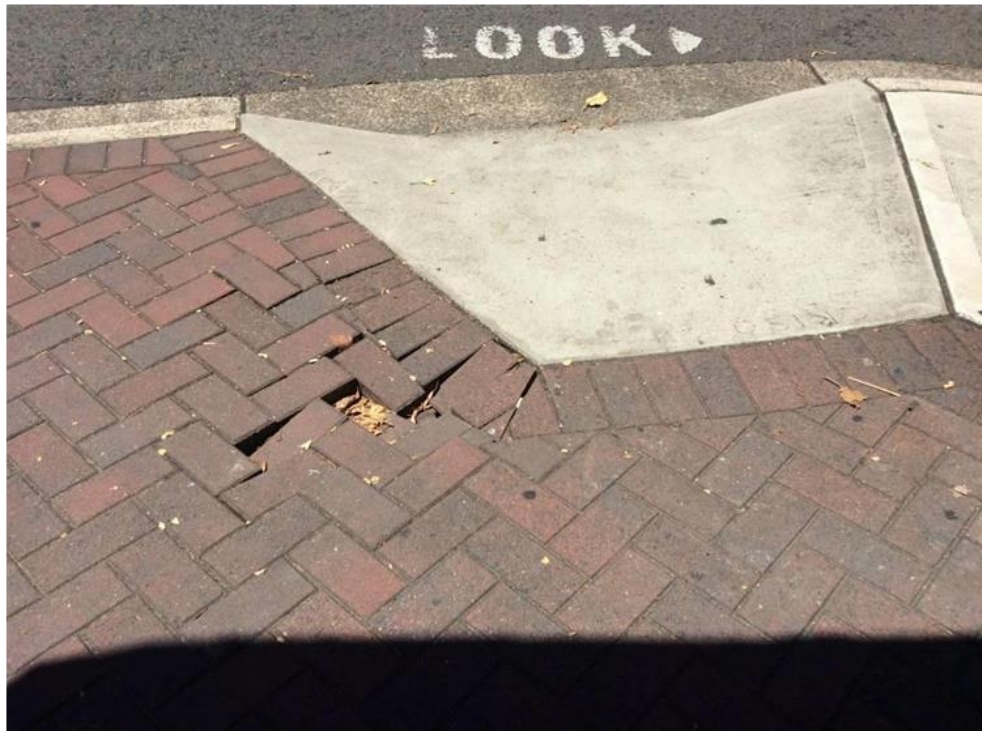
**Figure 4.4: Darley Road - Missing and Damaged Pavers near Kerb Ramp**

Shown in Figure 4.4 is an example of uneven and missing pavers. A hazard such as this may lead to a pedestrian tripping, in this case potentially falling into the roadway.

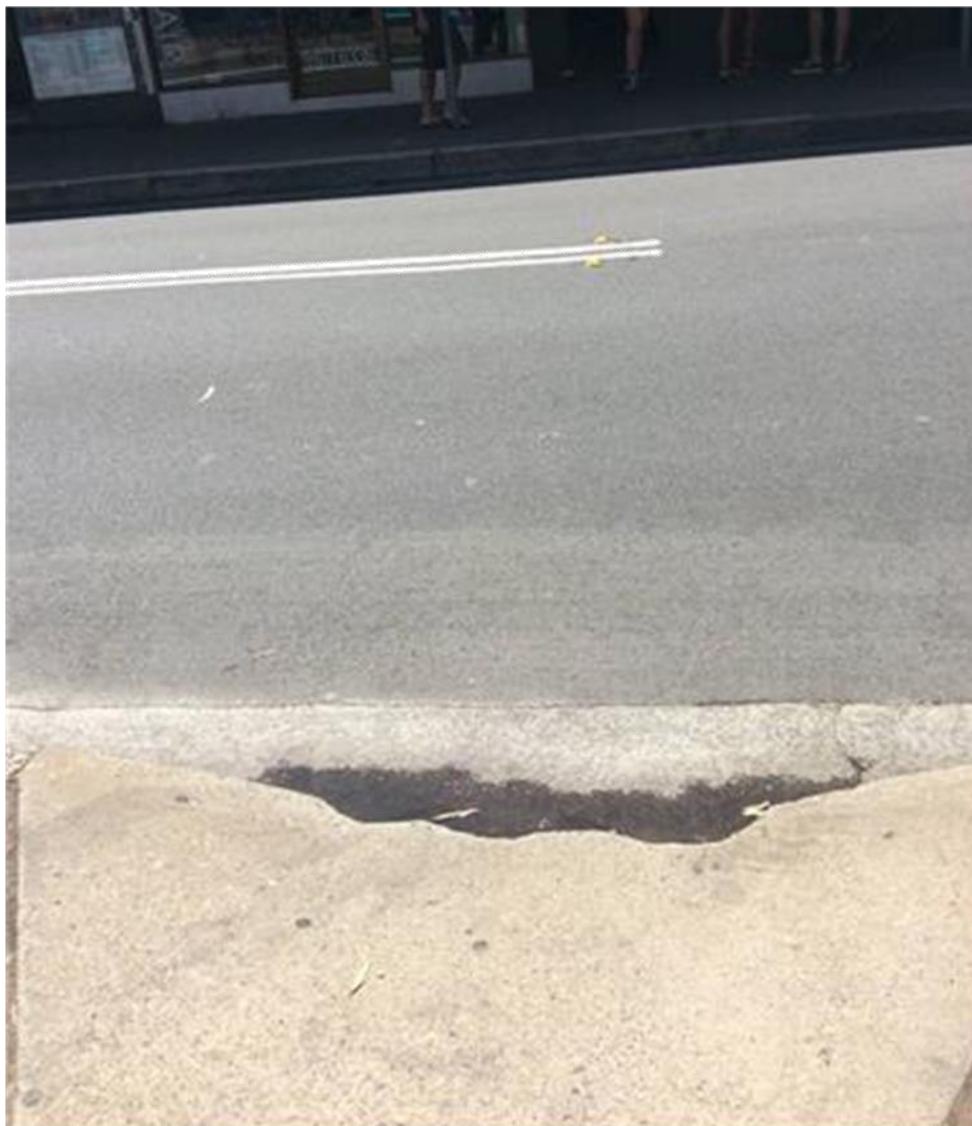
Reference WHS 74 South of Sydney Road

The example shown in Figure 4.5 is of a kerb ramp with ponding, ponding being the build-up of water, which may lead to pedestrians slipping and falling. The picture also shows an unconnected kerb ramp, which is when the kerb ramp has no kerb ramp on the other side of the road.

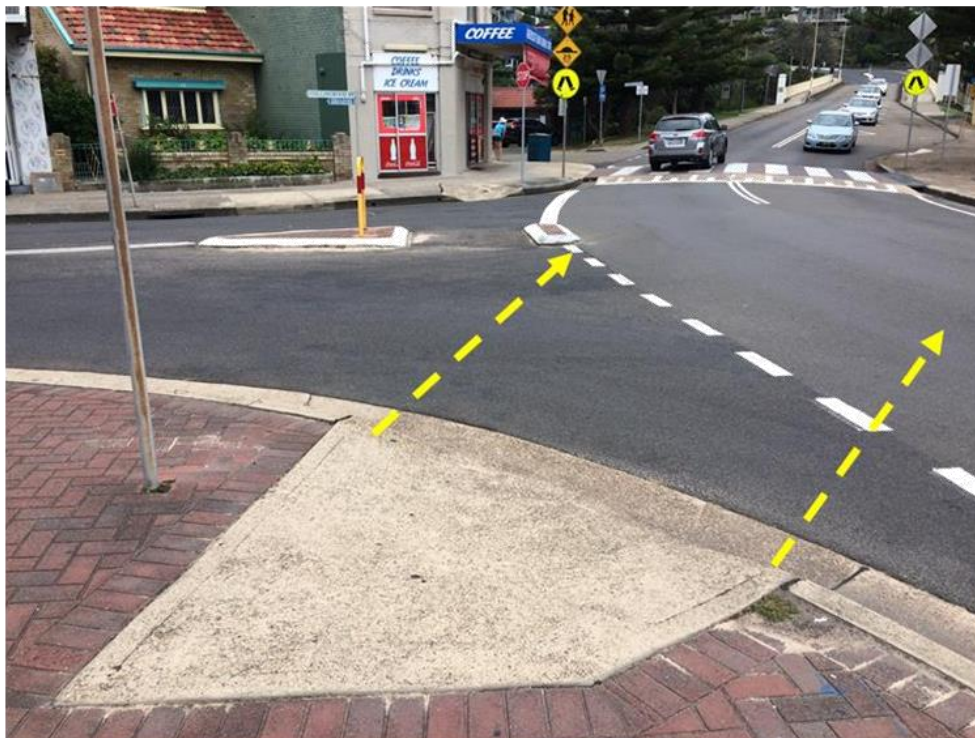
Reference: NS84 South of Collingwood Street

Shown below in Figure 4.6 is an example of an unaligned kerb ramp. An unaligned kerb ramp is a kerb ramp that does not line up with a kerb ramp on the opposite side of the intersection. As indicated by the arrows in the figure this kerb ramp in particular points a user towards the adjacent road.

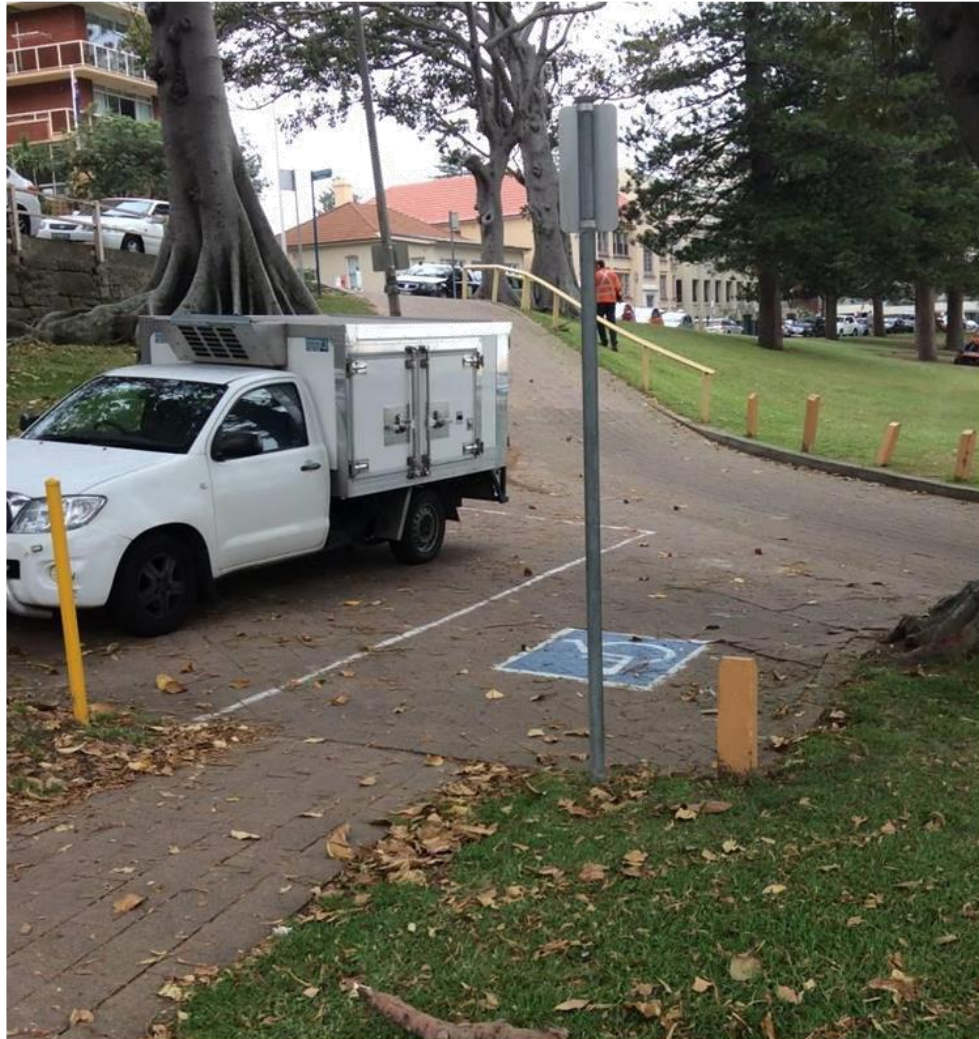
Reference FW25 West of Rowe Street

Shown in Figure 4.7 is an example of a non-compliant parking space. The space shown in the example has no shared area as defined in AS2890.6.

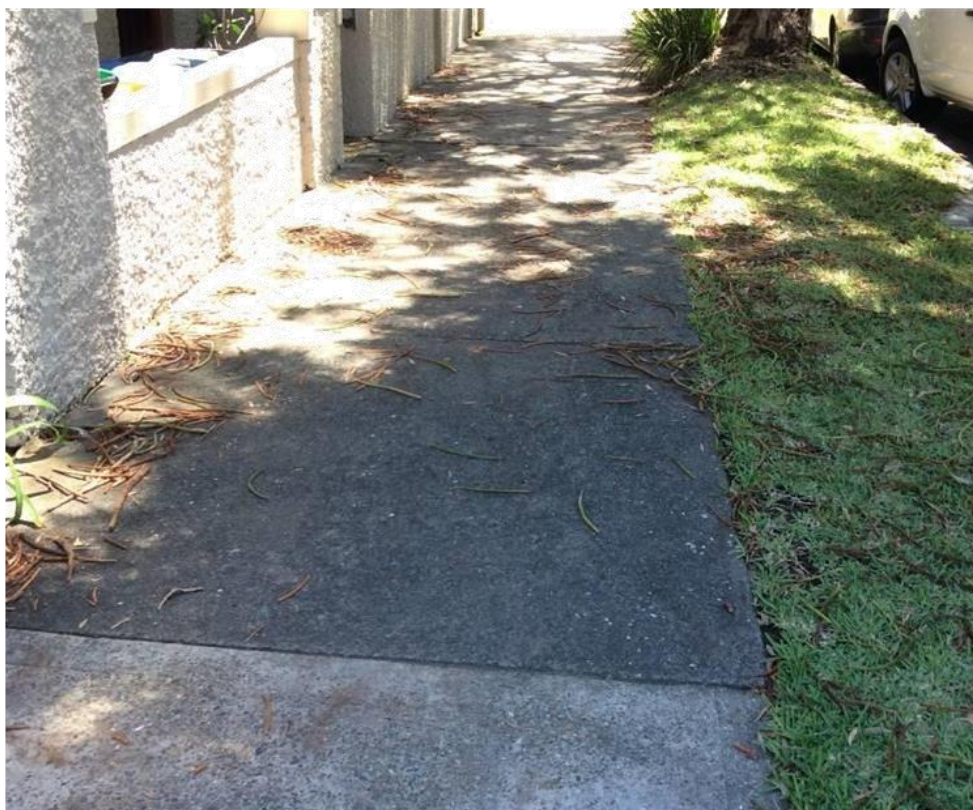
Reference OBR 9 South of Addison Road

Figure 4.8 is an example of leaf litter on a footpath. Leaf litter is classed as a slip hazard as it has the potential to cause a less able person to slip and fall.

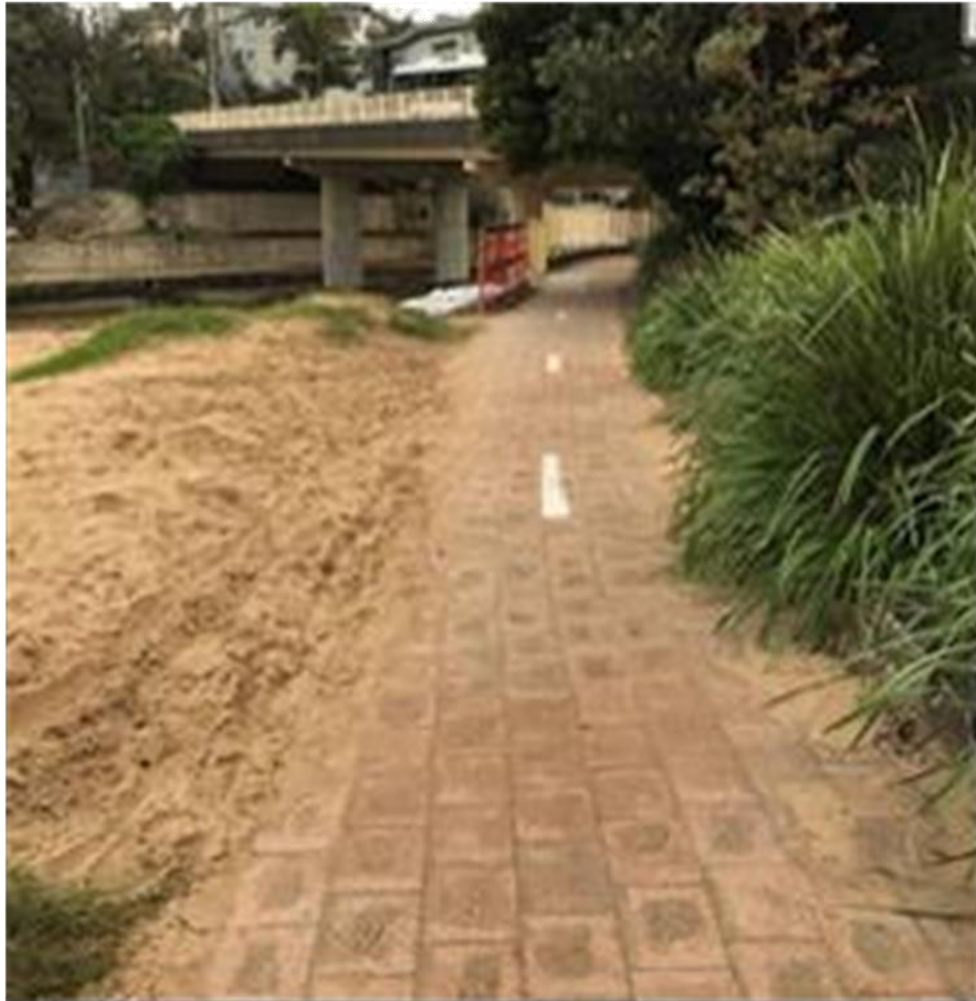
Reference ML 16

Shown below in Figure 4.9 is an example of sand on a footpath. Similar to the previous example sand on a path may cause pedestrians to slip and fall.

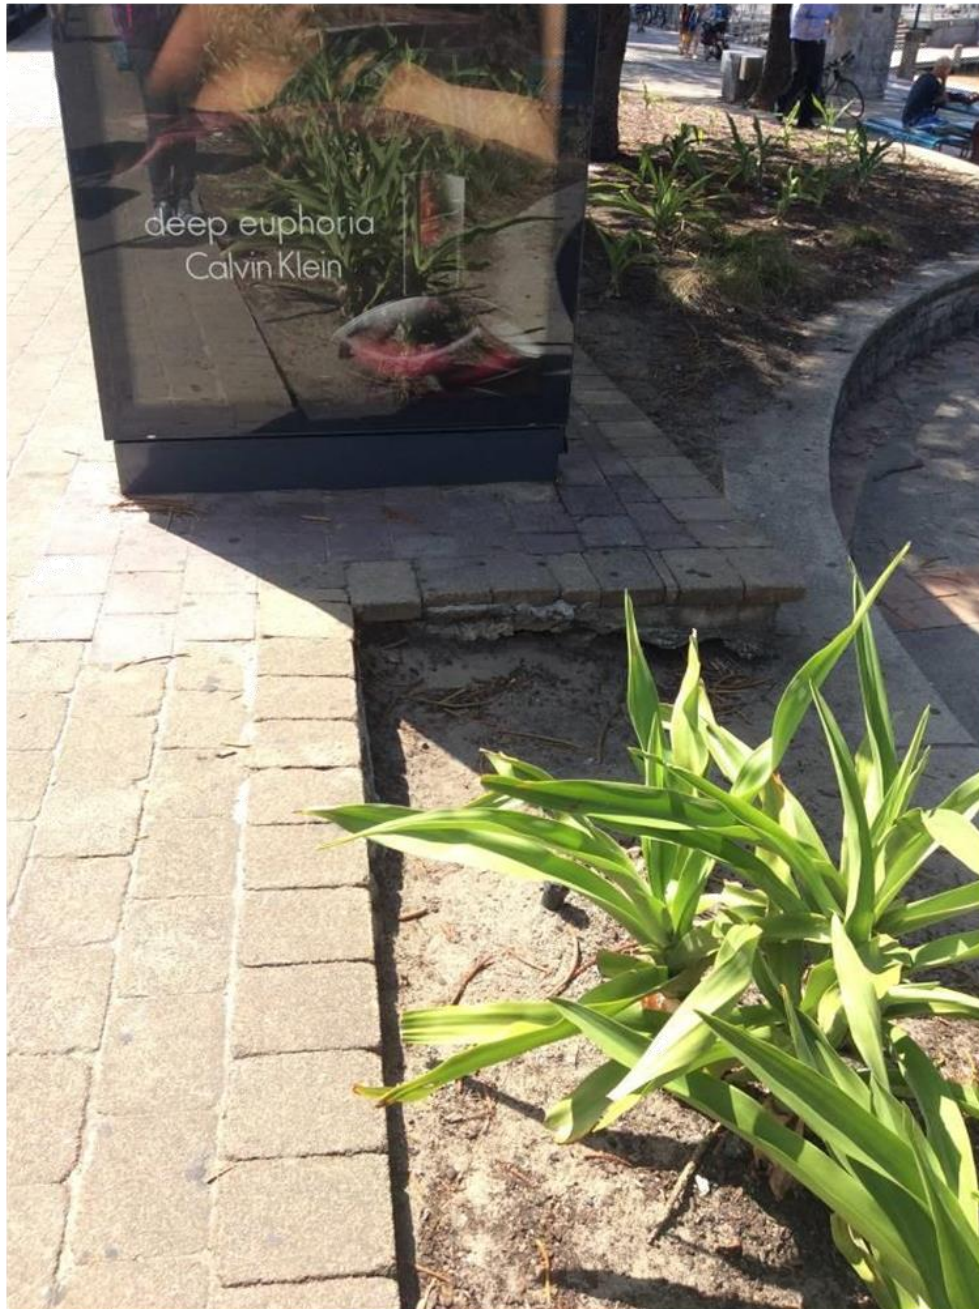
Reference WE 6 West of Eustace Street

Shown below in Figure 4.10 is an example of an unprotected drop. A drop off the side of a footpath as shown in this example may lead to injury.

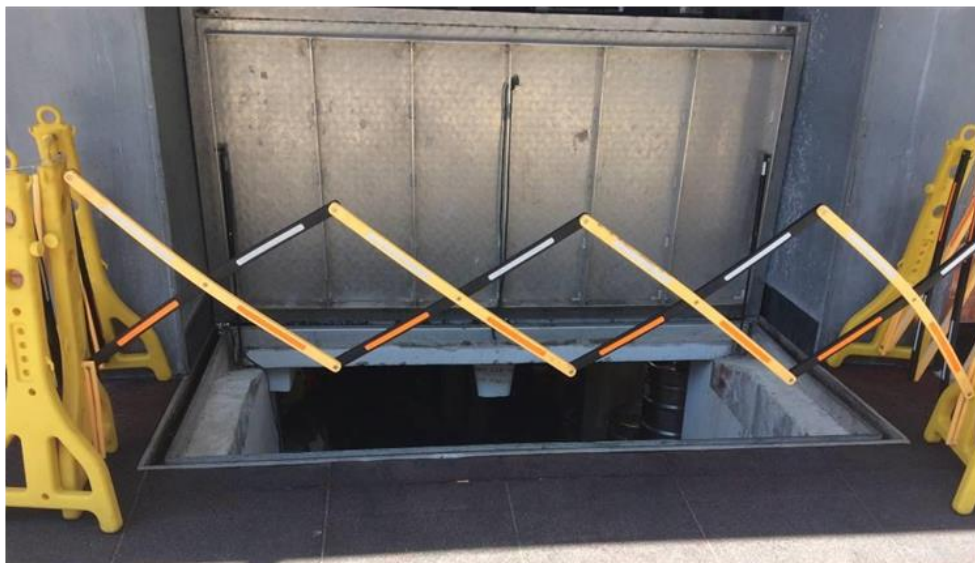
Reference PMSR 18 West of Central Avenue

Figure 4.11 shows an open cellar that was unattended at the time of the audit. If a distracted or vision impaired person were to walk and fall into the cellar it may cause significant injury.

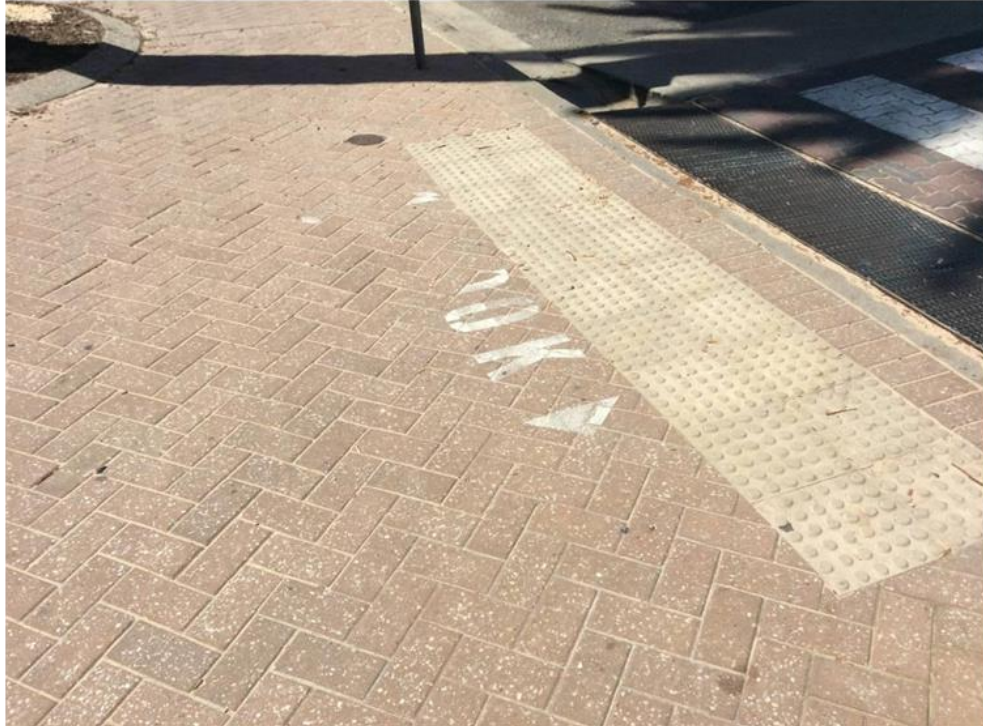
*Reference SS1 North of Ashburner Street*

Shown below in Figure 4.12, the direction "LOOK" linemarking and arrow is faded. This linemarking is in place to remind pedestrians of the need and direction to look for approaching vehicles.

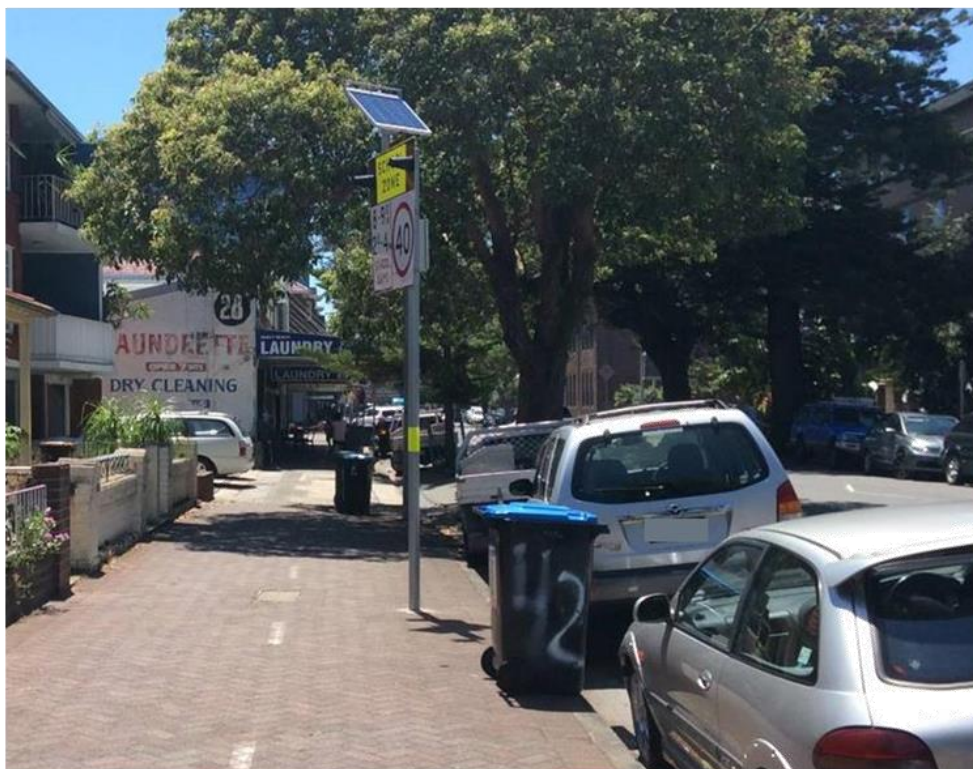
Reference DR182 North of Ashburner Street

Figure 4.13 is an example of a sign facing the wrong direction. In this example, the 40km/h school zone sign is facing the wrong direction and not towards the road.

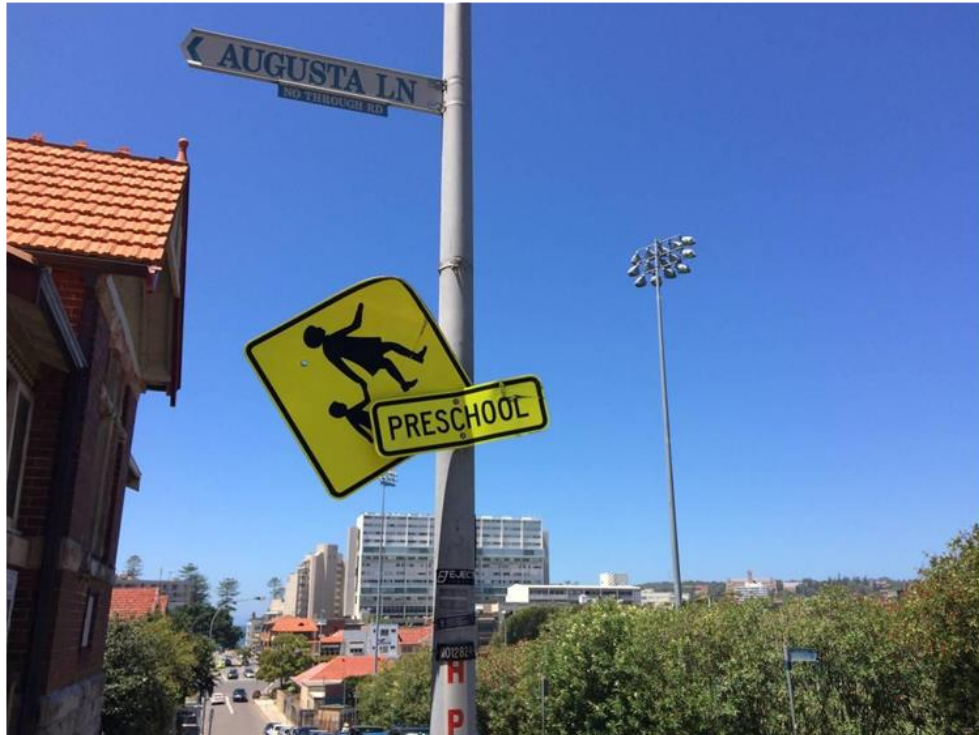
Reference RS108 West of Augusta Lane

Figure 4.14 shows a damaged warning sign. The damaged sign may not be visible to drivers and may increase the risk of a crash occurring involving pedestrians, in this case young children.

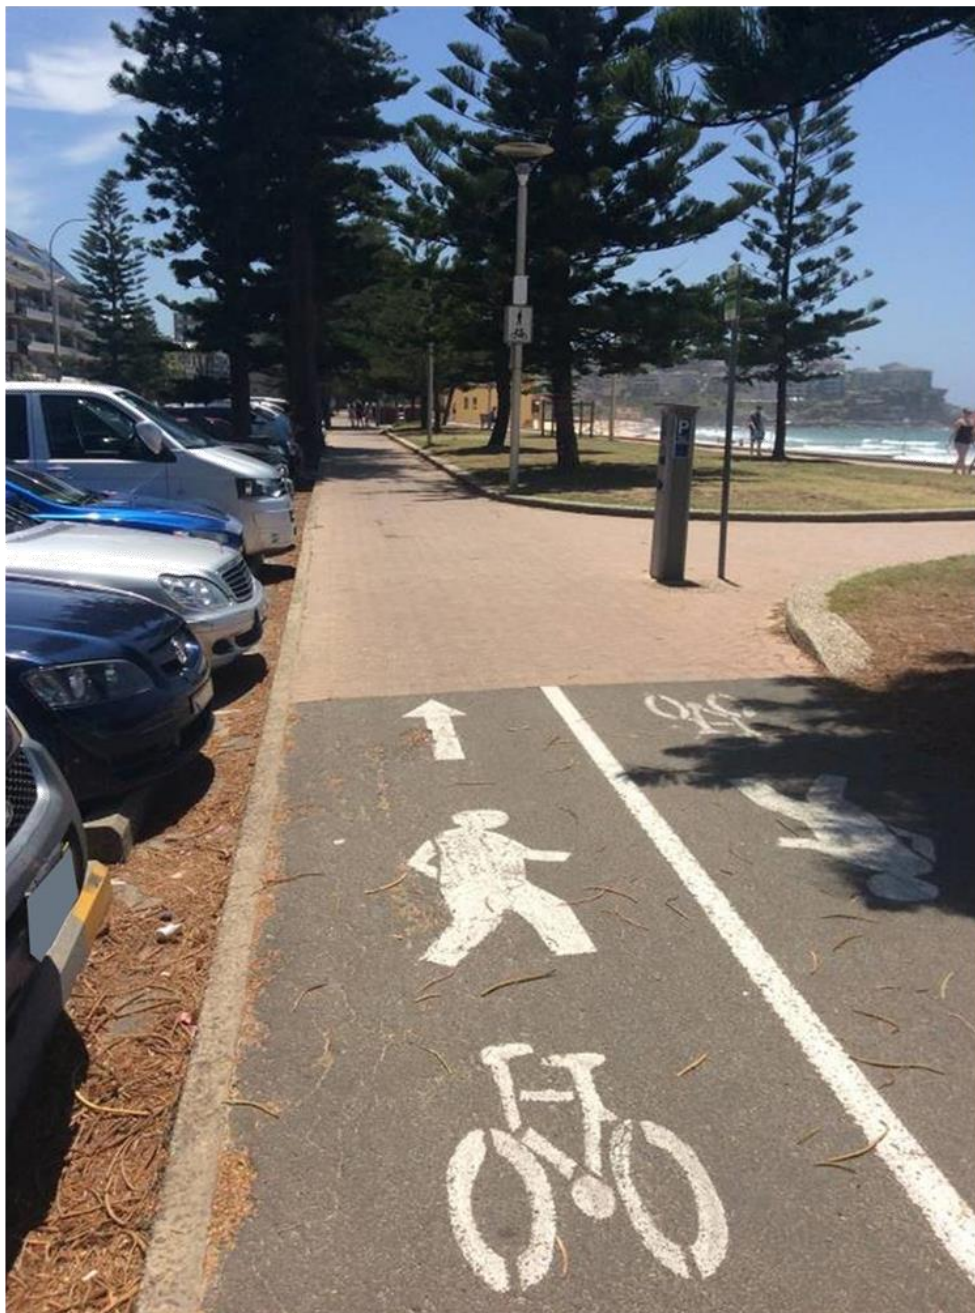
Reference MBF 6

In Figure 4.15, the linemarking for the shared path ends too early. In this case, the marking should continue the entire length of the foreshore. This missing linemarking may lead to a crash between cyclists and pedestrians using the shared path.

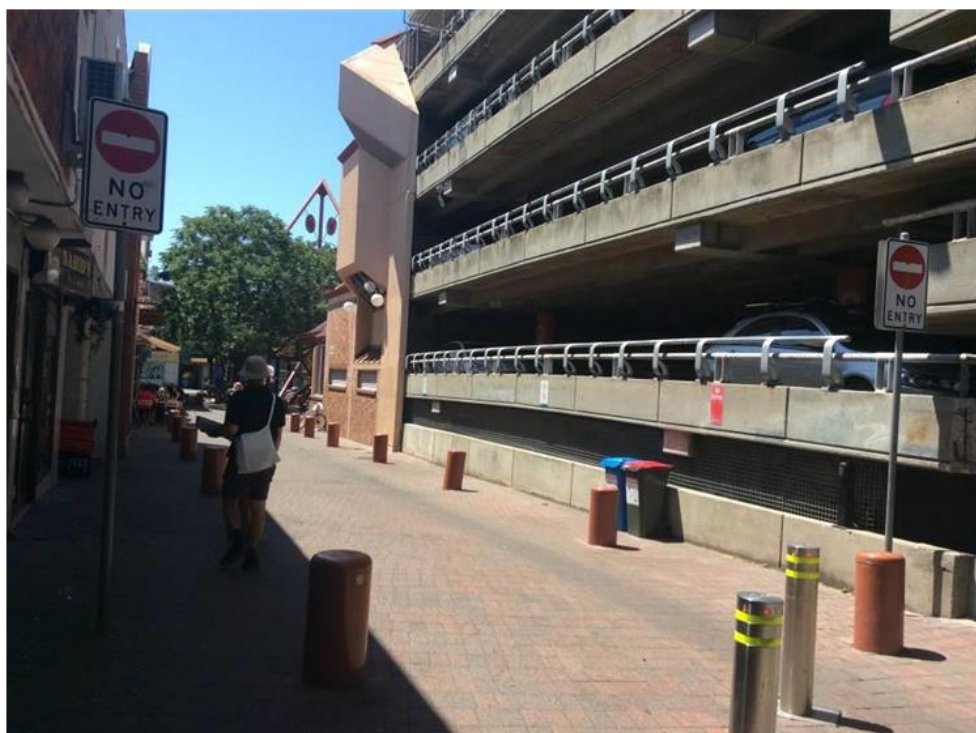
Reference ML 7

Shown below in Figure 4.16 is a set of bollards blocking the footpath. These bollards could lead to a visually impaired person or person who is less mobile sustaining an injury from a fall or tripping.

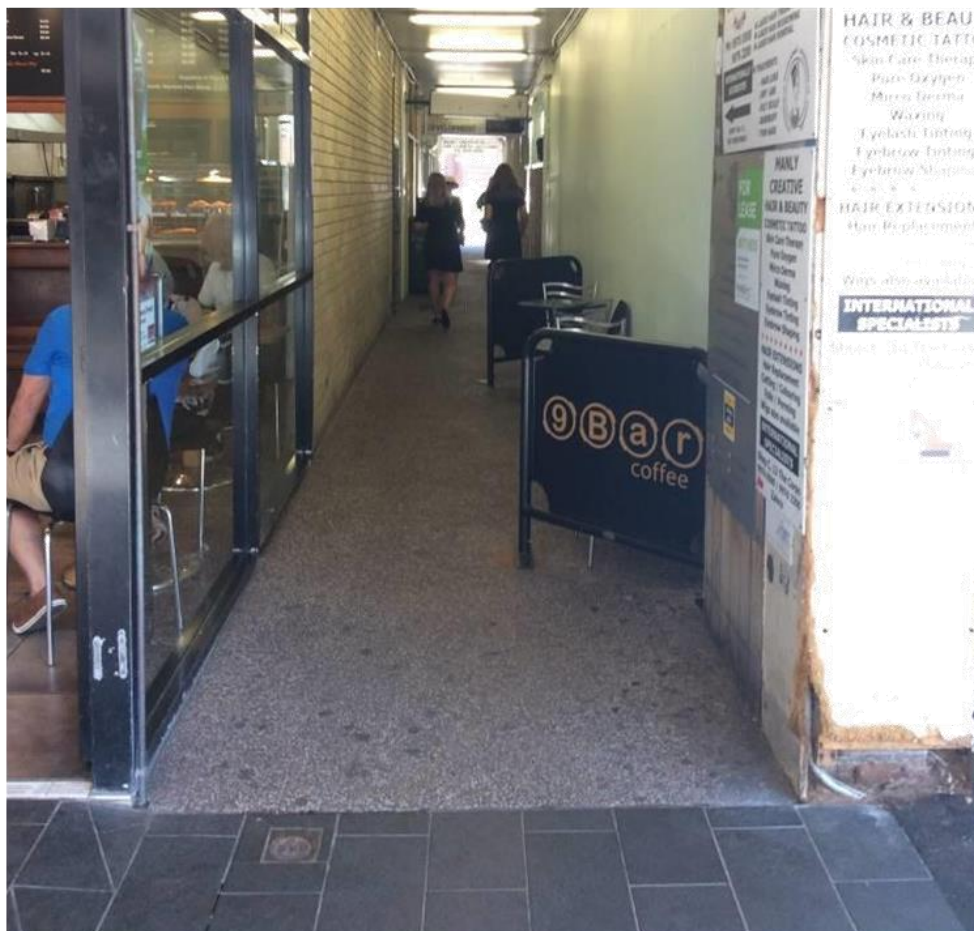
Reference TC42 West of Central Avenue

Figure 4.17 shows café tables blocking a narrow path. These tables may prevent a person who is less able from being able to pass and use the footpath.

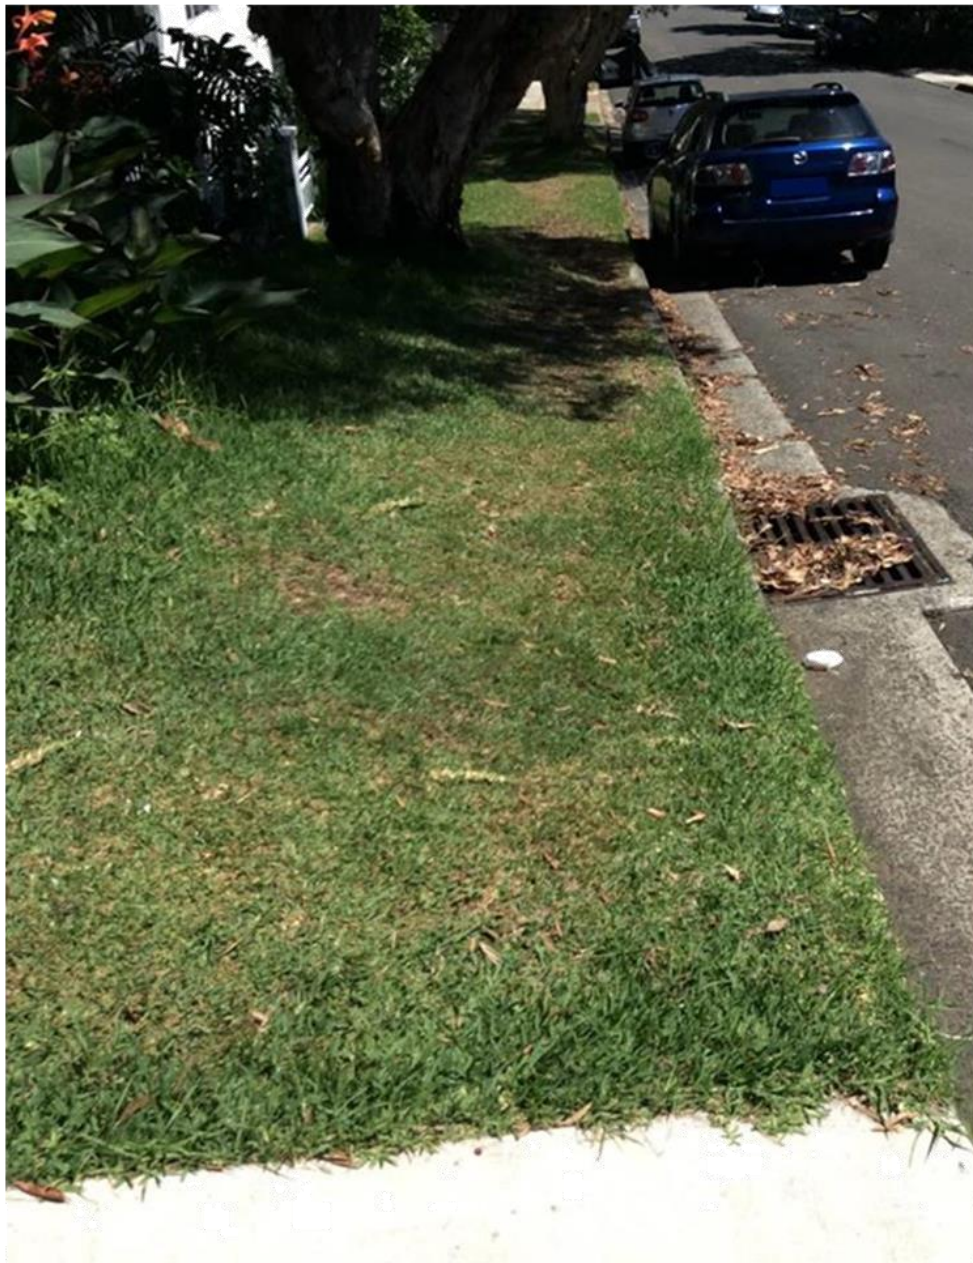
Reference MS 35 West of Osbourne Street

Shown below in Figure 4.18 is an example of a footpath ending and not continuing down the length of the street. This may prevent pedestrians who are less mobile from being able to access sections of the street or the facilities to which the streets lead.

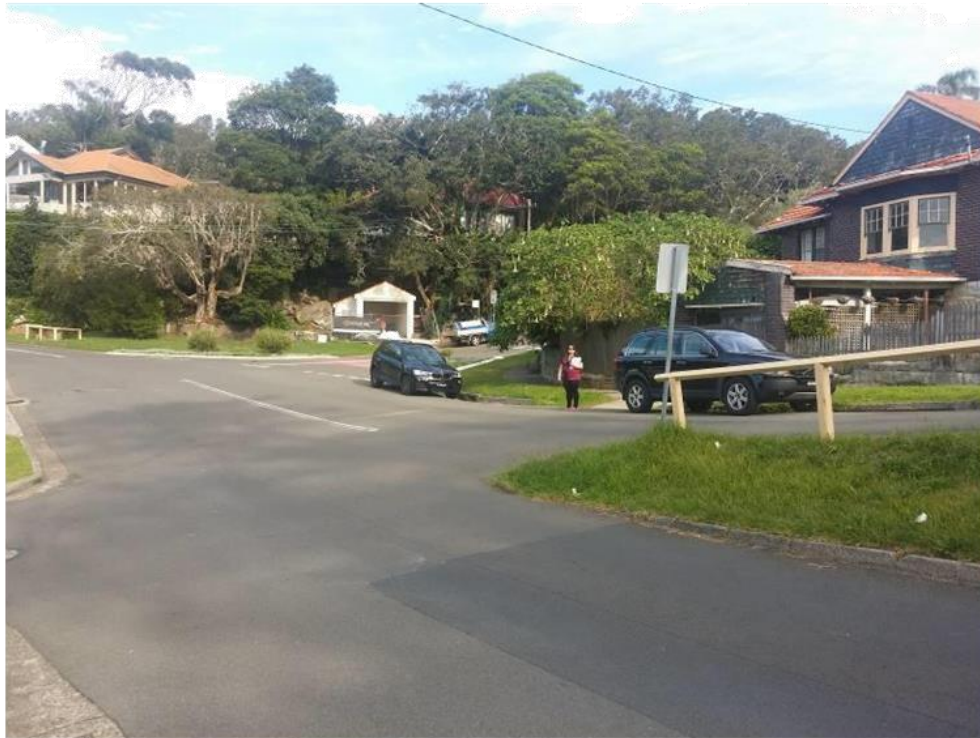
Reference BS44 North of Bower Lane

Figure 4.19 is an example of a missing crossing opportunity. In this case, a pedestrian is may not be able to cross the road safely because the road is wide, on a curve and there are no kerb ramps along a pedestrian's path of travel.

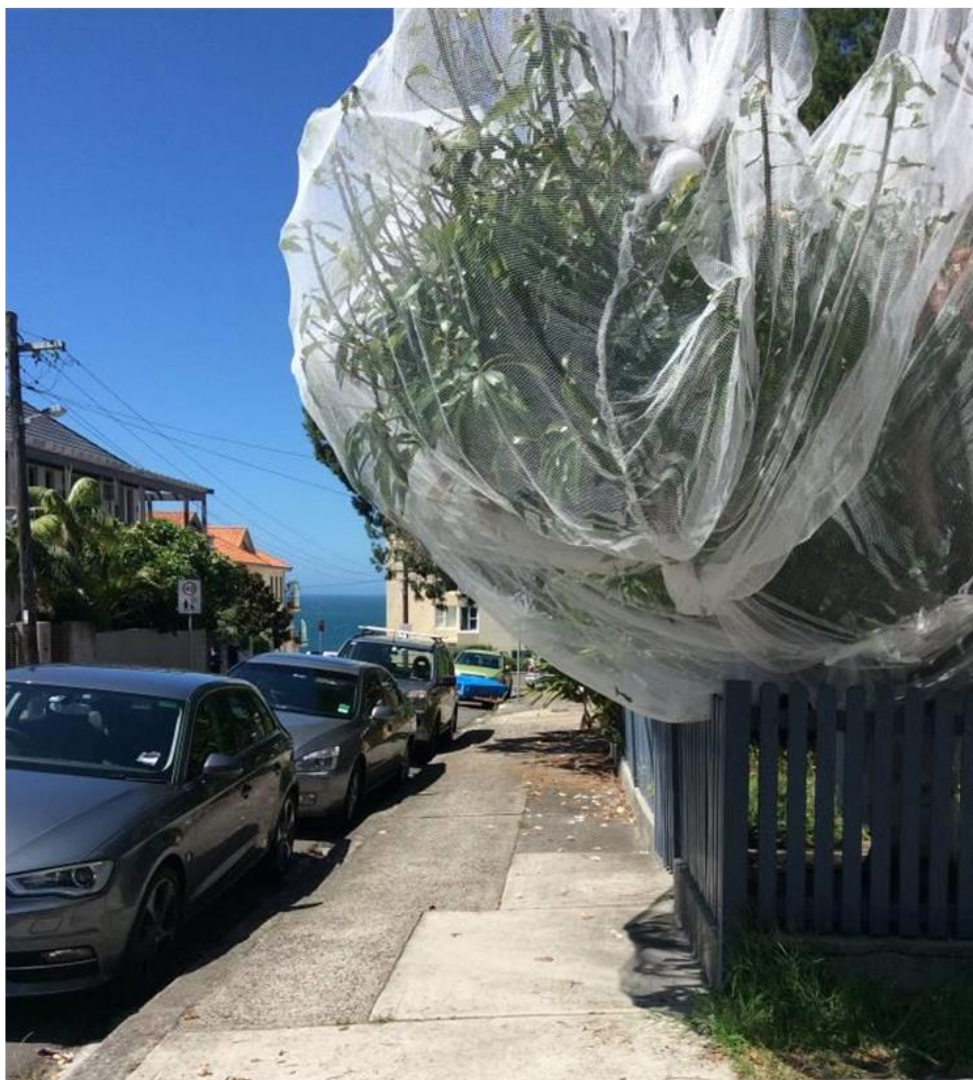
Reference RDS10 South of Cliff Street

Shown below in Figure 4.20 is an example of a bush or tree blocking a section of the footpath. This may prevent pedestrians from using this section of footpath.

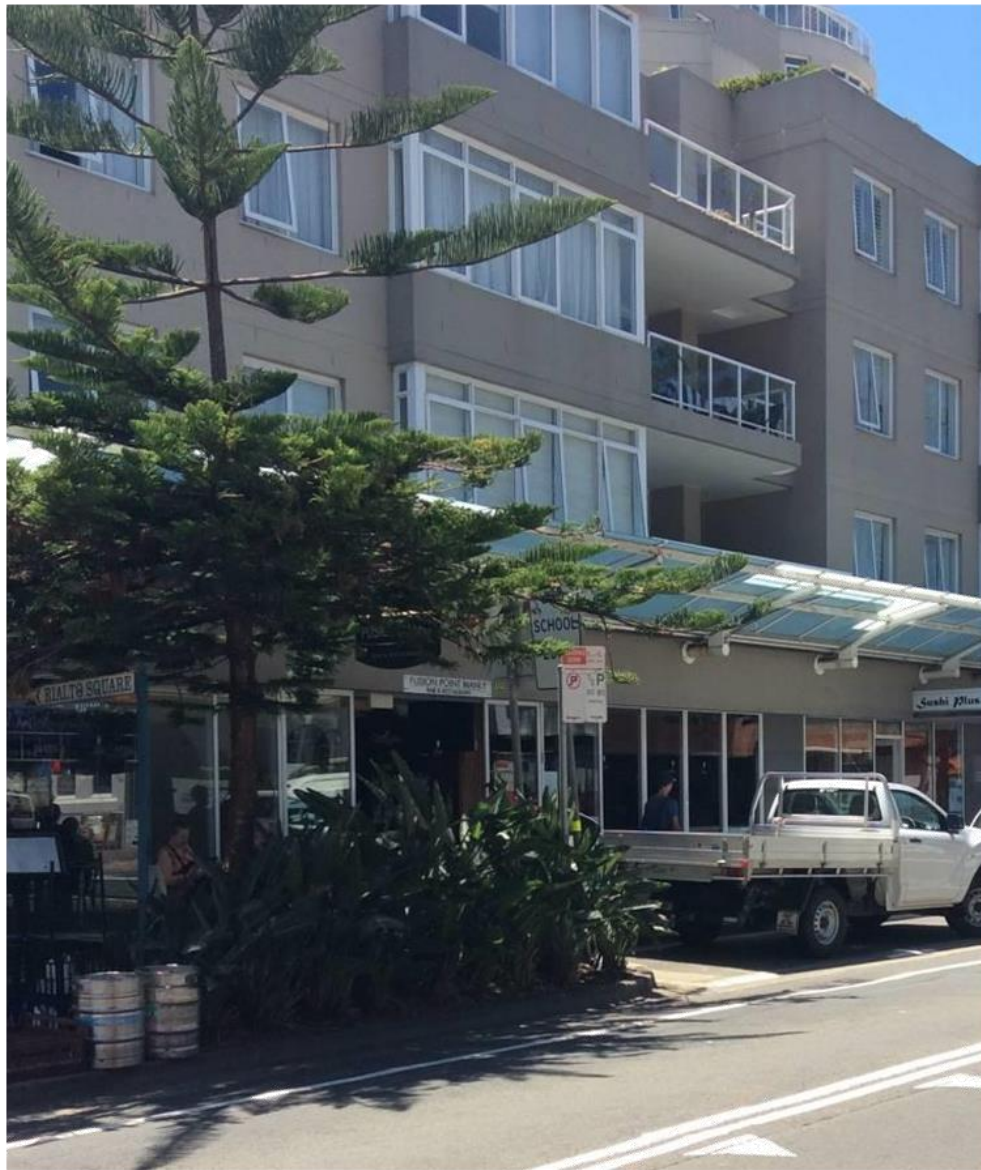
Reference WS22 West of South Steyne

Figure 4.21 shows a tree blocking an "end school zone" sign, which may prevent drivers from seeing the sign.

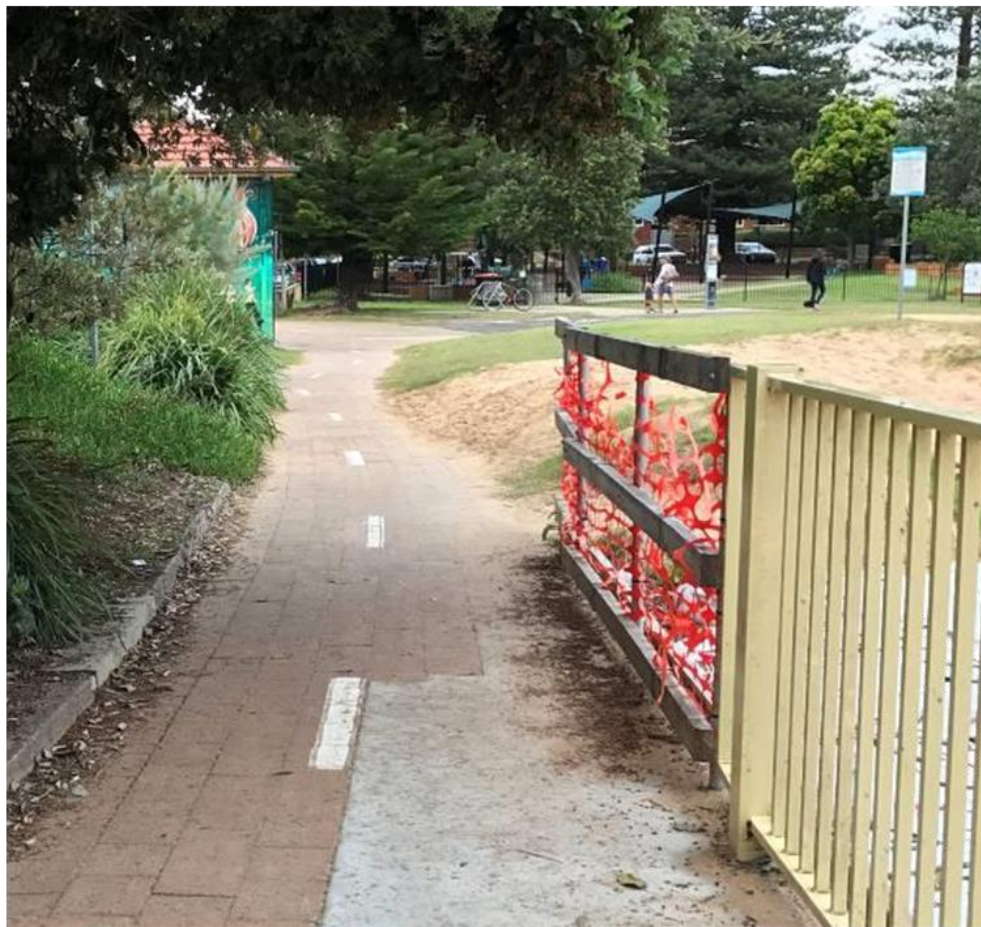
Reference ML 13 West of Bridge Road

Shown below in Figure 4.22 is a broken railing, which may pose a danger to passing pedestrians if they were to fall through the railing.

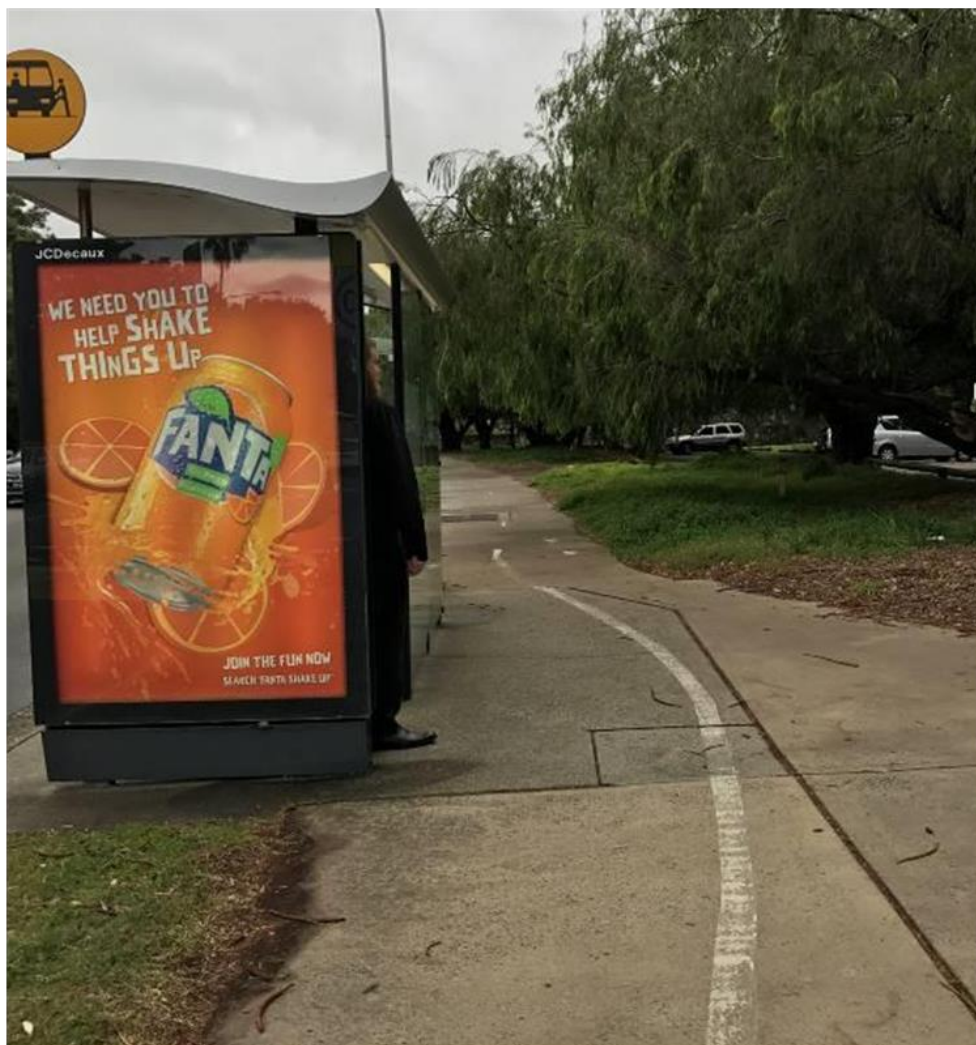
Reference PW 303 North of Eurobin Avenue

Shown below Figure 4.23 demonstrates blocked sightlines along a shared path. If a pedestrian using the bus shelter were to step out, a bicycle user would not be able to see them properly and it may lead to a crash and potentially an injury.

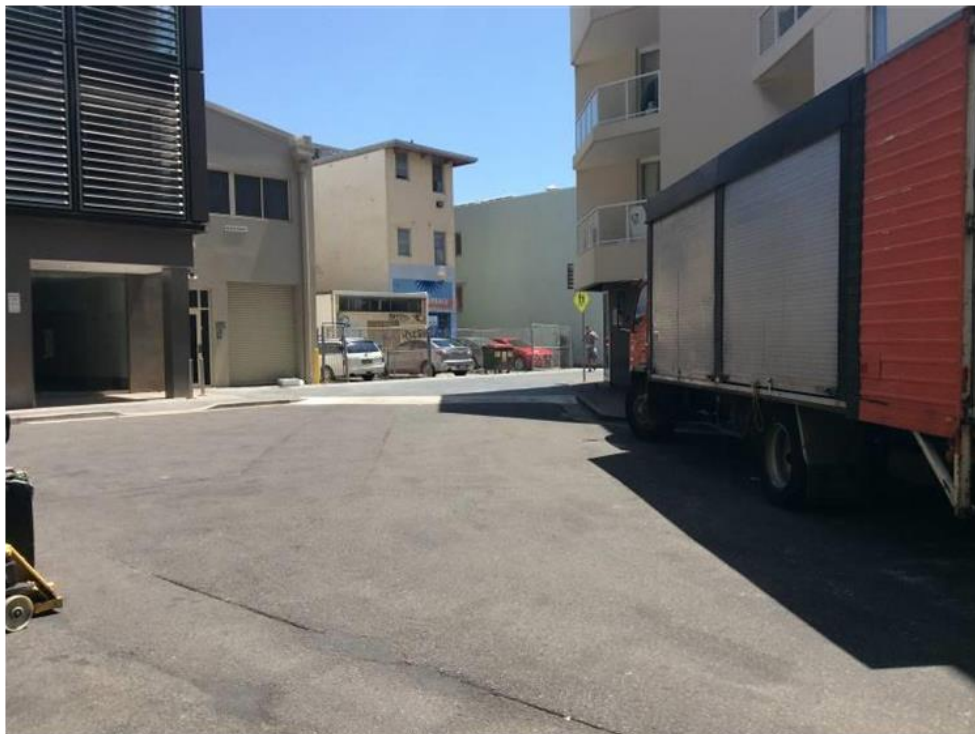
Reference RL 2

Figure 4.24 is an example of a high conflict area within a combination loading and high pedestrian area. This area contains trucks loading and offloading goods in loading docks and loading bays throughout the high pedestrian area. Trucks and large delivery vehicles tend to have reduced sightlines. If a pedestrian were to be in a truck's "blind spot" when it manoeuvred, it could lead to a serious injury.

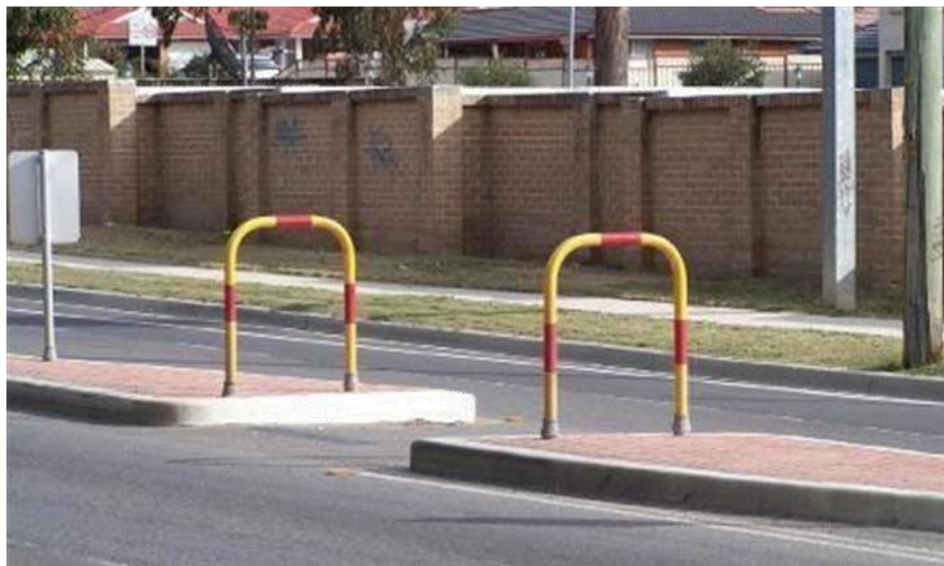
**Figure 6.2: Example of a Pedestrian Refuge**

A pedestrian refuge is an island in the middle of the road. The island allows pedestrians to cross the road in two stages. An example of a pedestrian is shown in Figure 6.2.

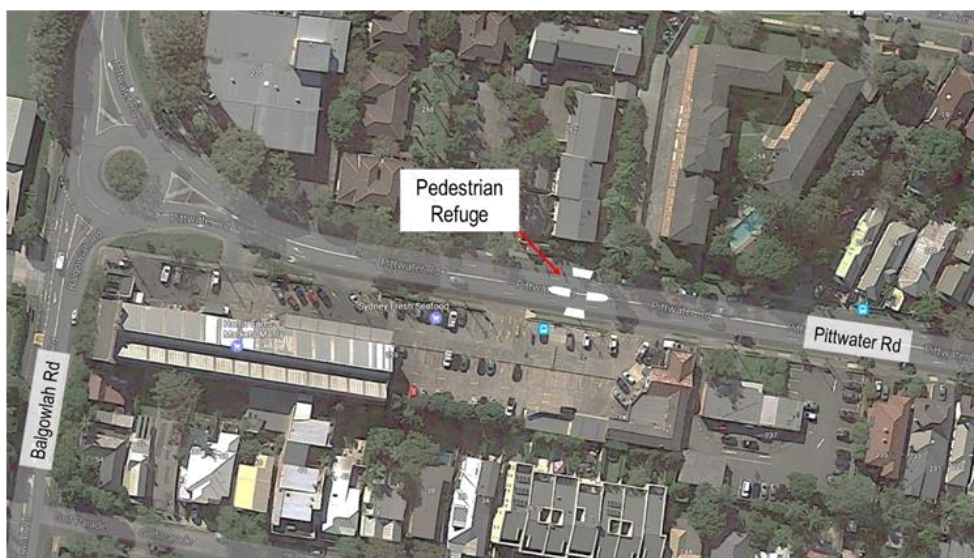
**Figure 6.3: Concept Design for Refuge Island on Pittwater Road**

Option 1 evaluates the construction of a pedestrian refuge and kerb extension on Pittwater Road. At the proposed location, a kerb extension would minimise the crossing distance. Although Pittwater Road is a four-lane road, it is operating as a two-lane road with kerb side parking allowed. Hence, the installation of kerb extensions and a refuge island are not likely to disrupt the existing traffic conditions. While refuges do not give pedestrians right of way, they allow crossing to be staged one traffic stream at a time. The relocation of bus stops would need to be considered in conjunction with Transport for New South Wales and Roads and Maritime Services.

It should be noted that this option, however, is only a short-term solution. With continued growth in the Manly LGA the need to install clearways along Pittwater Road to enable four lanes of free-flowing traffic would become apparent, this would then dictate the removal of the pedestrian refuge and if the pedestrian volumes warranted, a signalised mid-block crossing (traffic lights) could be installed in place of the refuge island.
