## MANLY BEACH, WHARF AND TOWN CENTRE PEDESTRIAN ACCESS & MANAGEMENT PLAN DRAFT

NORTHERN BEACHES COUNCIL

Project No: P2934

Issue date: 7 June 2017

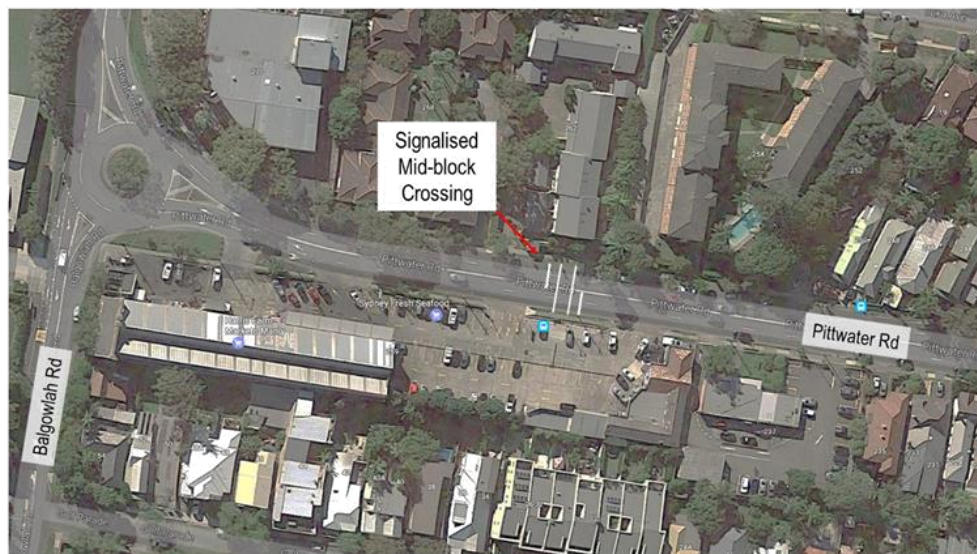
**Figure 6.4: Concept Design for a Mid-block Crossing (Pedestrian Traffic Lights) on Pittwater Road**

Option 2 proposes the installation of a signalised mid-block crossing (pedestrian traffic lights) in a similar location as proposed in Option 1. The installation of a signalised mid-block crossing may greatly reduce the risk for pedestrians wanting to cross Pittwater Road, specifically less mobile pedestrians who may not be able to cross at a refuge island in a timely or safe manner. Further consideration would need to be given to the coordination of the signal timing with the signalised intersection upstream and downstream. This would ensure that the installation of the signalised mid-block crossing (pedestrian traffic lights) does not worsen the existing traffic conditions. Figure 6.4 outlines the proposed location for the midblock crossing.

Although the existing pedestrian counts would not warrant for a signalised mid-block crossing, given the number of elderly residents located in the area, the installation of mid-block crossing is desirable. Additional consultation with Roads and Maritime Services to approve the installation of a signalised mid-block crossing would be required.

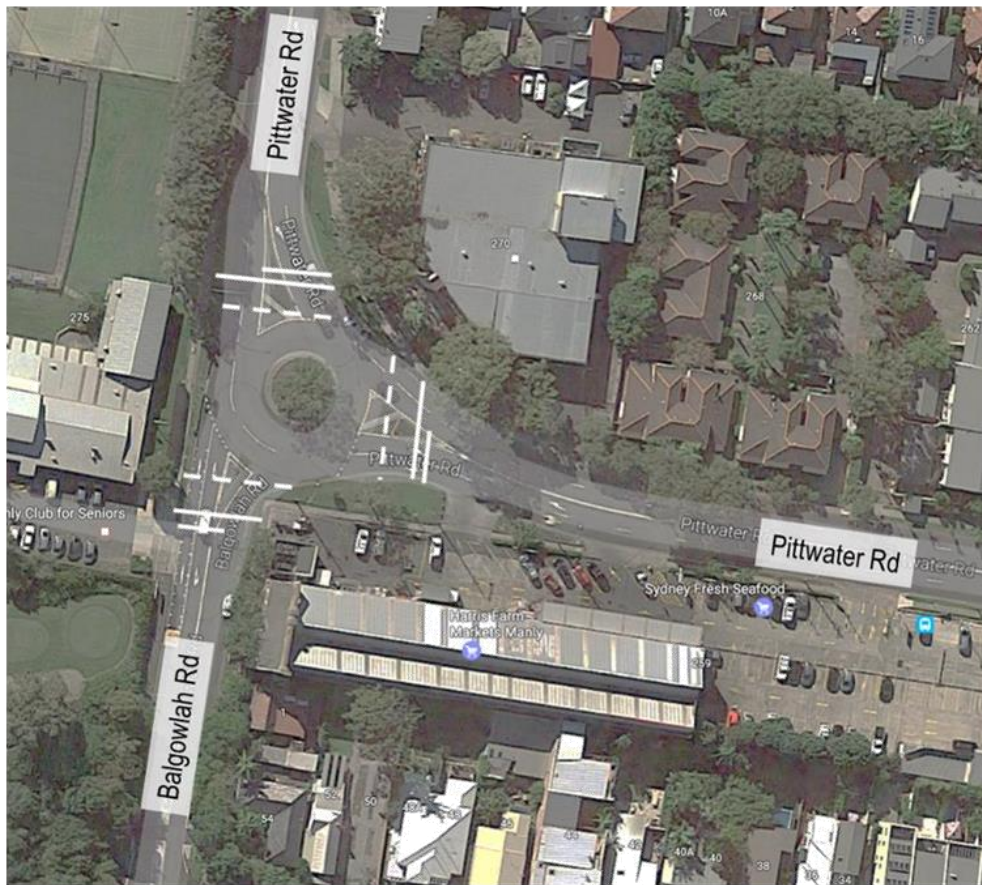
**Figure 6.5: Concept Design for Fully Signalised Intersection Pittwater Road**

Option 3 would be to convert the existing roundabout at Pittwater Road and Balgowlah Road into a signalised intersection (traffic lights). This option would provide protected pedestrian crossings on all approaches. Further analysis would be required in designing the intersection. Signal coordination with the signalised intersection upstream and downstream would be required. This option would involve significant civil construction works and may cause some disruption to traffic and considerable cost in the design and construction stages.

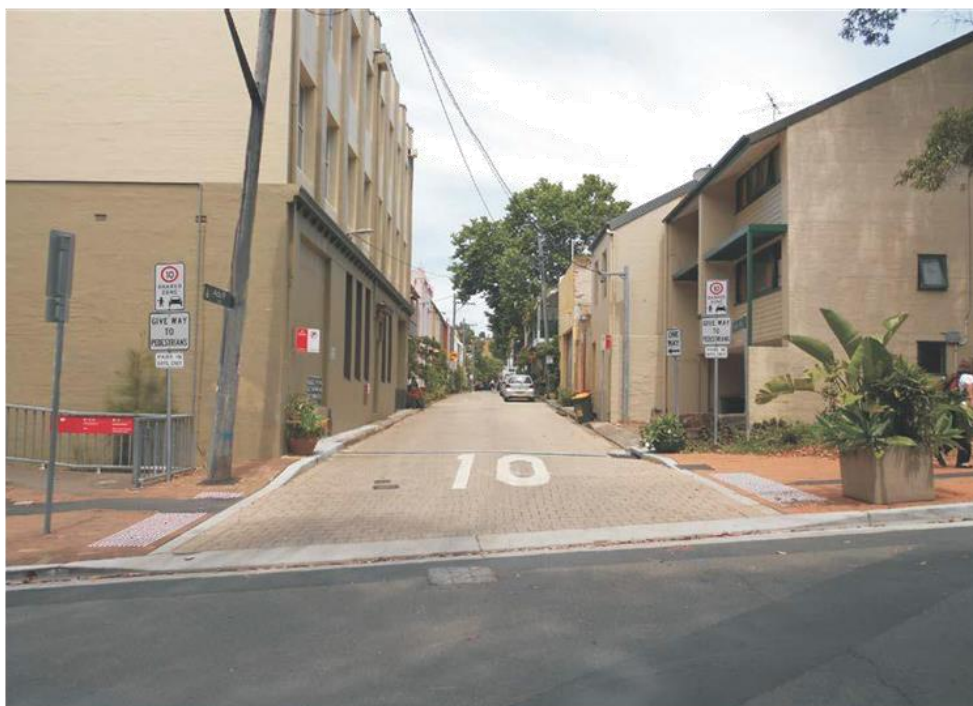
It is recommended that Bower Lane be converted to a shared zone, similar to the example shown in Figure 6.6, in accordance with the *Roads and Maritimes Services Design Implementation of Shared Zones Including Provision for Parking* (TTD 2016/001). A link to which can be found in Appendix A.

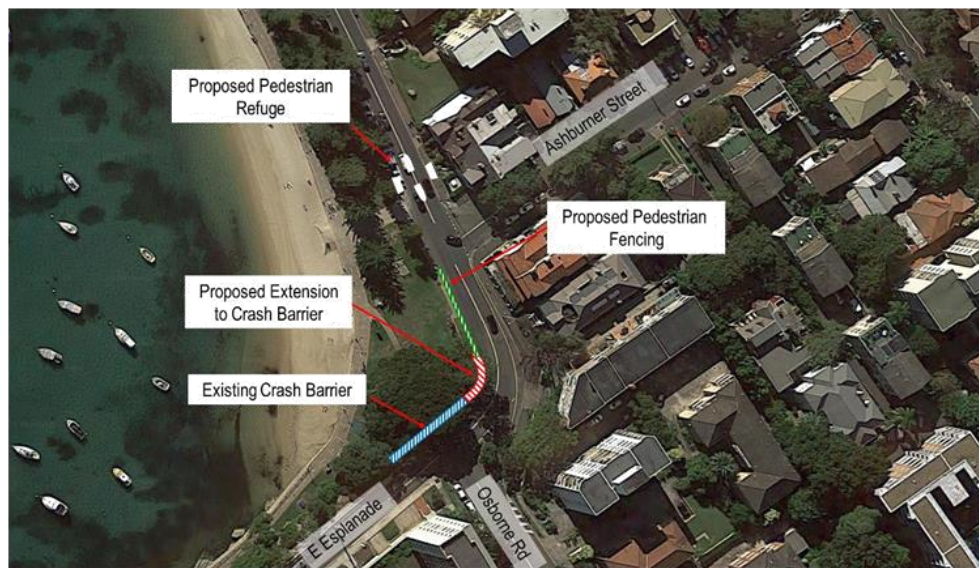
**Figure 6.8: Proposed Changes to East Esplanade and Ashburner Street**

To improve pedestrian safety further, the extension of the crash barrier on the northern side of East Esplanade, pedestrian fencing, and a pedestrian refuge just north of Ashburner Street are recommended, as shown in Figure 6.8. The intention is to direct pedestrians away from the corner and create a safe location to cross.

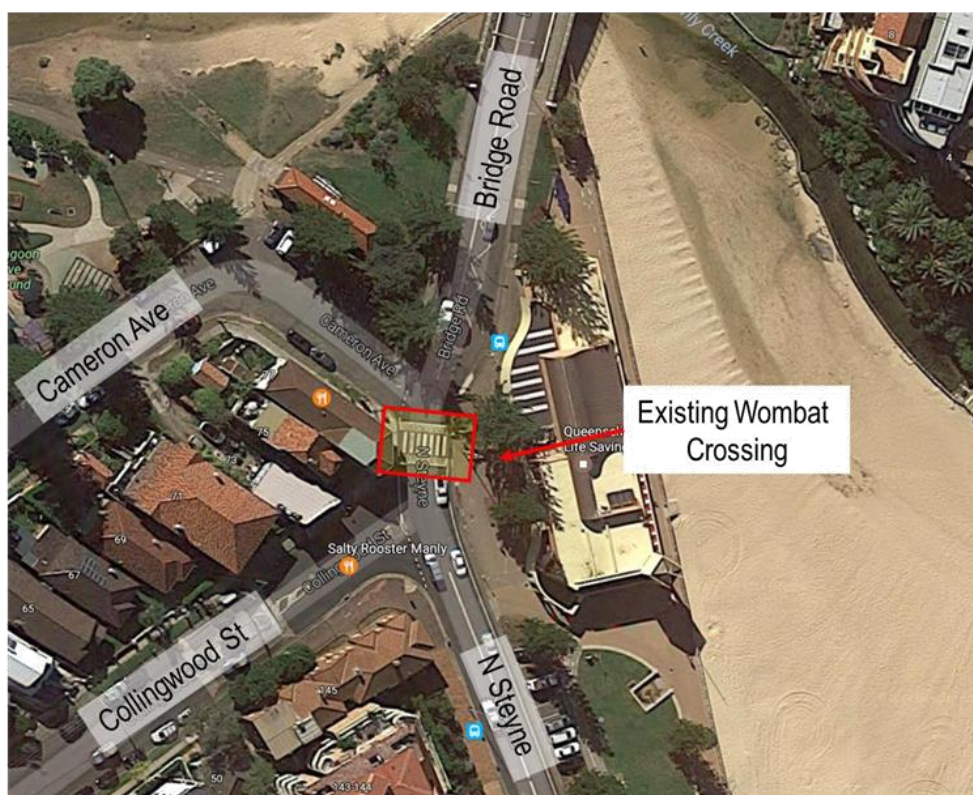
**Figure 6.9: Location of Pedestrian Crossing North Steyne and Bridge Road**

The location and use of the wombat crossing near Queenscliff Surf Life Saving Club located at the intersection of North Steyne, Collingwood Street, Cameron Avenue and Bridge Road was raised as a concern. It was identified that the use of this crossing was causing congestion for vehicles at the intersection. It was observed that pedestrians parked their cars in Cameron Avenue, which is time restricted to a period of less than 2 hours (2P parking), and then use the crossing to access the foreshore and Queenscliff Surf Life Saving Club (QSLSC). Given the regular use of the crossing for access to the QSLSC and other attractors, concerns were raised about the safety of children and other pedestrians, who would regularly use the crossing for the Nippers junior activities program and access to the beach.

An evaluation of the appropriateness of the crossing was undertaken and found that under section 7.2.4 in *Austrroads Guide to Traffic Management, Part 8: Local Area Traffic Management*, a wombat crossing at this location would be inappropriate. The section states, due to insufficient sight distance a wombat crossing would be inappropriate. The crossing is shown in Figure 6.9.

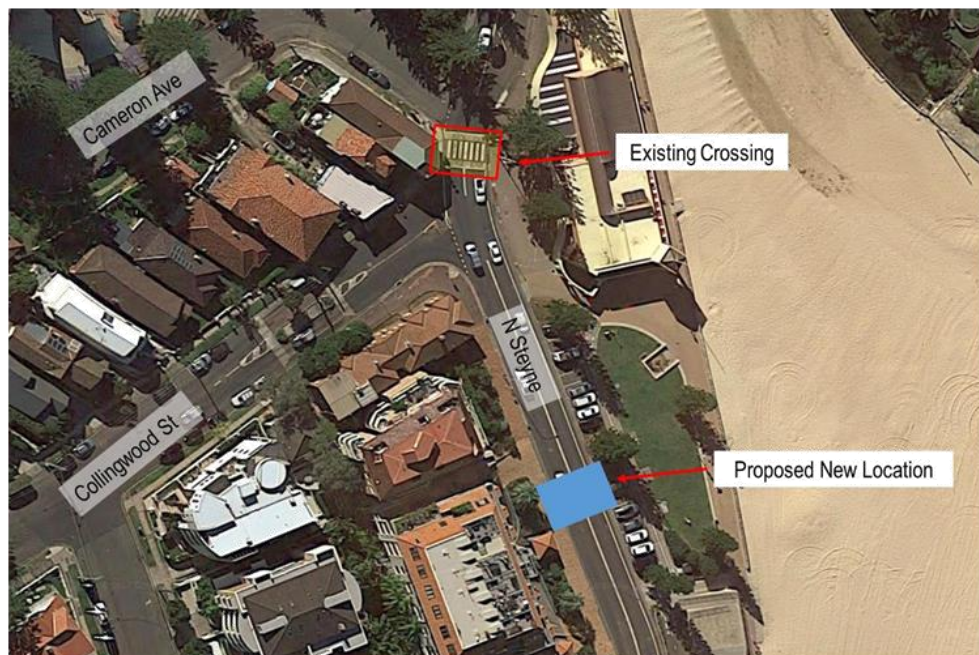
**Figure 6.10: Concept Design Relocation of North Steyne Pedestrian Crossing**

Option 1 involves the relocation of the existing wombat crossing south, approximately 50 to 60 metres along North Steyne, as shown in Figure 6.10. The location for the proposed wombat crossing is on a straight section of road with clear sightlines in both directions and no adjoining side streets.

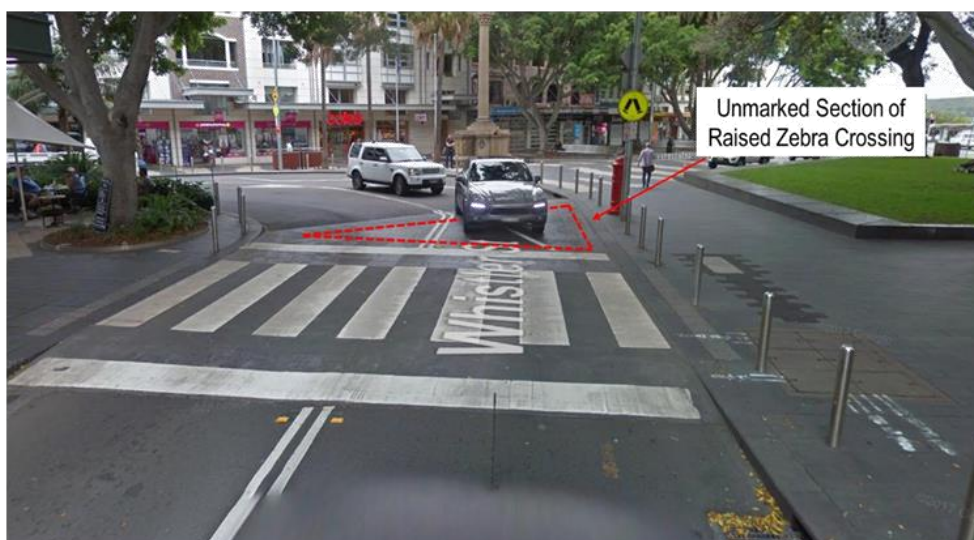
**Figure 6.13: Pedestrian Crossing Located at The Town Hall**

An audit was conducted pursuant to the guidelines set out in section 7.2.4 in the *Austroads Guide to Traffic Management, Part 8: Local Area Traffic Management*. The guidelines specify that the distance from the edge of the marked crossing to the outer edge of the ramp be no more than 1.5m. The limit is exceeded in this crossing, as shown in Figure 6.13.

Some pedestrians were observed to use the unmarked section of the crossing rather than cross at the marked section, which may pose a risk to pedestrians. This is due to drivers not expecting a pedestrian to step onto the road prior to the formal crossing.

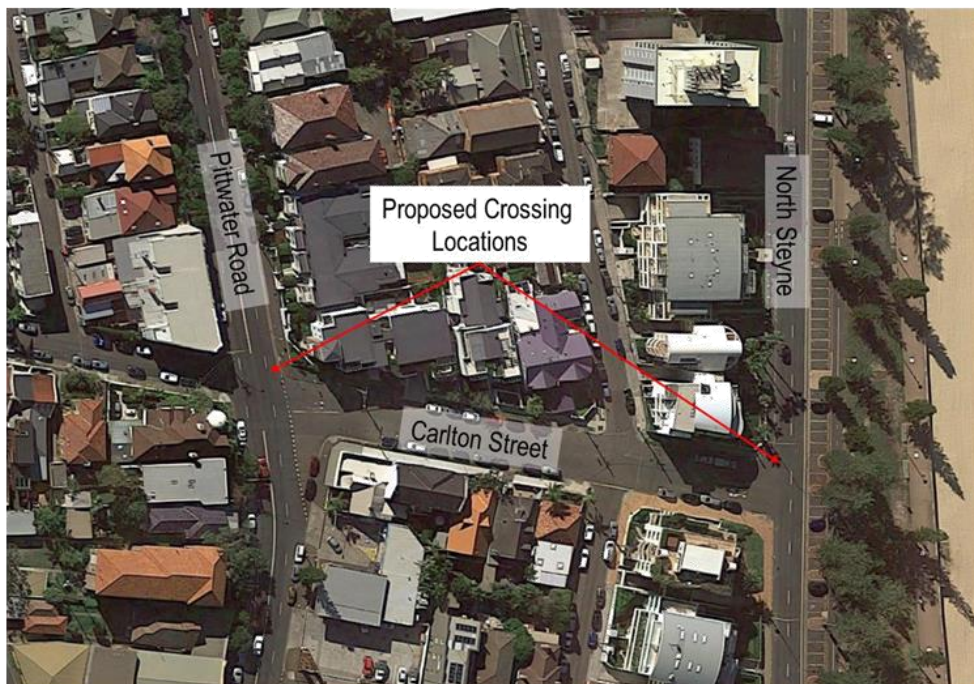
**Figure 6.15: Proposed Location for Pedestrian Crossing - Carlton Street**

The issue of crossing Pittwater Road and subsequently North Steyne, at or within proximity to Carlton Street, was raised. The main concern was that there was no existing pedestrian crossing at these locations.

Residents were concerned that it was too dangerous to cross Pittwater Road, especially with children, and that the nearest safe place to cross was Pine Street or Raglan Street, 220m North and 320m South of Carlton Street respectively. Two proposed locations for crossings are shown in Figure 6.15 below.

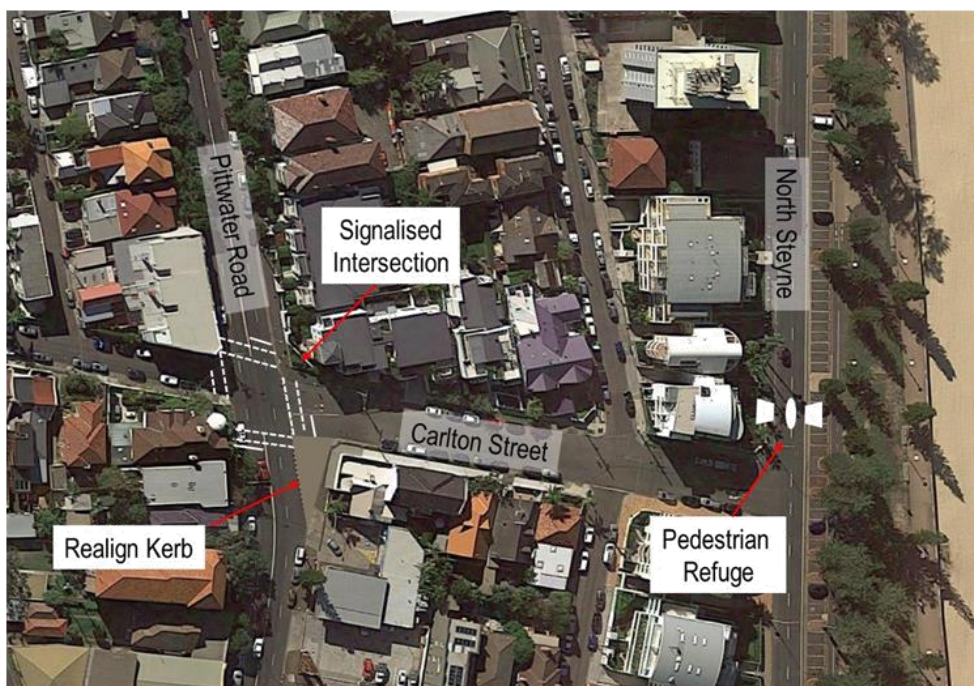
**Figure 6.16: Concept Design Pedestrian Infrastructure Carlton Street**

To allow safe crossing at Pittwater Road the intersection would need to be converted to a fully signalised intersection (traffic lights). This would allow for safe crossing for both those less mobile pedestrians and parents crossing with prams or children. In conjunction with the signalised intersection, a pedestrian refuge would need to be installed at North Steyne just north of Carlton Street. A concept design for the proposed crossings are shown in Figure 6.16.

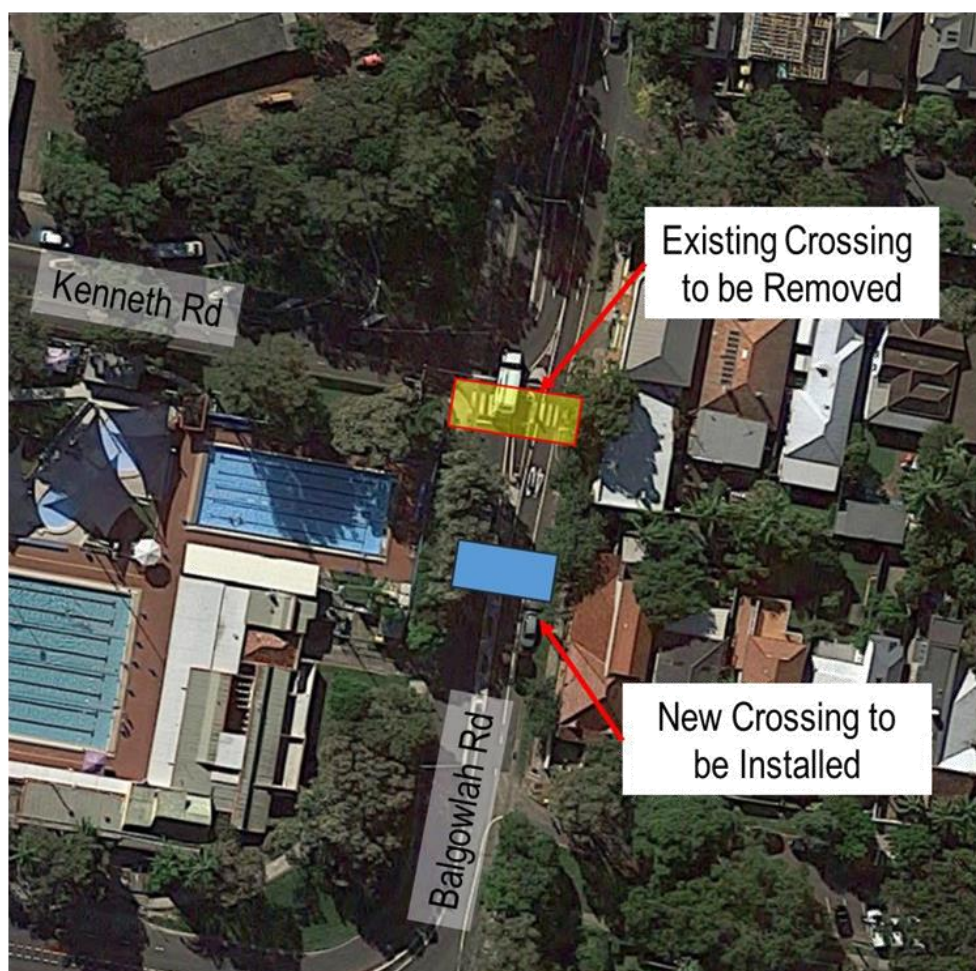
Figure 6.19: Option 2 Concept Design Relocation of Balgowlah Road Pedestrian Crossing

Option 2 recommends the zebra crossing be relocated 20 metres south along Balgowlah Road. This option would give drivers room to stop between the crossing and the stop line, reducing the likelihood for a driver to stop across the zebra crossing. It also increases visibility for pedestrians crossing, as vehicles turning into Kenneth Road from Balgowlah Road are less likely to obstruct the view of pedestrians. Although the new location has a decreased risk to pedestrians, some users may be less likely to use the crossing, as they would have to change path from the desired path of travel. The installation of the new crossing may also require removal of some parking near the Noahs Ark Child Care Centre and Manly Andrew Boy Charlton Swim School.

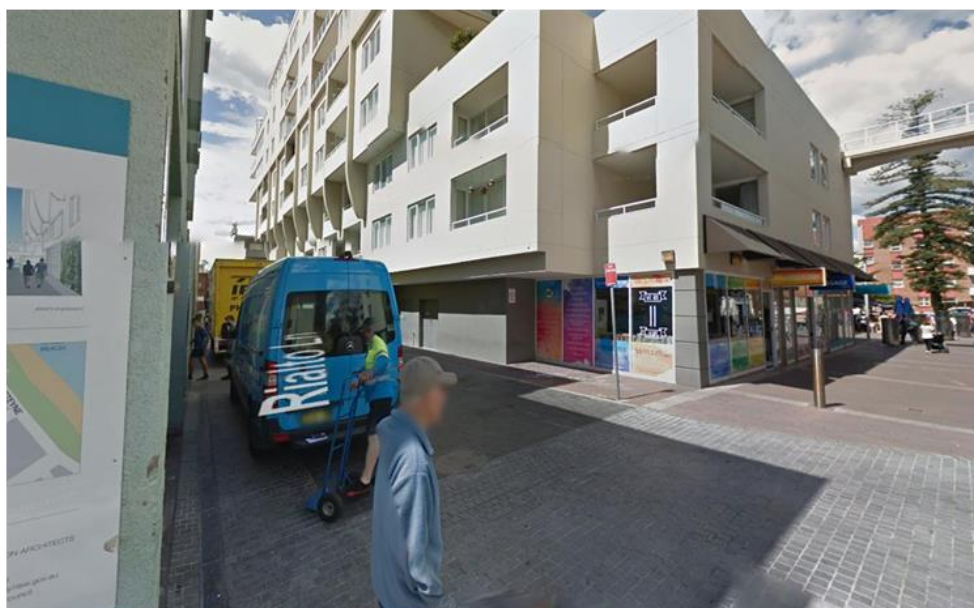
**Figure 6.25: View of Rialto Lane from Path to The Corso**

Rialto Lane was identified as having a higher risk to pedestrian safety due to the combined loading zone and pedestrian use. Changes have already been made to the area to pedestrianise the laneway; however, due to the high volume of cars and delivery vehicles, significant risk still exists for pedestrians.

According to the current Urban Design Guidelines from Northern Beach Council, there is a plan to enhance street/lane frontage to Rialto Lane, as such future developments will be required to incorporate active frontage. Thus, any development submitted after April 2002 will be subject to these guidelines.

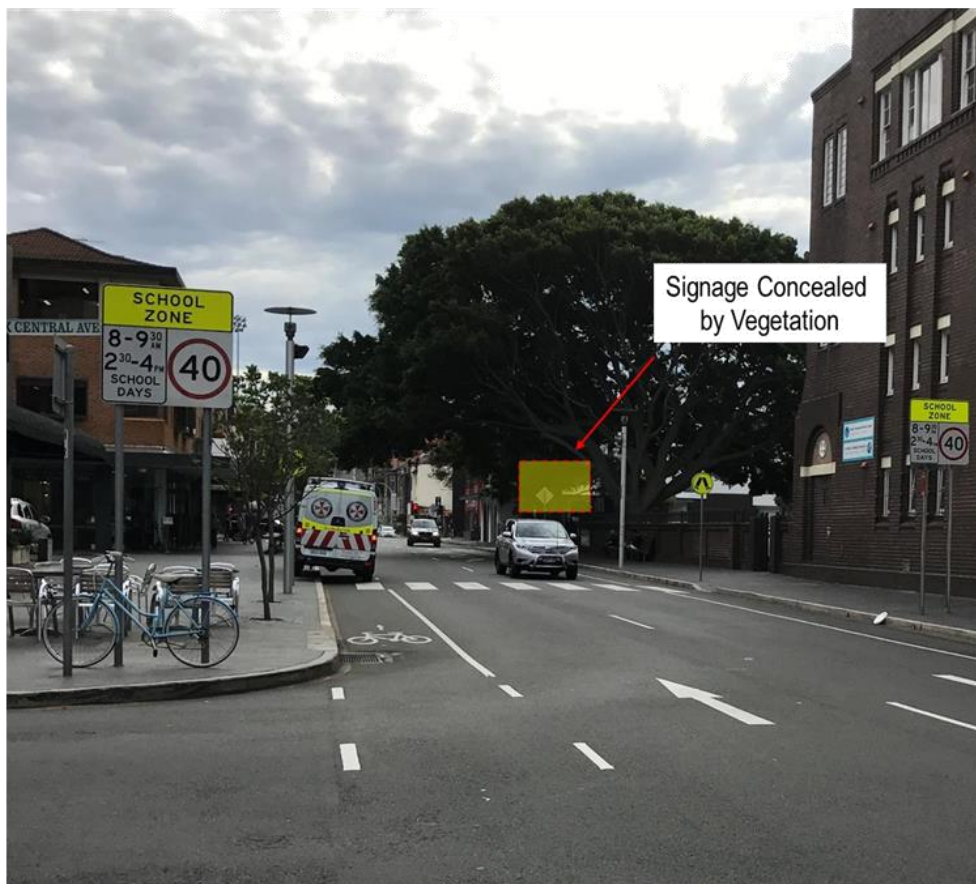
**Figure 6.26: Photo of Raglan Street Pedestrian Crossing**

Following the audit, the crossing was found to be non-compliant with *AS1742 Part 10: Pedestrian control and protection* and *Roads and Maritime Supplement to Australian Standard 1742 Manual of Uniform Control Devices parts 1-15 Version 2.4*. AS1742 and the supplement require double white centrelines on

each approach to the crossing, with a minimum length of 20 metres and Bi-directional Raised Reflective Pavement Markers at 5 metre spacing. As shown in Figure 6.26 below, the Raglan Street crossing does not currently meet this requirement.

It is recommended that the linemarking for the crossing in question be installed in accordance with AS1742 Part 10: Pedestrian control and protection and Roads and Maritime Supplement to Australian Standard 1742 Manual of Uniform Control Devices parts 1-15 Version 2.4.

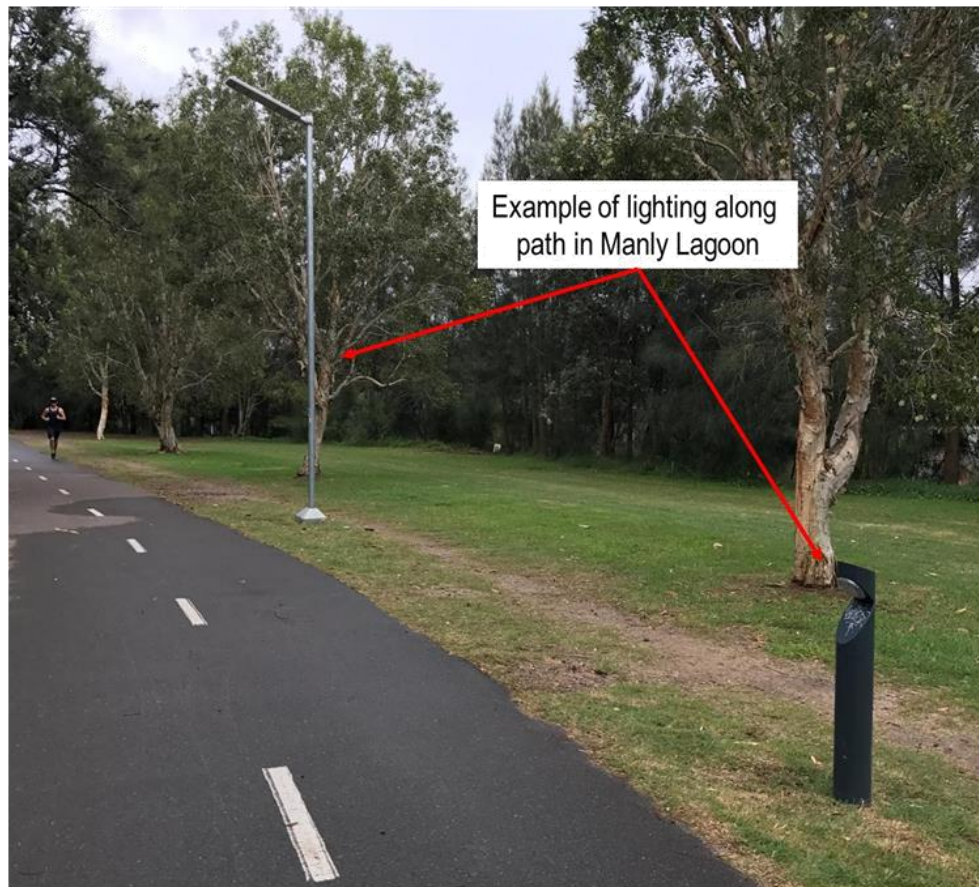
**Figure 6.30: Example of Existing Lighting in Manly Lagoon**

The issues of lack of or insufficient lighting throughout the Manly Lagoon were significant and the lagoon was identified as an area of concern. A site audit was conducted to assess the degree to which the issue effected pedestrian mobility.

The site was inspected in daylight and at night. It was initially assessed in daylight to document the already existing lighting, if any was present, taking note of location and the type of lighting that existed. Following this, the site was inspected at night, when the level of lighting was noted and how the lighting levels affected a pedestrian's ability to access and use the lagoon. It was found that there was already existing lighting infrastructure, as shown in Figure 6.30, although the level of visibility produced and spacing of the lighting was inadequate.

It is recommended that further advice be sought from an appropriate lighting consultant is regarding installation of adequate lighting along the length of the shared path, extending from Pittwater Road to Cameron Avenue and Bridge Road. As a part of this process, consideration should be given to residents abutting the Manly Lagoon, ensuring the lighting solution selected does not cause excessive light pollution.

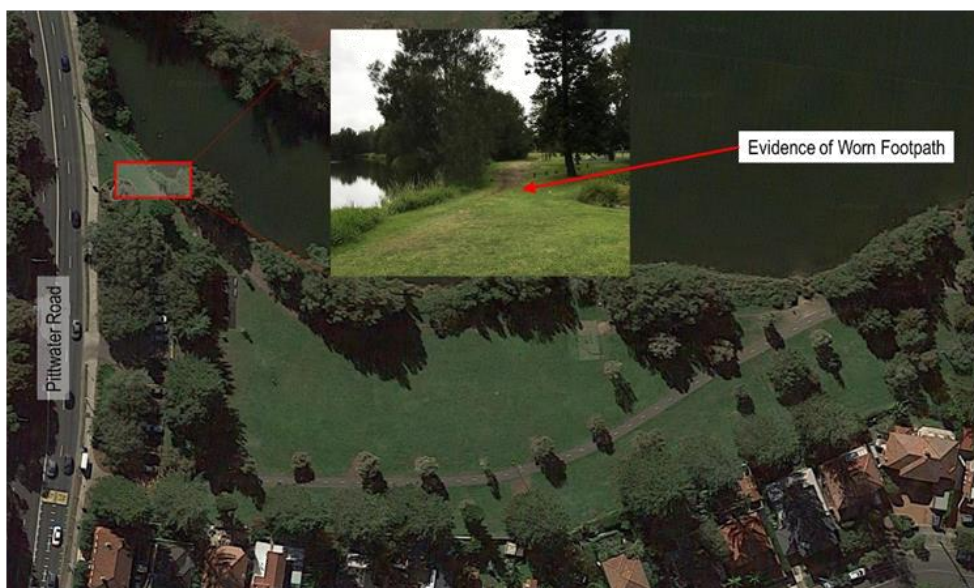
**Figure 6.31: Evidence of Worn Footpath along Manly Lagoon**

An audit of the shared path was conducted because of conflict between cyclists and pedestrians using the shared path along Manly Lagoon was raised as an issue of concern. At the time of the audit, a relatively high number of cyclists and pedestrians were noted using the shared path, although there was no apparent conflict from its shared use.

There is a second path worn in by pedestrian and cyclist activity along the foreshore of the lagoon, see Figure 6.31. This indicates that many pedestrians and cyclists may be using an alternative path along the foreshore instead of the shared path.

Option 2 is converting the worn path along the foreshore of the lagoon, as shown in Figure 6.31, to a pedestrian path, separated cycle path or shared path. This would enable all pedestrians to utilise the section of path and increase the capacity of the lagoon for pedestrians. It should be noted that existing the shared path should remain for shared use in conjunction with the creation of the alternative path.
