ATTACHMENT BOOKLET

ORDINARY COUNCIL MEETING

TUESDAY 24 OCTOBER 2017

No			
6.1	MONTHLY INVE	STMENT REPORT - AUGUST 2017	
	Attachment :	Investment Strategy and Portfolio Review 2016-17 Financial Year	2
8.3	WALK MANLY -	PEDESTRIAN ACCESS & MOBILITY PLAN	
	Attachment :	Manly Beach, Wharf & Town Centre - Pedestrian Access & Management Plan	21

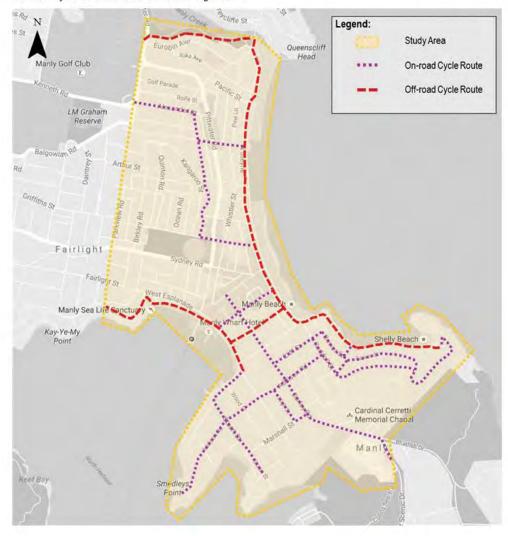
Cycling routes within the study area are designed for recreational activities as well as to promote cycling as a method of transportation. Using information supplied on the Northern Beaches Council website, a map of the main cycle routes is shown below in Figure 2.14.

Figure 2.14: Cycling routes within the study area

It should be noted that routes considered off-road in the above figure mainly consist of shared paths or a separated bicycle lane.

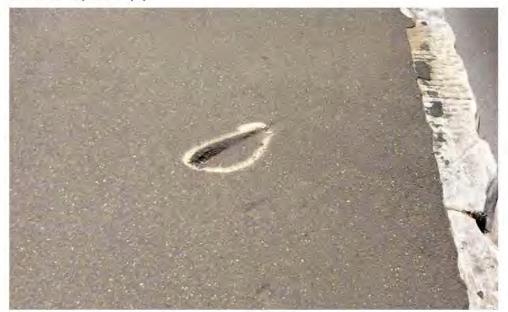
Reference: N108 North of Carlton Street

Figure 4.3 shows an example of a trip hazard, which is a foot-sized hole in the pavement. This hazard and other similar may lead to injury.

Figure 4.3: North Steyne - Hole in Pavement

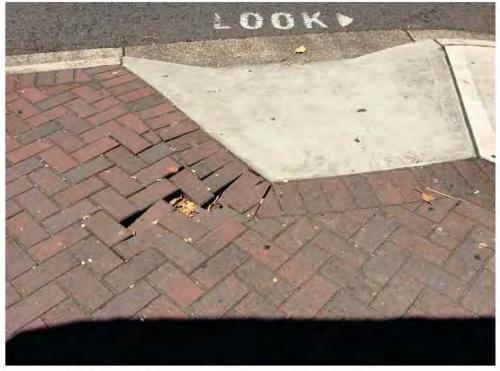
Reference: NS108 North of Wentworth Street

Shown in Figure 4.4 is an example of uneven and missing pavers. A hazard such as this may lead to a pedestrian tripping, in this case potentially falling into the roadway.

Figure 4.4: Darley Road - Missing and Damaged Pavers near Kerb Ramp

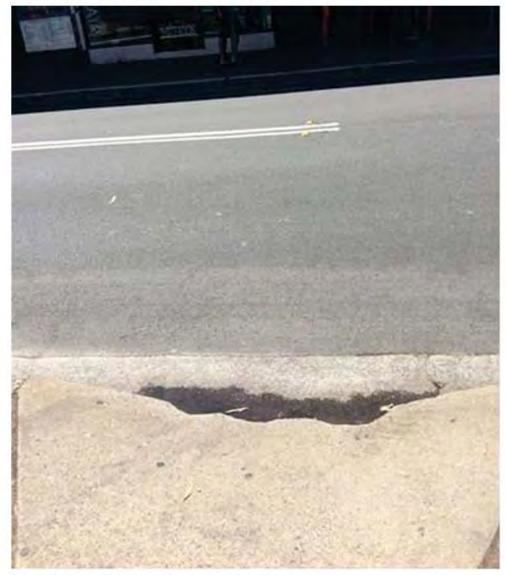
Reference WHS 74 South of Sydney Road

The example shown in Figure 4.5 is of a kerb ramp with ponding, ponding being the build-up of water, which may lead to pedestrians slipping and falling. The picture also shows an unconnected kerb ramp, which is when the kerb ramp has no kerb ramp on the other side of the road.

Figure 4.5: Whistler Street - Unconnected Kerb Ramp and Ponding

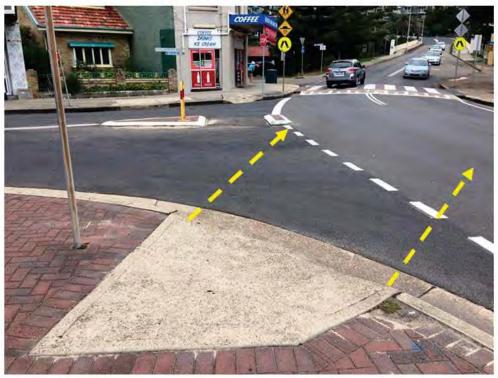
Reference: NS84 South of Collingwood Street

Shown below in Figure 4.6 is an example of an unaligned kerb ramp. An unaligned kerb ramp is a kerb ramp that does not line up with a kerb ramp on the opposite side of the intersection. As indicated by the arrows in the figure this kerb ramp in particular points a user towards the adjacent road.

Figure 4.6: North Steyne - Unaligned Kerb Ramp

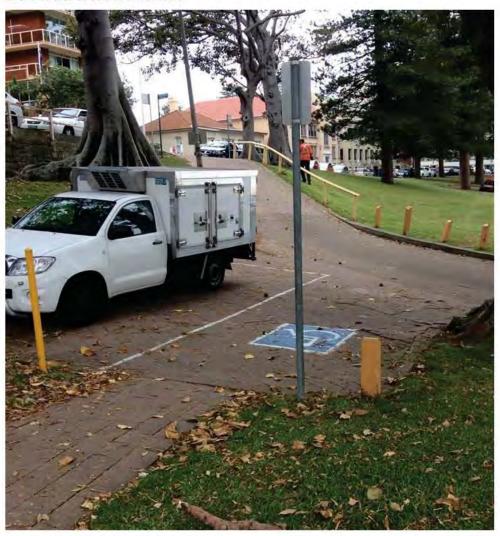
Reference FW25 West of Rowe Street

Shown in Figure 4.7 is an example of a non-compliant parking space. The space shown in the example has no shared area as defined in AS2890.6.

Figure 4.7: Fairlight Walk - Non-Compliant Mobility Impaired Parking

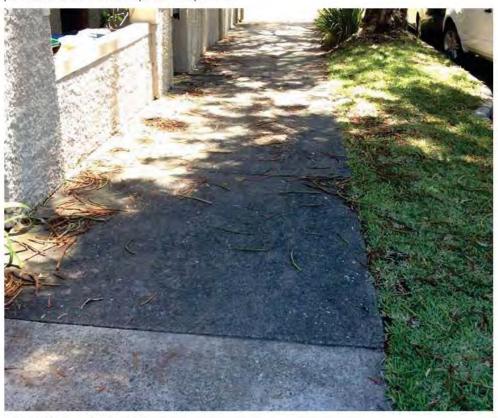
Reference OBR 9 South of Addison Road

Figure 4.8 is an example of leaf litter on a footpath. Leaf litter is classed as a slip hazard as it has the potential to cause a less able person to slip and fall.

Figure 4.8: Osbourne Road - Leaf Litter on Path

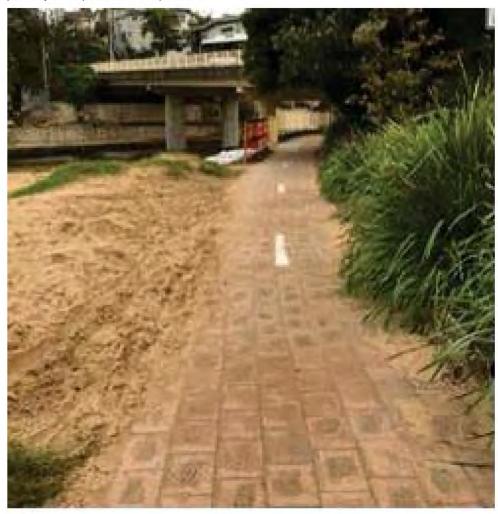
Reference ML 16

Shown below in Figure 4.9 is an example of sand on a footpath. Similar to the previous example sand on a path may cause pedestrians to slip and fall.

Figure 4.9: Manly Lagoon - Sand on Path

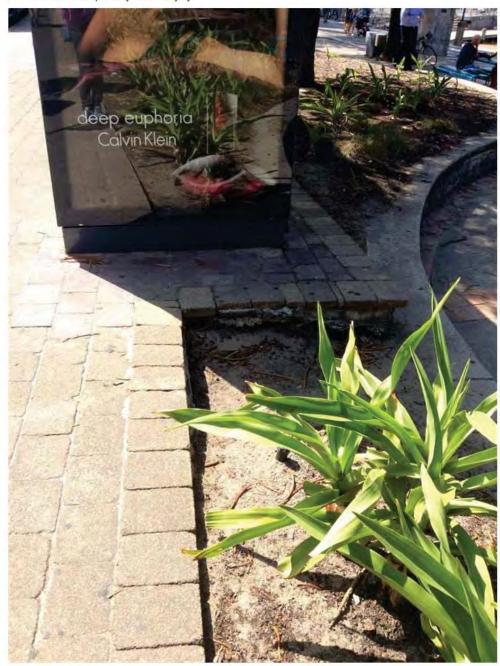
Reference WE 6 West of Eustace Street

Shown below in Figure 4.10 is an example of an unprotected drop. A drop off the side of a footpath as shown in this example may lead to injury.

Figure 4.10: West Esplanade - Unprotected Drop

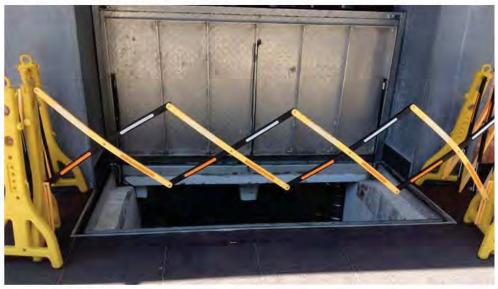
Reference PMSR 18 West of Central Avenue

Figure 4.11 shows an open cellar that was unattended at the time of the audit. If a distracted or vision impaired person were to walk and fall into the cellar it may cause significant injury.

Figure 4.11: Pedestrian Mall (Sydney Road) - Unattended Open Cellar

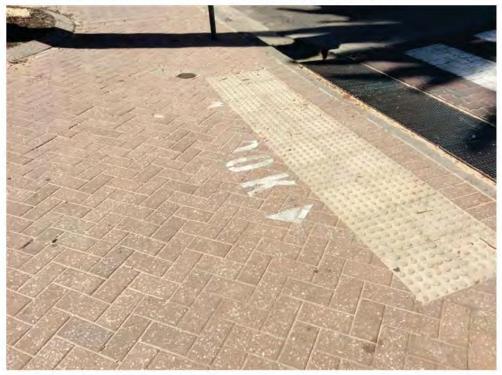
Reference SS1 North of Ashburner Street

Shown below in Figure 4.12, the direction "LOOK" linemarking and arrow is faded. This linemarking is in place to remind pedestrians of the need and direction to look for approaching vehicles.

Figure 4.12: South Steyne - "LOOK" and Directional Arrow are Faded

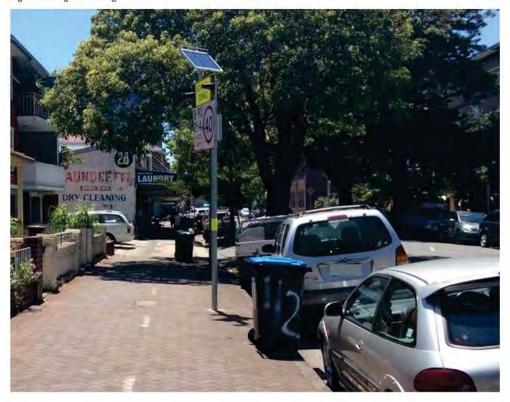
Reference DR182 North of Ashburner Street

Figure 4.13 is an example of a sign facing the wrong direction. In this example, the 40km/h school zone sign is facing the wrong direction and not towards the road.

Figure 4.13: Darley Road School Zone Sign Not Facing Road

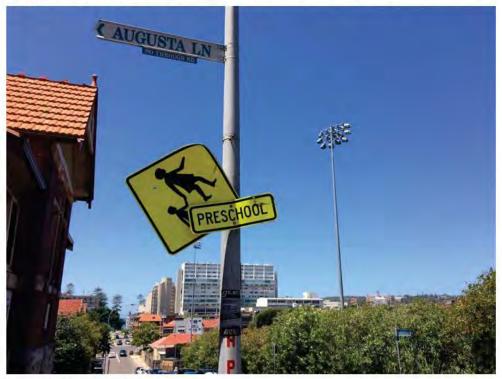
Reference RS108 West of Augusta Lane

Figure 4.14 shows a damaged warning sign. The damaged sign may not be visible to drivers and may increase the risk of a crash occurring involving pedestrians, in this case young children.

Figure 4.14: Raglan Street - Damaged Preschool Pedestrian Signage

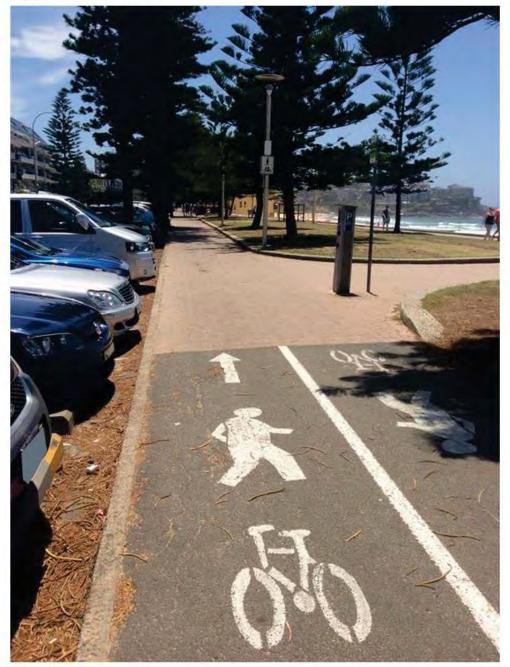
Reference MBF 6

In Figure 4.15, the linemarking for the shared path ends too early. In this case, the marking should continue the entire length of the foreshore. This missing linemarking may lead to a crash between cyclists and pedestrians using the shared path.

Figure 4.15: Manly Beach Foreshore - No Linemarking for Shared Path in Sections

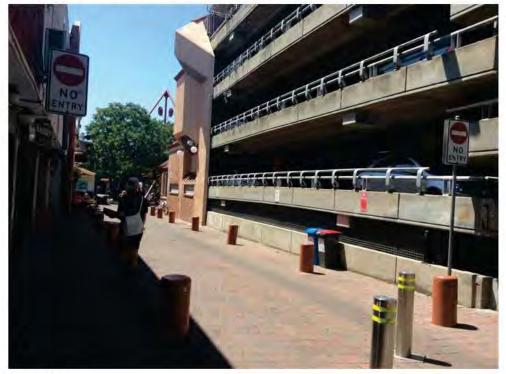
Reference ML 7

Shown below in Figure 4.16 is a set of bollards blocking the footpath. These bollards could lead to a visually impaired person or person who is less mobile sustaining an injury from a fall or tripping.

Figure 4.16: Manly Library – Bollards

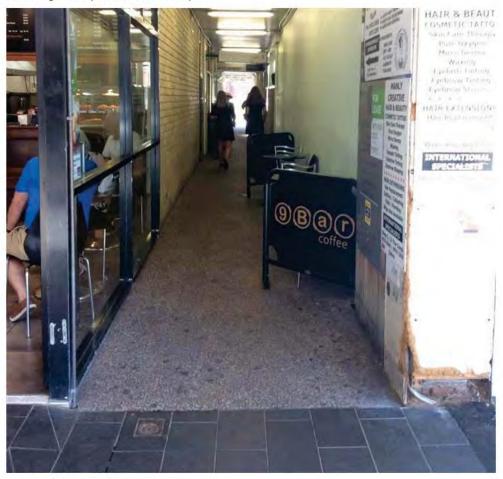
Reference TC42 West of Central Avenue

Figure 4.17 shows café tables blocking a narrow path. These tables may prevent a person who is less able from being able to pass and use the footpath.

Figure 4.17: Cafe Tables Blocking Narrow Path

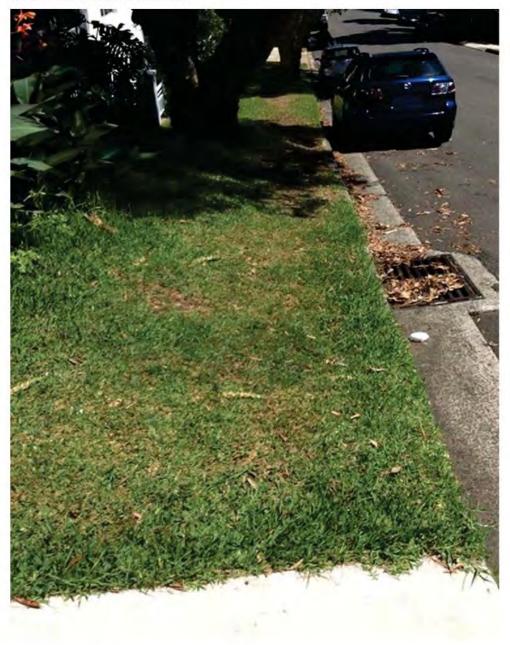
Reference MS 35 West of Osbourne Street

Shown below in Figure 4.18 is an example of a footpath ending and not continuing down the length of the street. This may prevent pedestrians who are less mobile from being able to access sections of the street or the facilities to which the streets lead.

Figure 4.18: Marshall Street - No Path

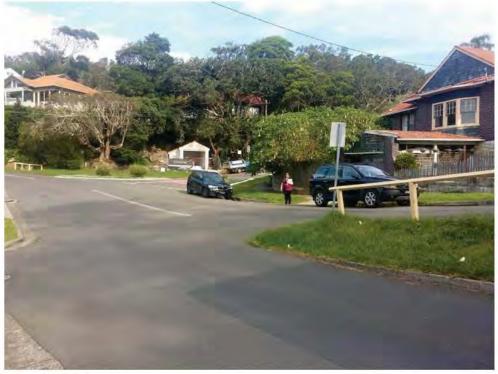
Reference BS44 North of Bower Lane

Figure 4.19 is an example of a missing crossing opportunity. In this case, a pedestrian is may not be able to cross the road safely because the road is wide, on a curve and there are no kerb ramps along a pedestrian's path of travel.

Figure 4.19: Bower Street - No Crossing Opportunity

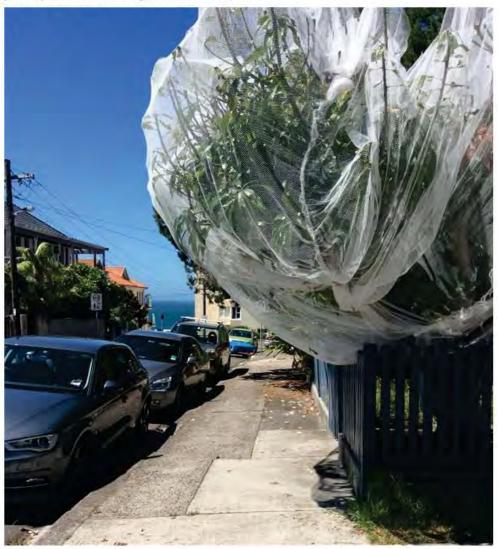
Reference RDS10 South of Cliff Street

Shown below in Figure 4.20 is an example of a bush or tree blocking a section of the footpath. This may prevent pedestrians from using this section of footpath.

Figure 4.20: Reddall Street - Overgrown Vegetation

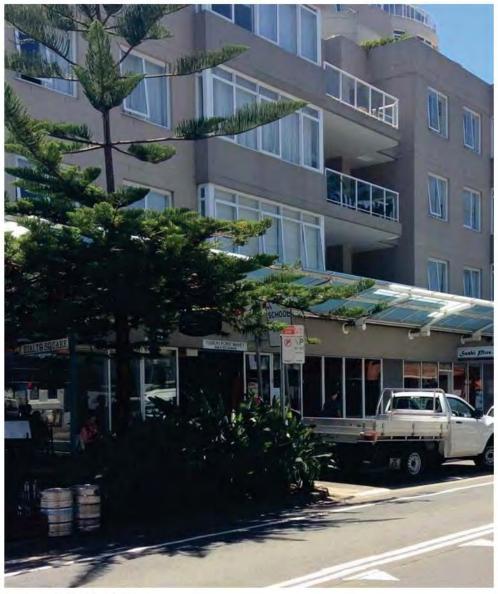
Reference WS22 West of South Steyne

Figure 4.21 shows a tree blocking an "end school zone" sign, which may prevent drivers from seeing the sign.

Figure 4.21: Wentworth Street - End of School Zone Sign Blocked by Vegetation

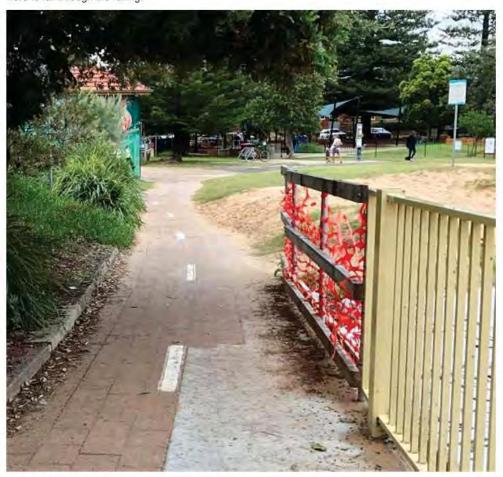
Reference ML 13 West of Bridge Road

Shown below in Figure 4.22 is a broken railing, which may pose a danger to passing pedestrians if they were to fall through the railing.

Figure 4.22: Manly Lagoon - Broken Railing

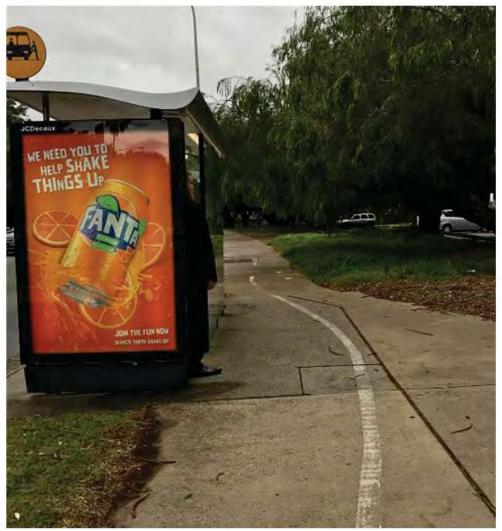
Reference PW 303 North of Eurobin Avenue

Shown below Figure 4.23 demonstrates blocked sightlines along a shared path. If a pedestrian using the bus shelter were to step out, a bicycle user would not be able to see them properly and it may lead to a crash and potentially an injury.

Figure 4.23: Pittwater Road - Advertisement Block Sightlines for Shared Path

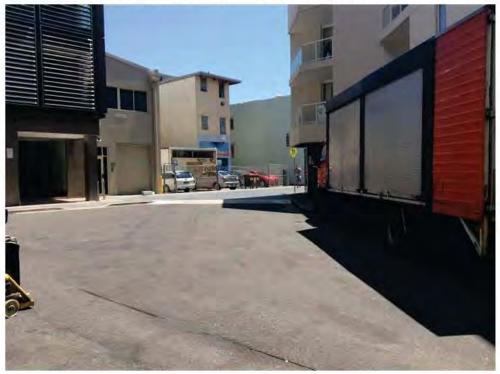
Reference RL 2

Figure 4.24 is an example of a high conflict area within a combination loading and high pedestrian area. This area contains trucks loading and offloading goods in loading docks and loading bays throughout the high pedestrian area. Trucks and large delivery vehicles tend to have reduced sightlines. If a pedestrian were to be in a truck's "blind spot" when it manoeuvred, it could lead to a serious injury.

Figure 4.24: High Conflict Area within Combination of Loading Zone and High Pedestrian Area

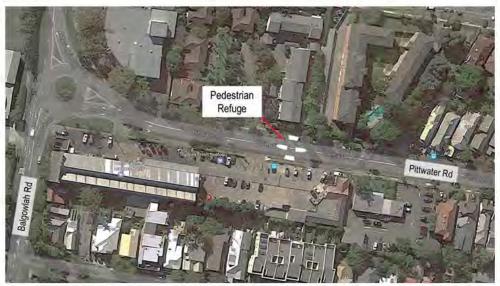
Figure 6.3: Concept Design for Refuge Island on Pittwater Road

It should be noted that this option, however, is only a short-term solution. With continued growth in the Manly LGA the need to install clearways along Pittwater Road to enable four lanes of free-flowing traffic would become apparent, this would then dictate the removal of the pedestrian refuge and if the pedestrian volumes warranted, a signalised mid-block crossing (traffic lights) could be installed in place of the refuge island.

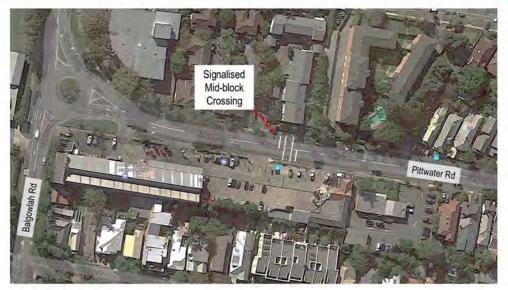
Figure 6.4: Concept Design for a Mid-block Crossing (Pedestrian Traffic Lights) on Pittwater Road

Option 2 proposes the installation of a signalised mid-block crossing (pedestrian traffic lights) in a similar location as proposed in Option 1. The installation of a signalised mid-block crossing may greatly reduce the risk for pedestrians wanting to cross Pittwater Road, specifically less mobile pedestrians who may not be able to cross at a refuge island in a timely or safe manner. Further consideration would need to be given to the coordination of the signal timing with the signalised intersection upstream and downstream. This would ensure that the installation of the signalised mid-block crossing (pedestrian traffic lights) does not worsen the existing traffic conditions. Figure 6.4 outlines the proposed location for the midblock crossing.

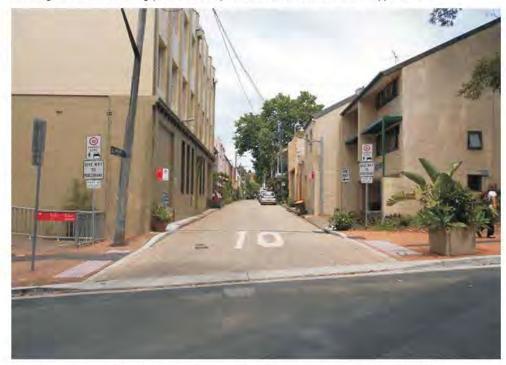
It is recommended that Bower Lane be converted to a shared zone, similar to the example shown in Figure 6.6, in accordance with the *Roads and Maritimes Services Design Implementation of Shared Zones Including Provision for Parking (TTD 2016/001)*. A link to which can be found in Appendix A.

Figure 6.6: Example of a Shared Zone

Reconfiguring Bower Lane into a shared zone would entail the removal of the kerb and thus widen the existing laneway. This would allow commercial vehicles to complete a three-point turn wholly within the lane and remove the need to reverse in and out of the lane. The change to a shared zone would also involve the installation of smooth paving to create a more comfortable and safer walking environment for all user groups, as shown in the example of a shared zone in Figure 6.6 above.

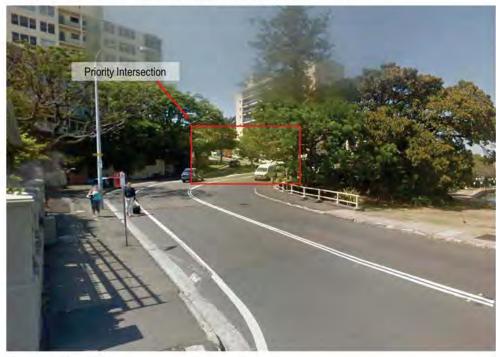
- This location would not allow adequate sight distance for pedestrians to see approaching cars and similarly for a driver to see pedestrians who may be crossing; and
- Drivers travelling down the hill are likely to take longer to come to a stop.

Figure 6.7: View from Ashburner Street towards the Priority Intersection

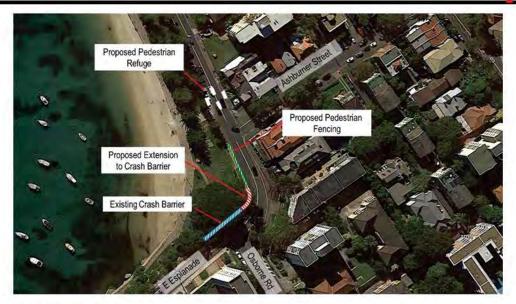
Figure 6.8: Proposed Changes to East Esplanade and Ashburner Street

To improve pedestrian safety further, the extension of the crash barrier on the northern side of East Esplanade, pedestrian fencing, and a pedestrian refuge just north of Ashburner Street are recommended, as shown in Figure 6.8. The intention is to direct pedestrians away from the corner and create a safe location to cross.

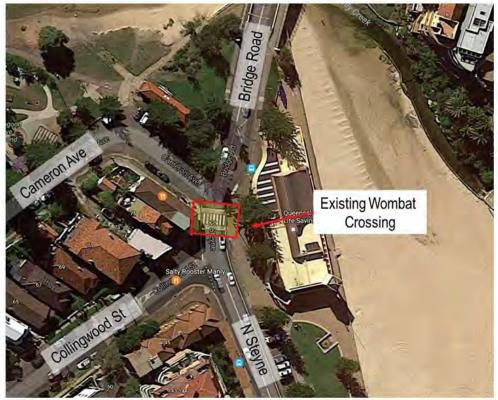
An evaluation of the appropriateness of the crossing was undertaken and found that under section 7.2.4 in Austroads Guide to Traffic Management, Part 8: Local Area Traffic Management, a wombat crossing at this location would be inappropriate. The section states, due to insufficient sight distance a wombat crossing would be inappropriate. The crossing is shown in Figure 6.9.

Figure 6.9: Location of Pedestrian Crossing North Steyne and Bridge Road

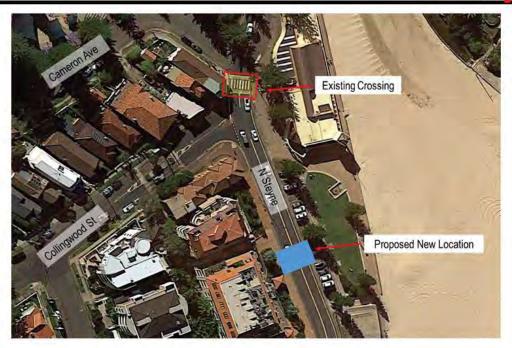
Figure 6.10: Concept Design Relocation of North Steyne Pedestrian Crossing

Option 1 involves the relocation of the existing wombat crossing south, approximately 50 to 60 metres along North Steyne, as shown in Figure 6.10. The location for the proposed wombat crossing is on a straight section of road with clear sightlines in both directions and no adjoining side streets.

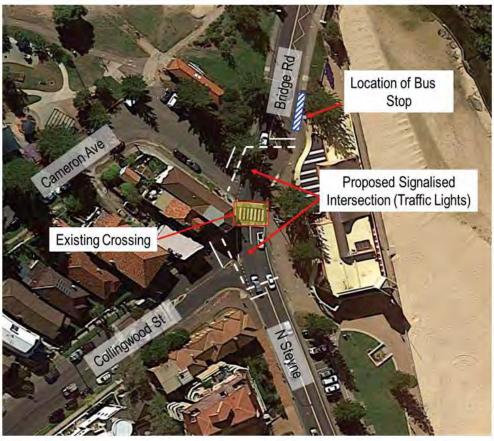
Figure 6.11: Concept Design for North Steyne and Bridge Road Signalised Intersection

Option 2 proposes the installation of a signalised intersection (traffic lights) at the intersection of North Steyne, Collingwood Street, Cameron Avenue, and Bridge Road as shown in Figure 6.11.

This option allows for protected pedestrian crossing opportunities at all four streets reducing the risk to pedestrians. The signalised intersection may assist in reducing congestion, as all vehicle movements would be controlled. However, this option would involve significant civil works and may cause disruption to traffic during the construction stage. Also of note is the location of a bus stop on Bridge Road, 5 meters north of Cameron Avenue as shown in Figure 6.11. Consideration should be given to the bus stop during design.

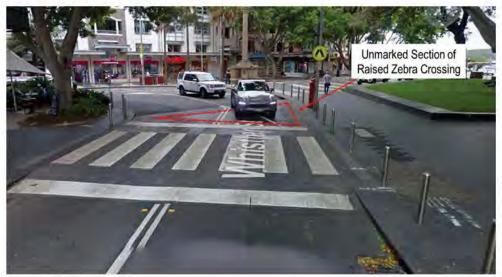
Some pedestrians were observed to use the unmarked section of the crossing rather than cross at the marked section, which may pose a risk to pedestrians. This is due to drivers not expecting a pedestrian to step onto the road prior to the formal crossing.

Figure 6.13: Pedestrian Crossing Located at The Town Hall

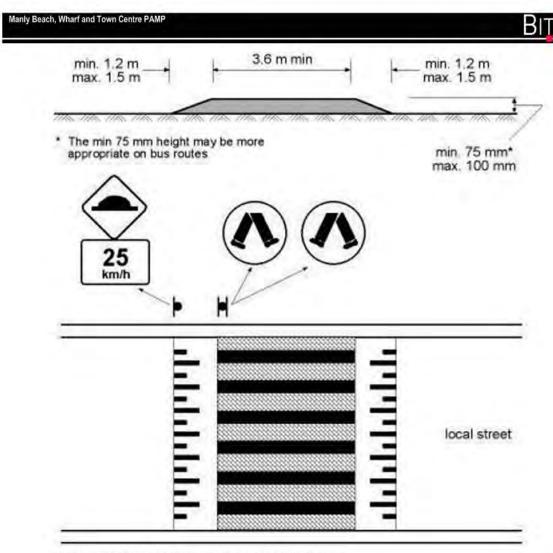
Figure 6.14: Extract from Austroads Specifying Raised Crossing Dimensions

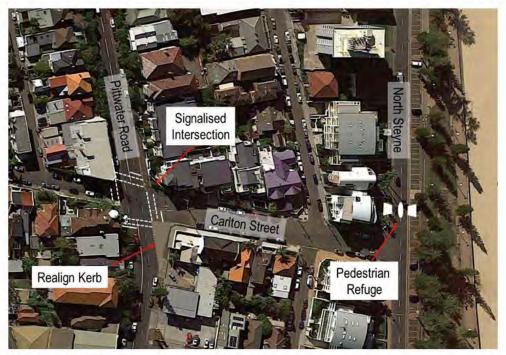
Figure 6.16: Concept Design Pedestrian Infrastructure Carlton Street

To allow safe crossing at Pittwater Road the intersection would need to be converted to a fully signalised intersection (traffic lights). This would allow for safe crossing for both those less mobile pedestrians and parents crossing with prams or children. In conjunction with the signalised intersection, a pedestrian refuge would need to be installed at North Steyne just north of Carlton Street. A concept design for the proposed crossings are shown in Figure 6.16.

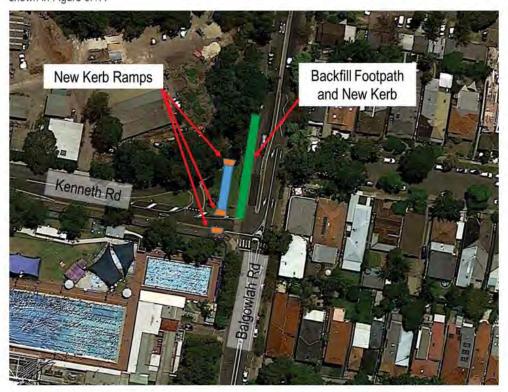
Figure 6.17: Concept Design for Balgowlah Road and Kenneth Road Footpath

It is recommended that the footpath along the slip lane island should be filled in and replaced with a new path on the island that would line up with the kerb ramp on the northern side of the intersection. This is shown in Figure 6.17.

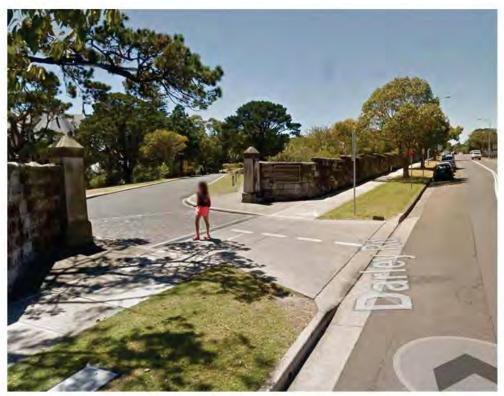
From the audit, it was observed that the shared path along the eastern side of Darley Road between Marshall Street and Bluefish Drive lacked proper linemarking and signage. Figure 6.20 shows an example of where the path crosses a driveway. There is a lack of pavement markings to warn the driver of the potential cyclists along the path. The lack of signage and markings poses a risk to cyclists as stated above and for pedestrians who may not be aware of cyclists on the path.

Figure 6.20: Example of Shared Path Crossing Driveway Darley Road

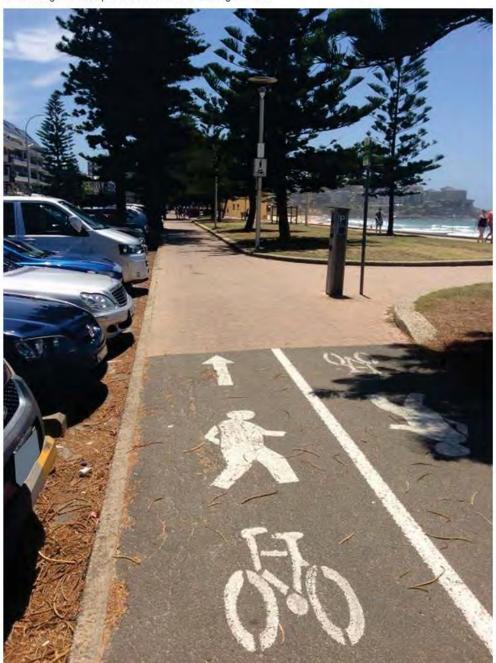
The shared path that runs the length of the Manly Foreshore was identified as having issues with missing linemarking. An example can be seen below in Figure 6.23.

Figure 6.23: Manly Foreshore Shared Path Missing Linemarking

As shown in Figure 6.23, shared path users currently interact with people exiting cars or crossing the road, which is located next to the shared path. Pedestrians were observed stopping in the middle of the shared path unaware of shared path users, cyclists and pedestrians using the shared path.

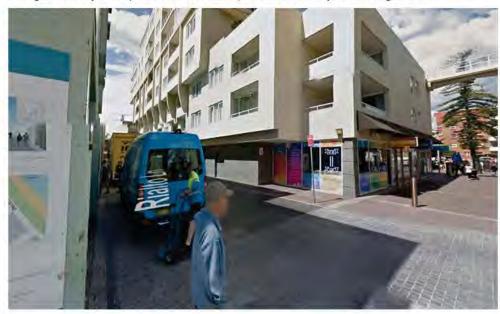
Rialto Lane was identified as having a higher risk to pedestrian safety due to the combined loading zone and pedestrian use. Changes have already been made to the area to pedestrianise the laneway; however, due to the high volume of cars and delivery vehicles, significant risk still exists for pedestrians.

Figure 6.25: View of Rialto Lane from Path to The Corso

According to the current Urban Design Guidelines from Northern Beach Council, there is a plan to enhance street/lane frontage to Rialto Lane, as such future developments will be required to incorporate active frontage. Thus, any development submitted after April 2002 will be subject to these guidelines.

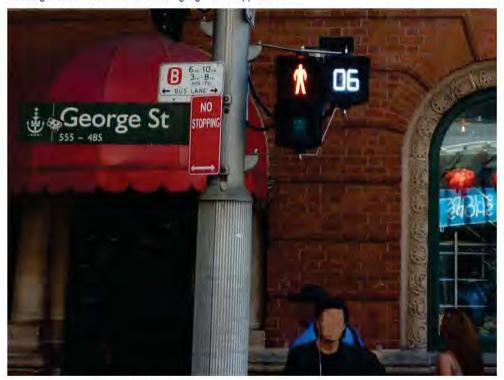
Figure 6.28: Example of a Countdown Timer

A potential solution to the issues surrounding the crossing at the intersection is installation of a countdown timer. A countdown timer would allow pedestrians to cross the intersection safely and give pedestrians an indication of the remaining time available to cross. This is likely to reduce the number of pedestrians crossing the road after the red crossing signal has appeared.

In order to install a countdown timer changes would need to be made to current phasing. The pedestrians crossing phase would have to be confined to a separate phase, with all sides of the intersection crossing simultaneously. This is likely to increase the wait time for pedestrians, as the phase(s) associated with crossing will occur less frequently. It is also likely to increase wait time for motorists, as the pedestrian crossing phase will have a longer duration.

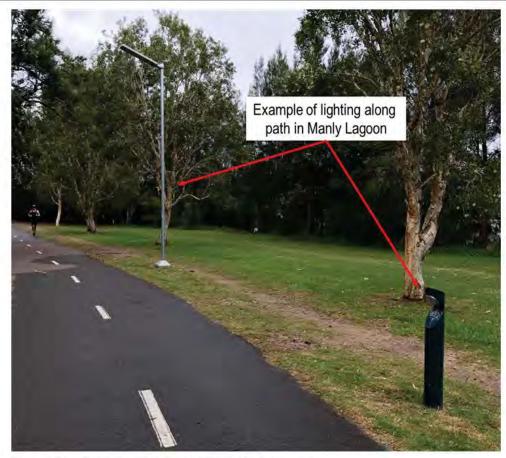
The site was inspected in daylight and at night. It was initially assessed in daylight to document the already existing lighting, if any was present, taking note of location and the type of lighting that existed. Following this, the site was inspected at night, when the level of lighting was noted and how the lighting levels affected a pedestrian's ability to access and use the lagoon. It was found that there was already existing lighting infrastructure, as shown in Figure 6.30, although the level of visibility produced and spacing of the lighting was inadequate.

Figure 6.30: Example of Existing Lighting in Manly Lagoon

It is recommended that lighting be installed along the length of the shared path, extending from Pittwater Road to Cameron Ave and Bridge Road. The lighting should meet P3 lighting standard as defined by the AS/NZS 1158.3.1:2005 Lighting for Roads and Public Spaces. As a part of this process, consideration should be given to residents abutting the Manly Lagoon, ensuring the lighting solution selected does not cause excessive light pollution and meets the requirements of AS 4282-1997 Control of obtrusive effects of outdoor lighting.

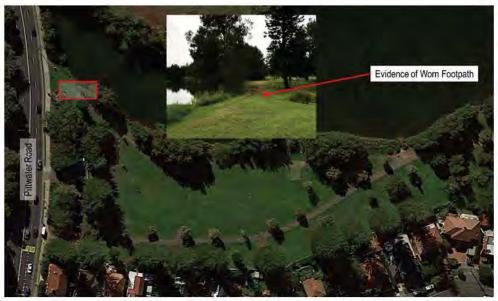
Figure 6.31: Evidence of Worn Footpath along Manly Lagoon

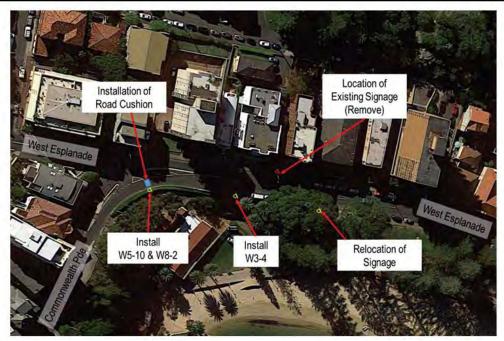
Figure 6.33: Concept Design for Commonwealth Parade Refuge and Road Cushion

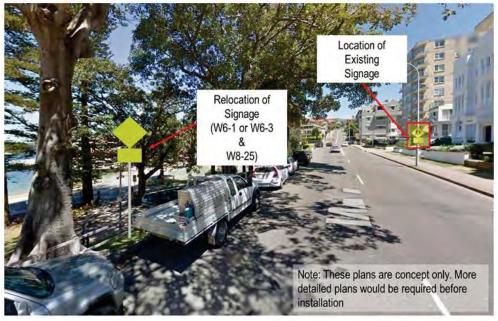
An audit of the refuge was undertaken by Bitzios Consulting and found the pedestrian refuge warning sign to be in a location that was not ideal. As seen in Figure 6.34, the Pedestrian refuge warning sign is located on the right-hand side of the road for traffic on approach to the refuge. AS1742 Part 10: Pedestrian control and protection and Roads shows the position of the warning sign on the left-hand side of approaching traffic. During the audit, it was also found that the sightlines on approach to the refuge increased the risk to pedestrians as there was little time for a driver to react to pedestrians crossing at the refuge.

Figure 6.34: Street View of Concept Plan for Refuge Signage

It is recommended that the existing pedestrian refuge waring sign on the eastern approach be relocated to the left-hand side of the road and road cushions be installed on the eastern approach; a concept design can be seen in Figure 6.33, Figure 6.34 and Figure 6.35.

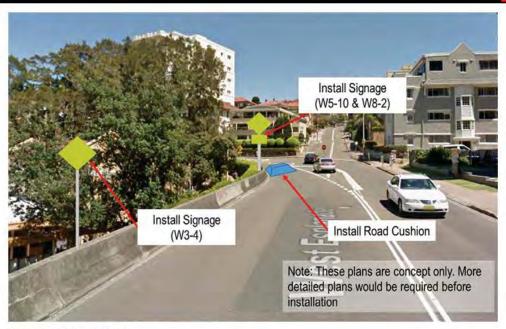
Figure 6.35: Street View of Concept Plan for Road Cushion

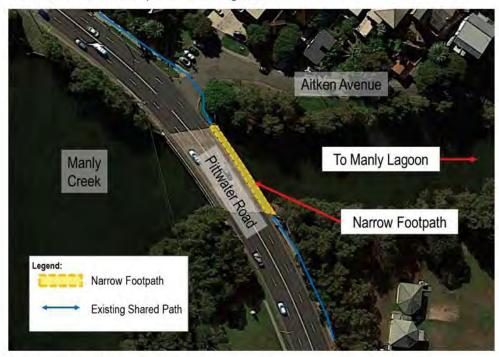
- the risk of a pedestrian falling into the roadway when trying to pass other users with the reduced width;
 and
- the discontinuity of the shared path, as cyclists have to dismount to safely cross.

The location of the narrow footpath is shown in Figure 6.37.

Figure 6.37: Location of Narrow Footpath, Pittwater Road
