Appendix A – Literature on Seawall Impacts and other Human Influences on Beaches

DRAFT COASTAL PROTECTION WORKS
CONCEPT DESIGN AND CONCEPT ALIGNMENT
COLLARROY CARPARK

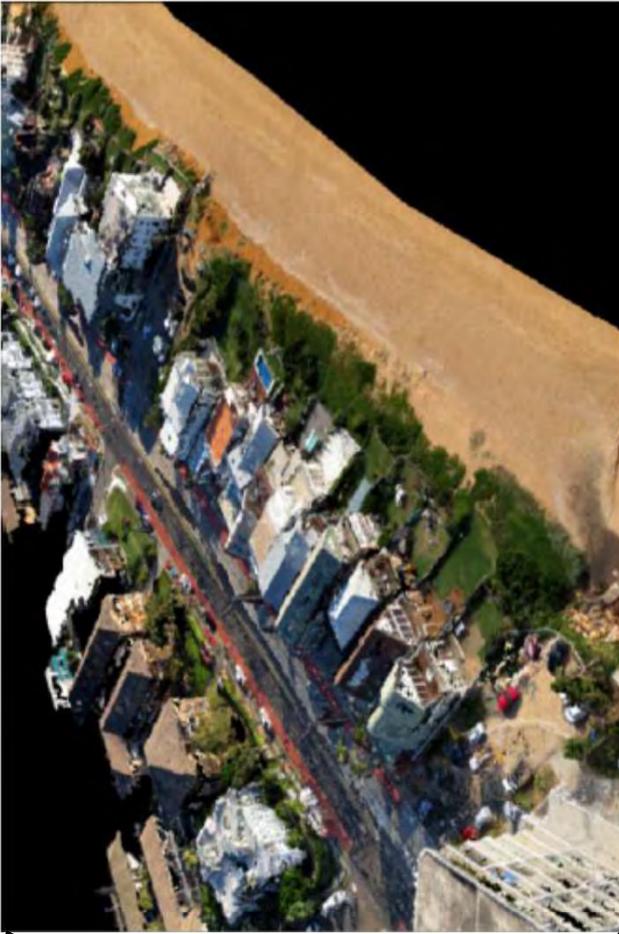
3D UAV Survey 1 June 2016

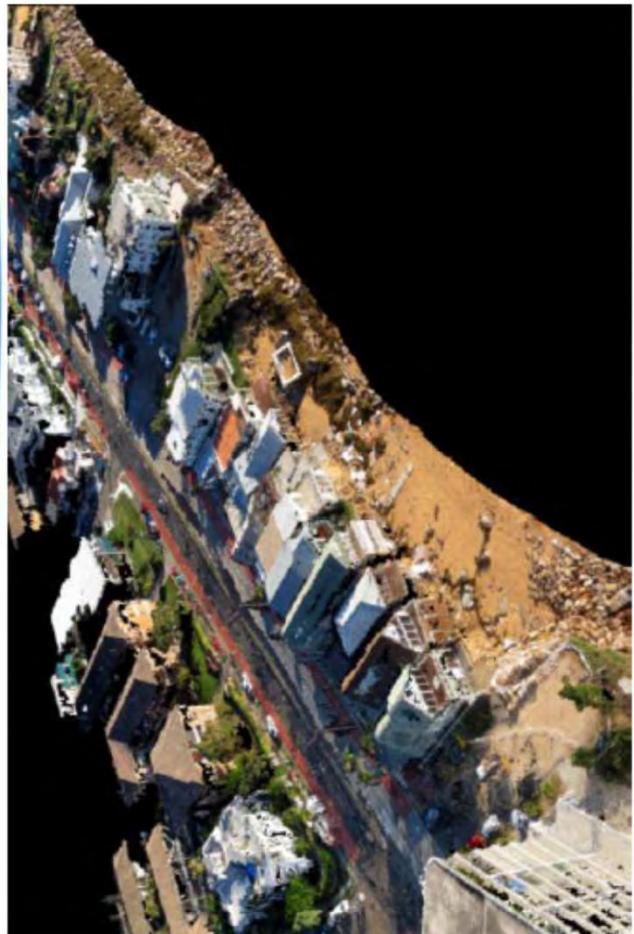
3D UAV Survey 10 June 2016

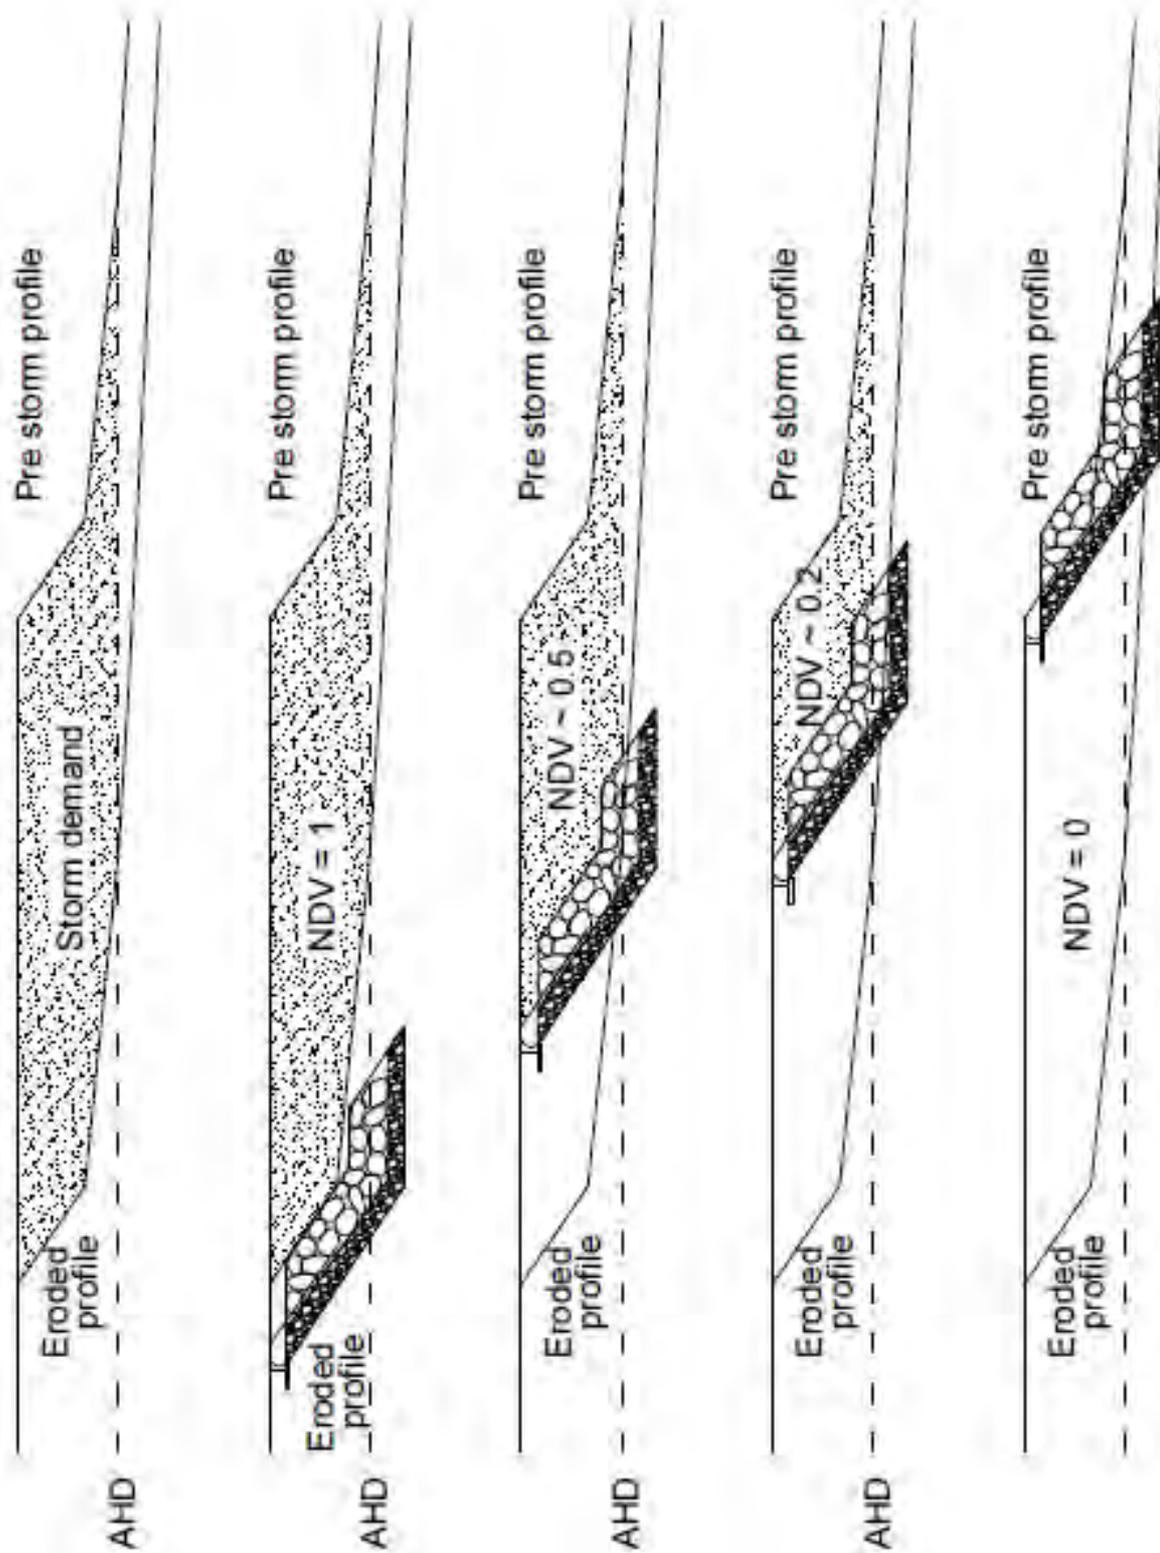
NDV is the available sand volume seaward of a seawall divided by the storm demand

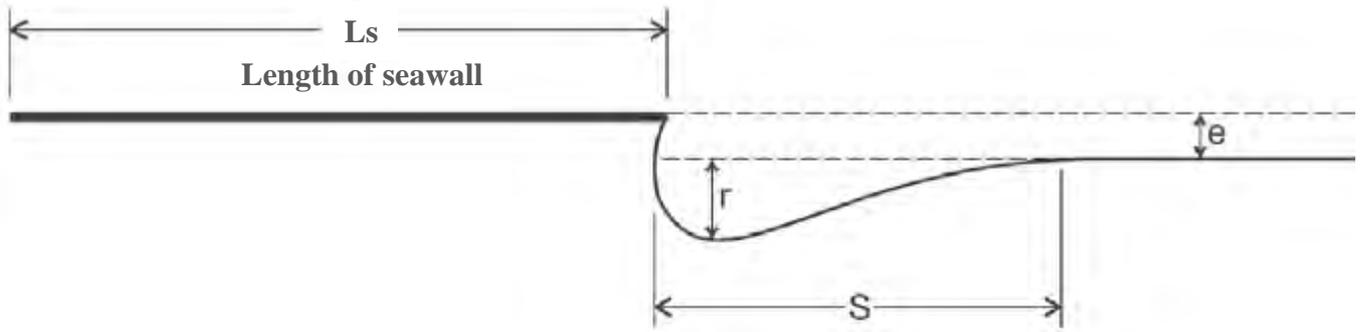
$$e = SD \text{ (Storm Demand)}$$

$$S = 100 + 0.6 Ls \text{ (S max = 400 m): the estimated length of seawall end effect}$$

$$r = AE = (1 - NDV) * SD: \text{the estimated additional erosion from the seawall end effect}$$

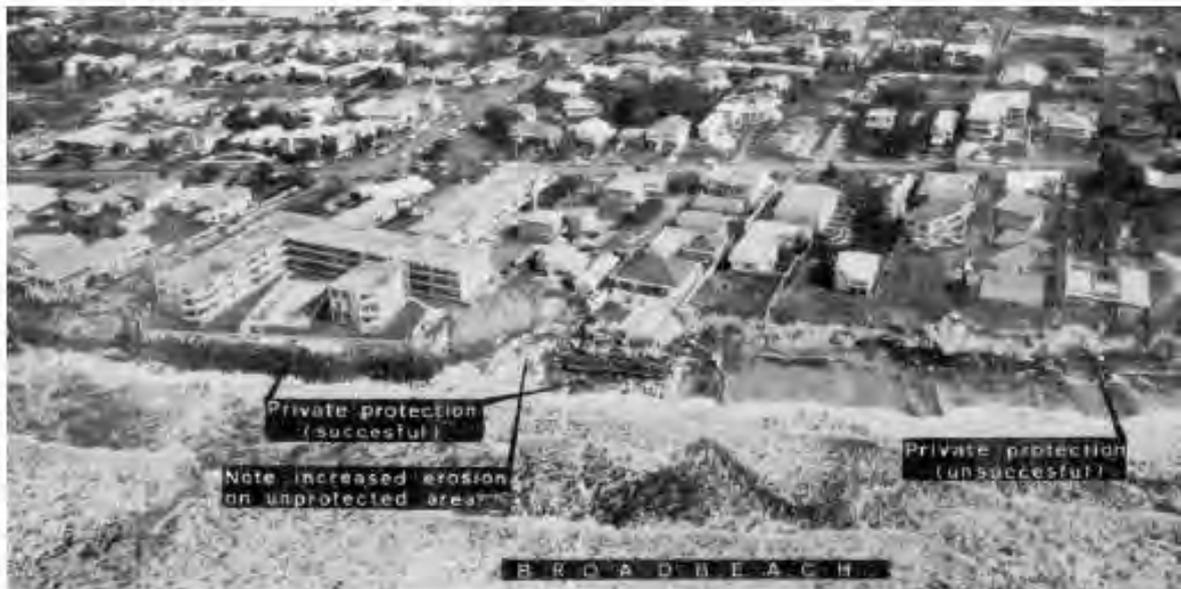
Gold Coast, 1967 (Source: Delft, 1970)

Recommended from this study:

(Modified from McDougal et al, 1987)

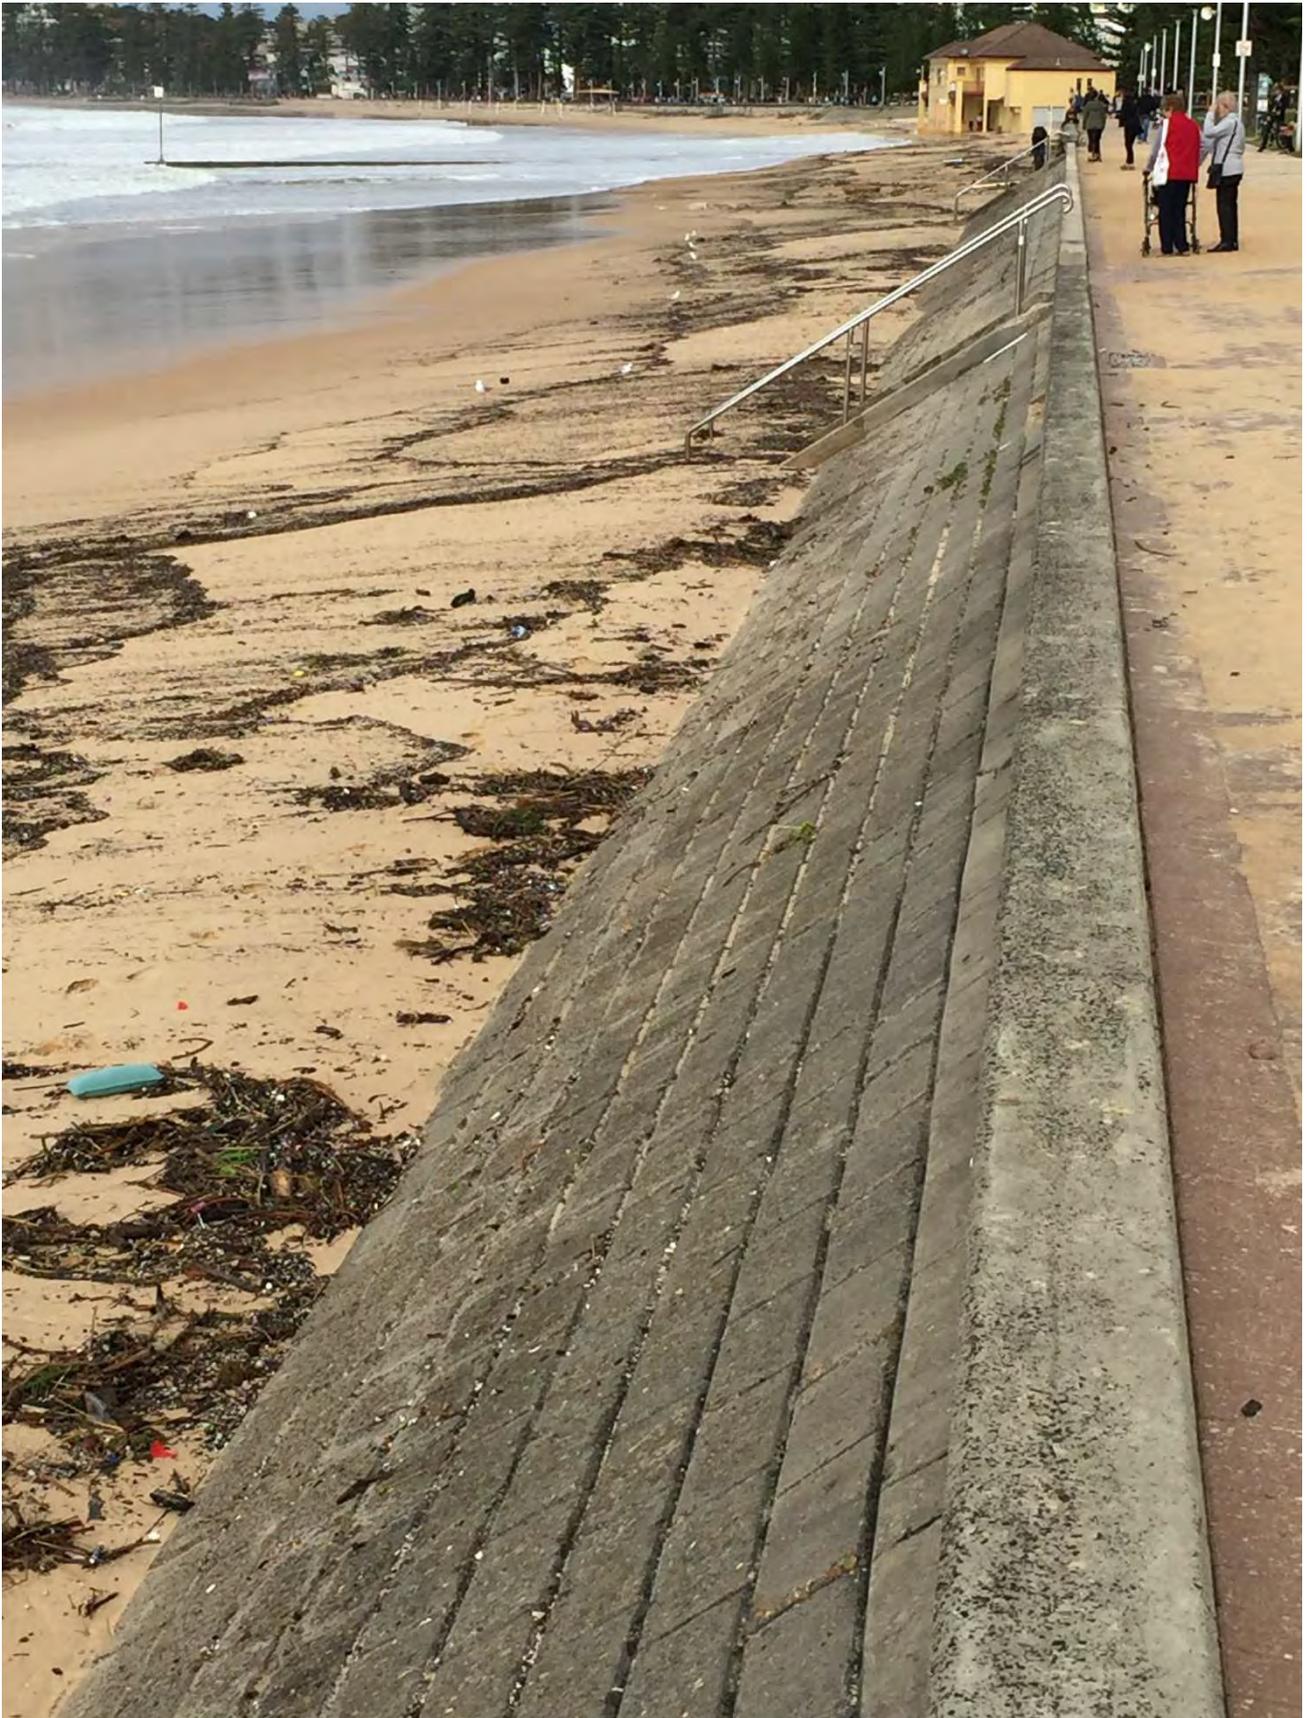
NOTE – there is no apparent difference in beach erosion between sloping and vertical seawall sections along Manly Beach

wave overtopping rates. While conventional paradigms suggest that less reflective structures should induce less erosion of fronting beaches, Griggs et al. (1991) found little difference when analysing vertical and sloping, permeable structures in Monterey Bay, California. This has been observed also during recent storms in Sydney where no discernible difference in beach scour levels were observed along adjacent vertical and sloping components of the Manly Beach seawall as shown in **Figure A2**).

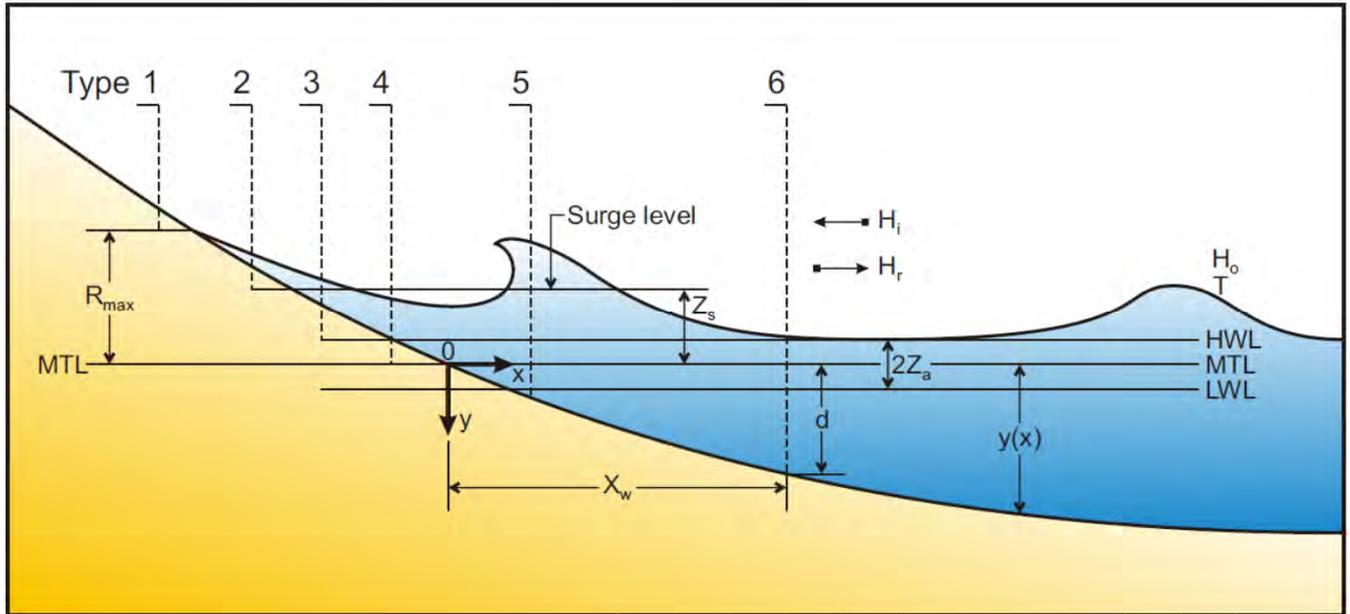
a) Seawall location according to Weggel classification
 [Source: Weggel (1988)]

Type	Location of Seawall
1	Landward of maximum level of run-up during storms. The wall does not affect either hydraulic or sedimentation processes under any wave or water level conditions, although may affect aeolian processes.
2	Above still water level of maximum storm surge and below the level of maximum run-up. Exposed only to the run-up of waves during storm events.
3	Above normal high water and below the still water level of storm surge. Base will be submerged during storms and during exceptionally high astronomical tides but will normally be above water.
4	Within the normal tide range; base is submerged at high water.
5	Seaward of mean low water; base is always submerged; subjected to breaking and broken waves.
6	So far seaward that incident waves do not break on or seaward [of the wall].

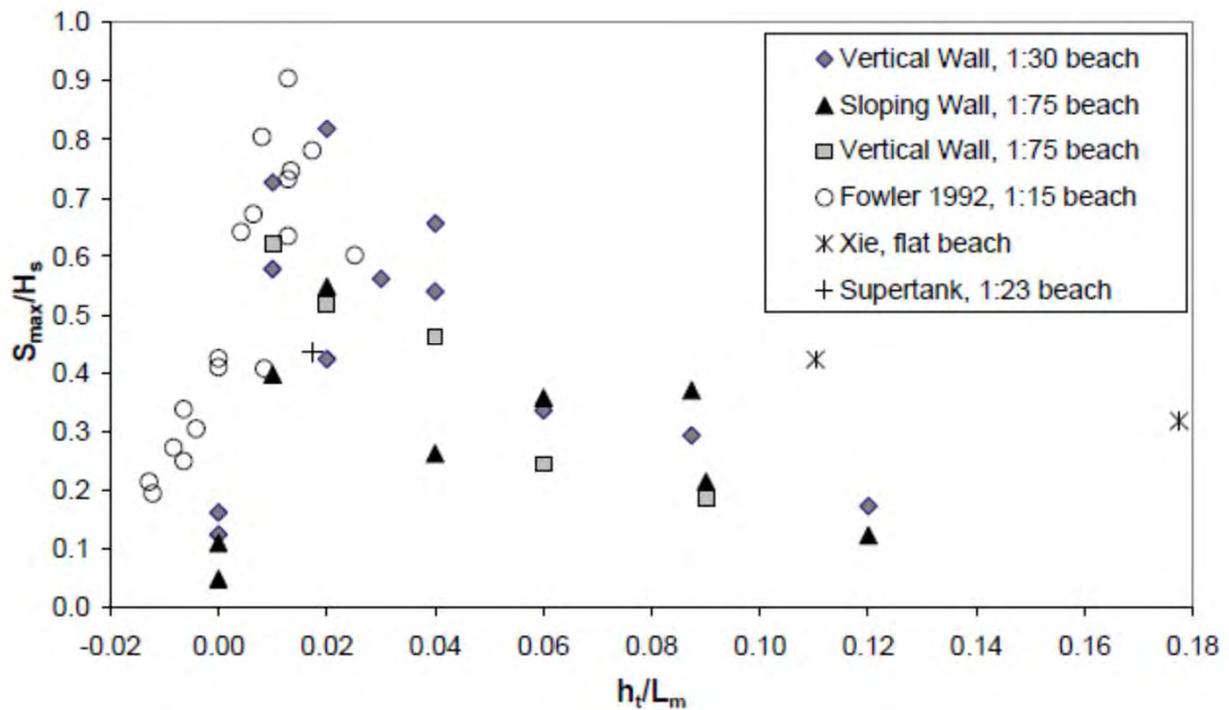
b) Laboratory Measurements of Relative Maximum Scour Depth
 (Source: Sutherland et al, 2007)

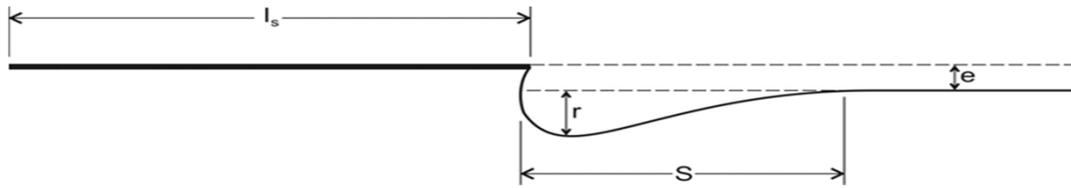
a) Schematic Diagram of Excess Seawall End Erosion, Depth and Length – see **Figure 9** for definition of terms (Source: McDougal et al., 1987)

The general concept of increased beach erosion at the end of a seawall (hereby termed excess seawall end erosion) is shown in **Figure A4a** together with a field example **Figure A4b** from the Gold Coast, Queensland after cyclones in 1967. The shape of the observed embayment due to end effects often resembled the *zeta* curve or parabolic bay shape (Silvester *et al.*, 1980).

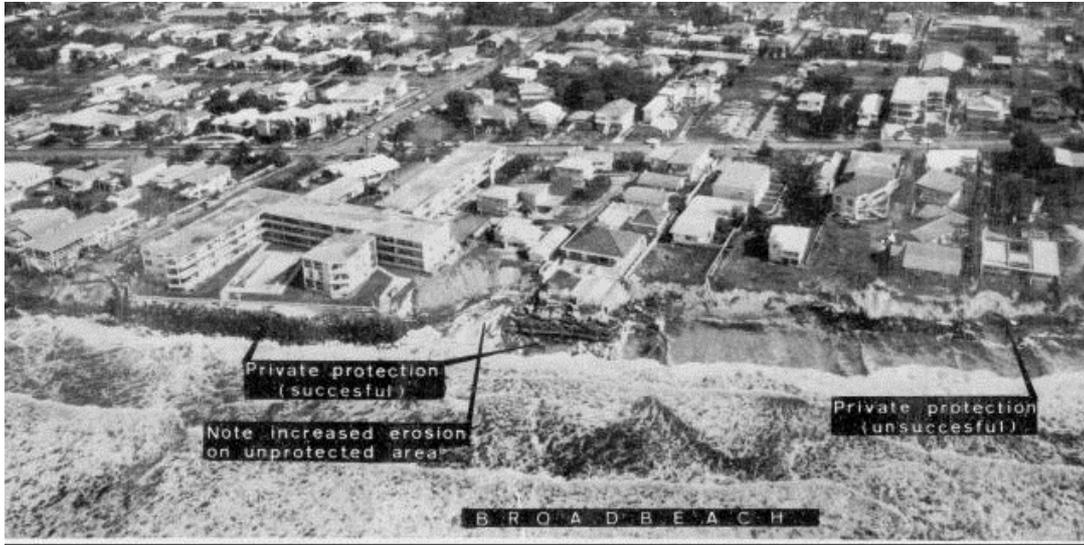
b) Example of Excess Seawall End Erosion – Gold Coast, 1967 (Source: Delft, 1970)

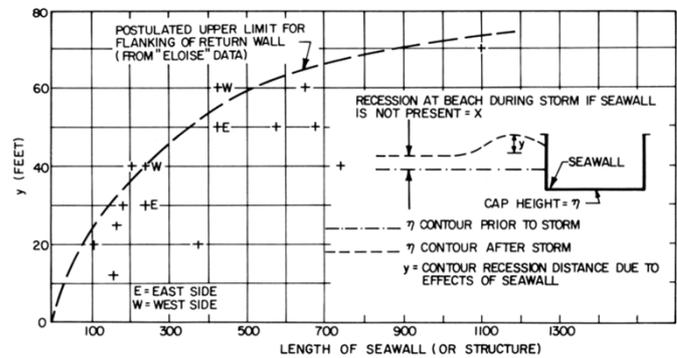
c) Additional Bluff Recession Due to Seawalls Following Hurricane Eloise (Source: Chiu, 1977)

Chiu (1977) presented field data obtained from Walton and Sensabaugh (1978) of the depth of (seawall associated) excess erosion observed adjacent to several seawalls on the Gulf Coast of the United States following Hurricane Eloise in 1975. Their values are presented within **Figure A4c** and show that while significant scatter is evident, there is a general relationship of increased localised landward depth of erosion adjacent to the seawall end with increased seawall length. Furthermore, the data tends to asymptote towards a limiting erosion depth indicating that as the length of seawall increases, erosion depth does not also linearly increase. The scatter present in the data was attributed by McDougal *et al.* (1987) to the multitude of site specific variables including pre-storm beach configuration, elevation of the structure toe, size and source of sediment and the intensity, direction and duration of the storm.

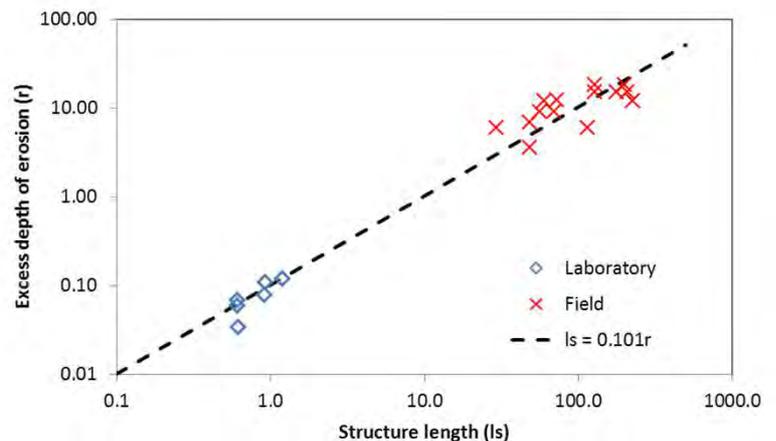
d) Excess Depth of Erosion as a Function of Seawall Length [Source: Basco (2004); Field; Chiu (1977); Laboratory: McDougal et al (1987)]

McDougal *et al.* (1987) undertook subsequent laboratory experimentation in a small scale wave basin facility and observed similar excess erosion at the ends of a seawall placed at or above the still water level. A best fit linear trend line was found to give a correlation

where “ r ” is the excess depth of flanking erosion and L_s is the length of structure. The maximum length of flanking erosion, “ s ” was similarly related to seawall length with a best fit linear trend line found giving a correlation coefficient of $R = 0.94$ and the expression:

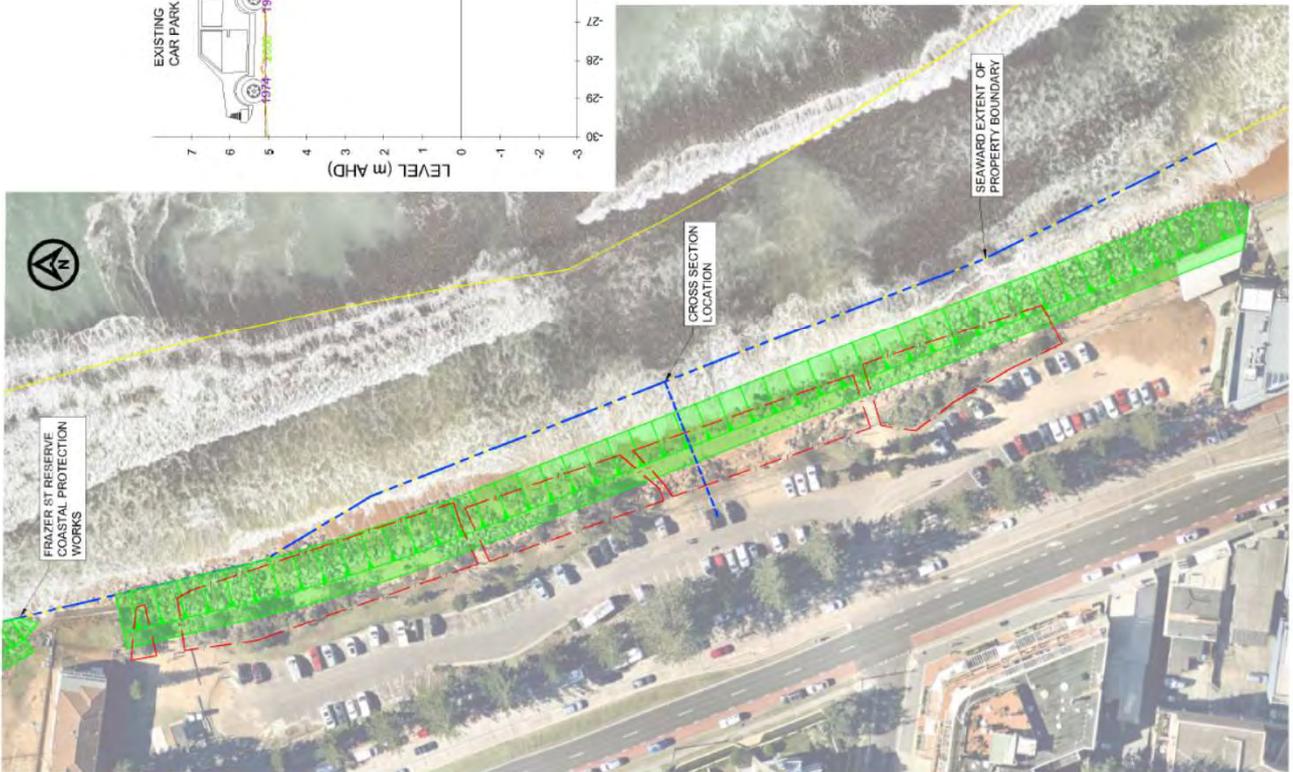
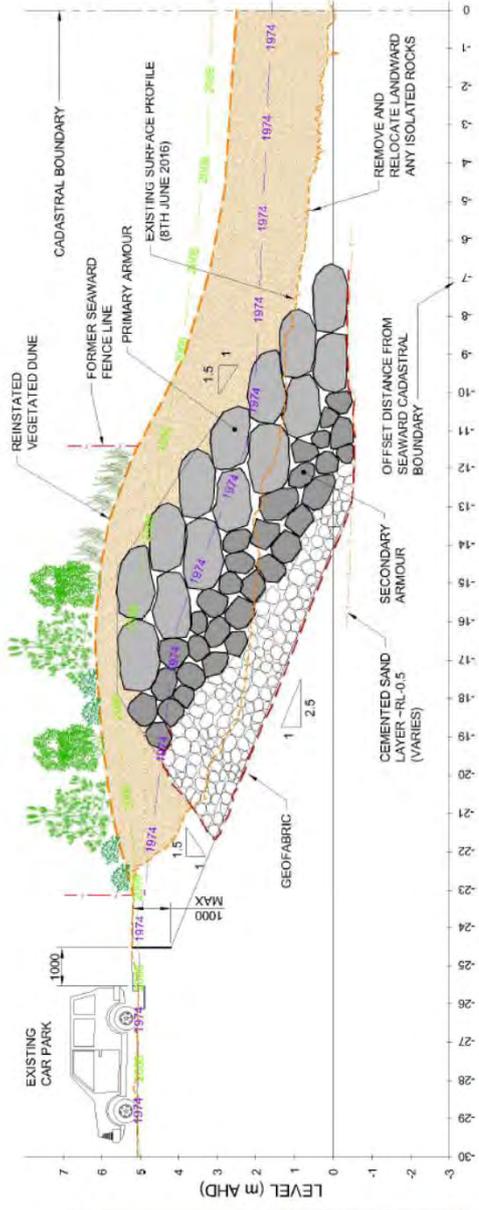
TYPICAL SECTION
1:125

- ALIGNMENT OF WORKS IS GOVERNED BY CARPARK LOCATION AND ADJACENT UTILITIES. WORKS TO BE LOCATED AS FAR LANDWARD AS POSSIBLE.
- CONCEPT ONLY. SUBJECT TO DETAILED DESIGN.
- CREST LEVEL OF WORKS TO BE CONFIRMED DURING DETAILED DESIGN BASED ON CONSIDERATION OF OVERTOPPING RATES, PUBLIC RISK DAMAGE BEHIND CREST, AND ADAPTATION STRATEGIES FOR SEA LEVEL RISE.
- EXCAVATION SLOPES SHOWN ARE INDICATIVE ONLY.
- UNDERSIZED ROCK TO BE REMOVED FROM BEACH AND PLACED LANDWARD OF SECONDARY ARMOUR OR DISPOSED OFF SITE.
- BEACH PROFILES FOR 1974 (ERODED) AND 2006 (ACCRETED) ALSO SHOWN FOR INFORMATION.

The indicative locations and representative rubble mound rock concept design cross-sections are shown in **Figure A7** to **Figure A10** inclusively. Expected wave overtopping rates for vertical structures are indicated to be significantly higher than for the rubble mound concept designs, necessitating higher seawall crest levels and/or additional drainage design. It is noted further that consideration should be given to the fact that a single wave under storm conditions can result in overtopping rates that are up to 100 times greater than the estimated average wave overtopping rates (van der Meer 1994) shown in **Table A4** and **Table A5**.

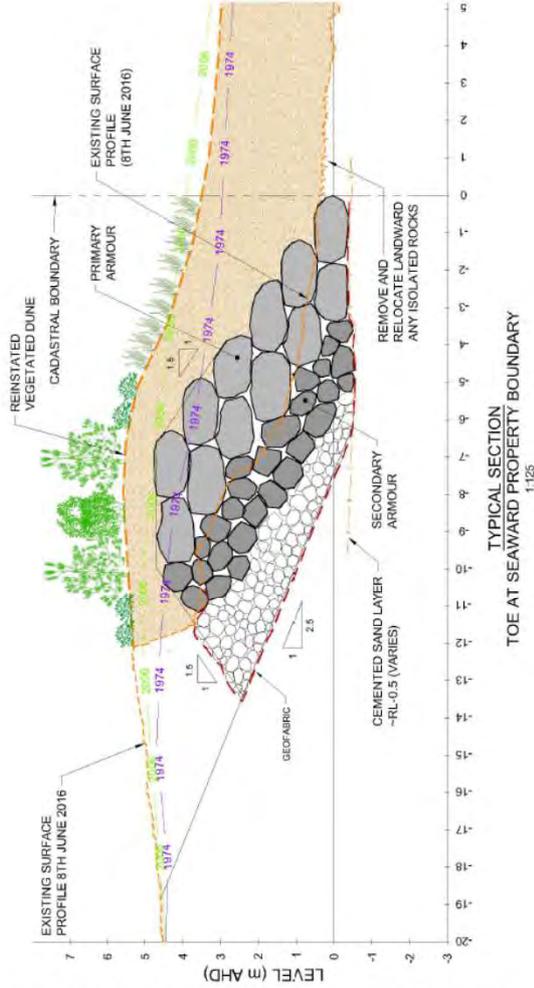
DRAFT COASTAL PROTECTION WORKS
CONCEPT DESIGN AND CONCEPT ALIGNMENT
FRAZER ST RESERVE

1. ALIGNMENT OF WORKS IS GOVERNED BY PROPERTY BOUNDARY. WORKS TO BE LOCATED AS FAR LANDWARD AS POSSIBLE.
2. CONCEPT ONLY, SUBJECT TO DETAILED DESIGN.
3. CREST LEVEL OF WORKS TO BE CONFIRMED DURING DETAILED DESIGN BASED ON CONSIDERATION OF OVERTOPPING RATES, PUBLIC RISK, DAMAGE BEHIND CREST, AND ADAPTION STRATEGIES FOR SEA LEVEL RISE.
4. EXCAVATION SLOPES SHOWN ARE INDICATIVE ONLY.
5. UNDERSIZED ROCK TO BE REMOVED FROM BEACH AND PLACED LANDWARD OF SECONDARY ARMOUR OR DISPOSED OFF SITE.
6. BEACH PROFILES FOR 1974 (ERODED) AND 2006 (ACCRETED) ALSO SHOWN FOR INFORMATION.

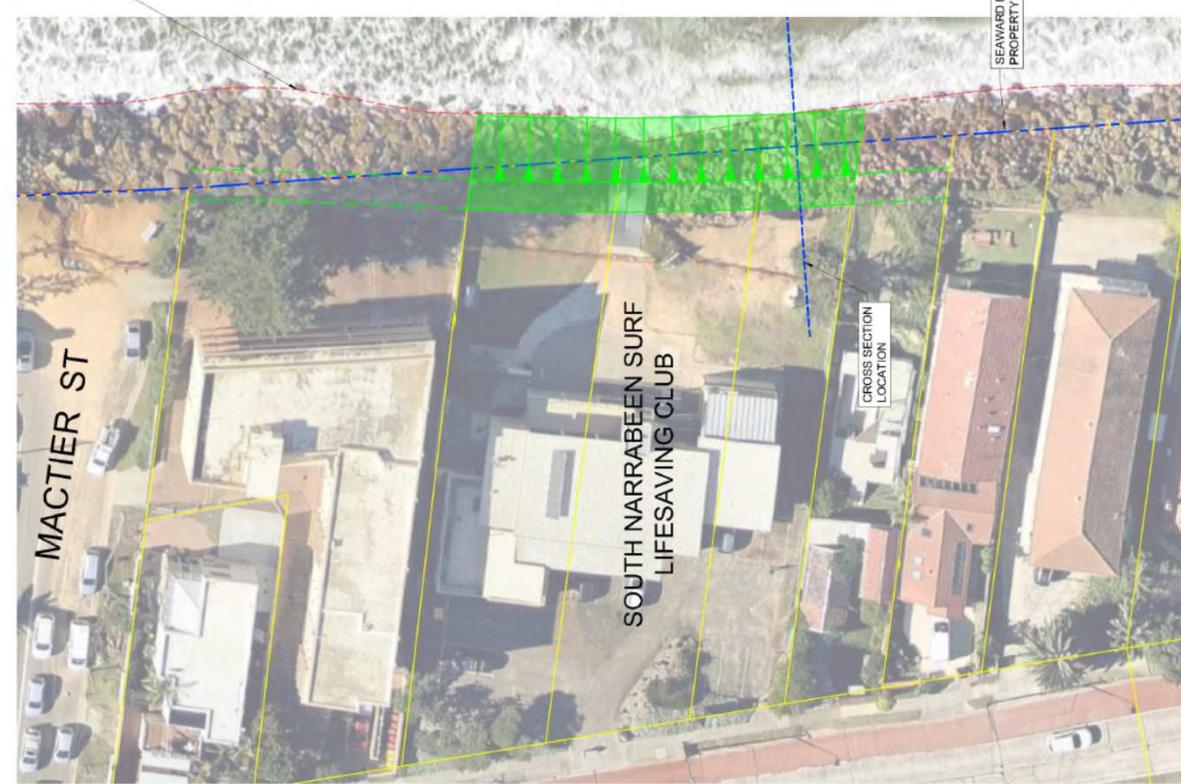
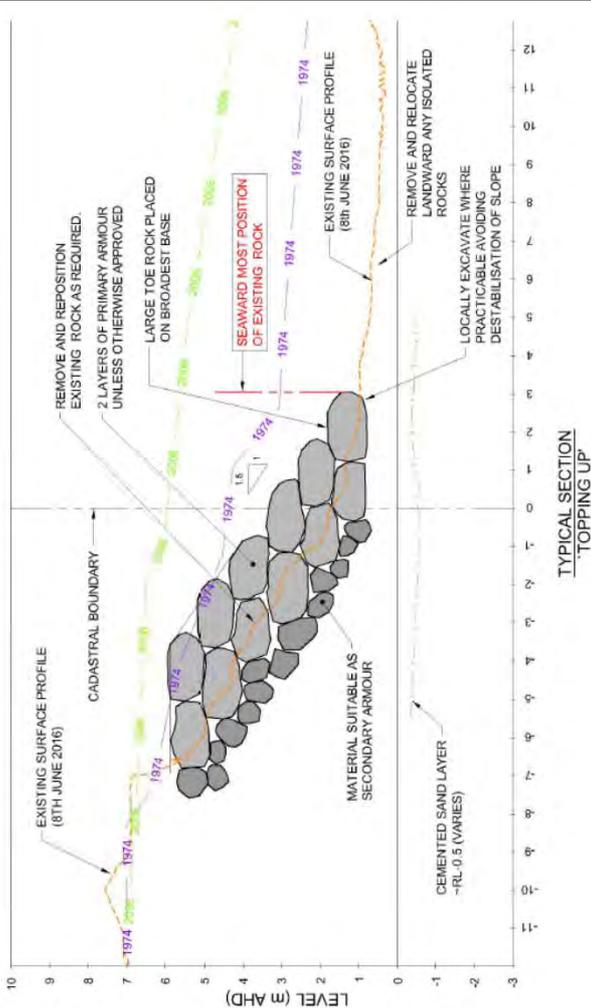
APPROXIMATE SEAWARD EXTENT OF EXISTING ROCK PROTECTION (8th JUNE 2016)

1. ALIGNMENT OF WORKS IS GOVERNED BY SEAWARD MOST POSITION OF EXISTING ROCK. TOLERANCE FOR EXTENDING PAST EXISTING ROCK NOMINALLY 2m.
2. CONCEPT ONLY, SUBJECT TO DETAILED DESIGN.
3. CREST LEVEL OF WORKS TO BE CONFIRMED DURING DETAILED DESIGN. DESIGN TO TAKE INTO ACCOUNT OVERTOPPING RATES, PREDICTED DAMAGE BEHIND CREST, AND ADAPTATION STRATEGIES FOR SEA LEVEL RISE.
4. BEACH PROFILES FOR 1974 (ERODED) AND 2006 (ACCRETED) ALSO SHOWN FOR INFORMATION.

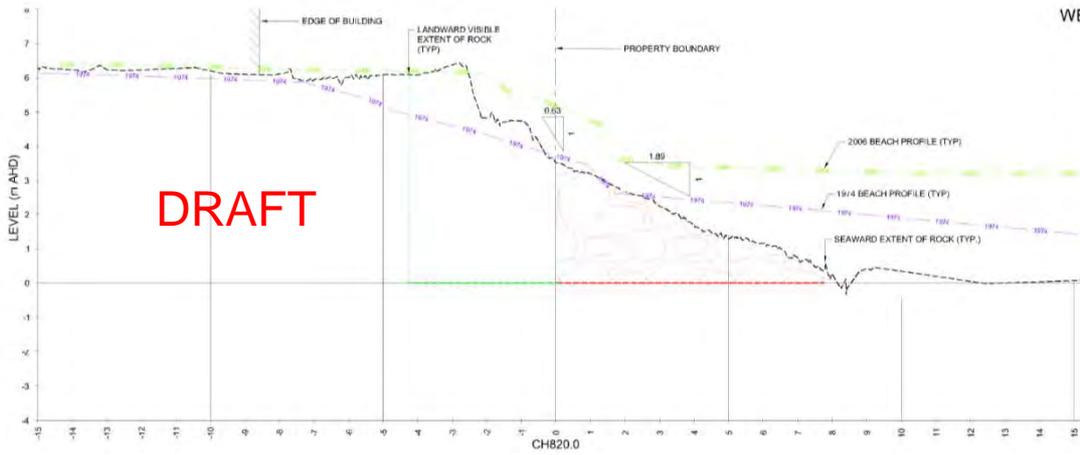
WETHERILL ST ROAD HEAD AND ADJACENT AREAS
SECTIONS SHEET 3

NOTE:
EDGE OF BUILDING IS PROJECTED ON TO
CROSS SECTION ON A LINE PARALLEL TO THE
PROPERTY BOUNDARY

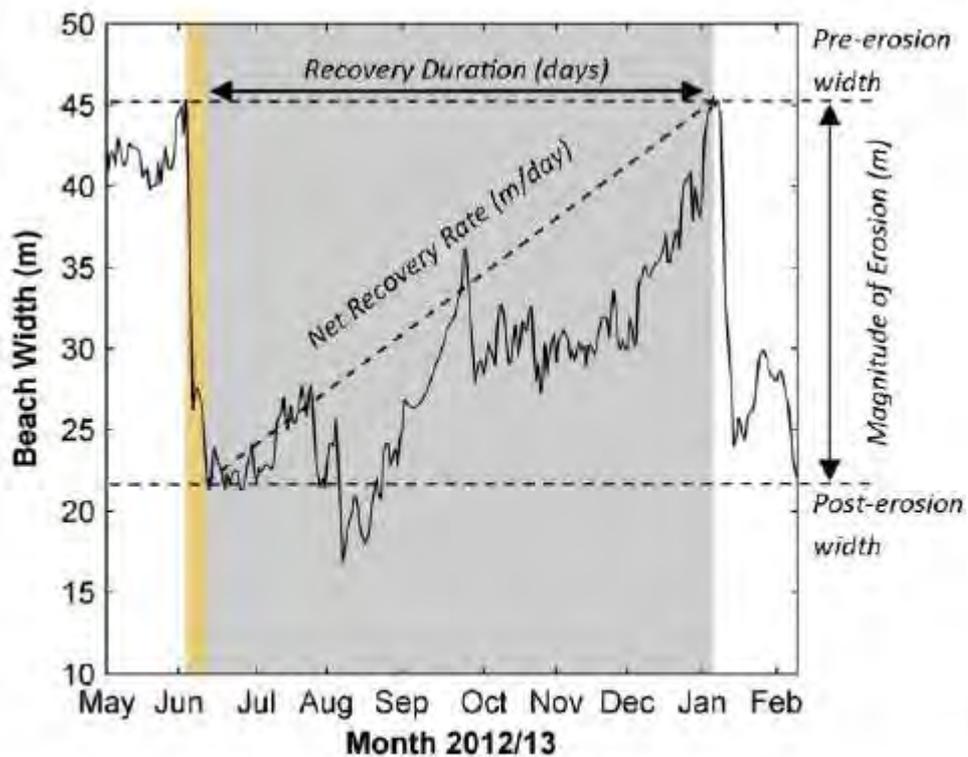
Illustration depicting erosion period (yellow) and subsequent recovery period (grey) in beach width with duration and net recovery rate.

Phillips et al (2015) (**Figure A11**) analysed beach recovery for Collaroy-Narrabeen, by measuring beach width at the 0.7 m AHD (mean high water) elevation. Phillips studied 10 recovery events from 2004 to 2013 and found an average recovery rate of 0.10 m/day and an average maximum recovery rate (based on a fortnightly moving average) of 0.48 m/day. The highest recovery rate (based on a fortnightly moving average) measured was 0.68 m/day. They noted that rapid recovery can occur when a nearshore sand bar welds to the beach face, which may account for the maximum observed short term rate of 6.4 m/day, but this is somewhat damped out by the use of a fortnightly moving average.

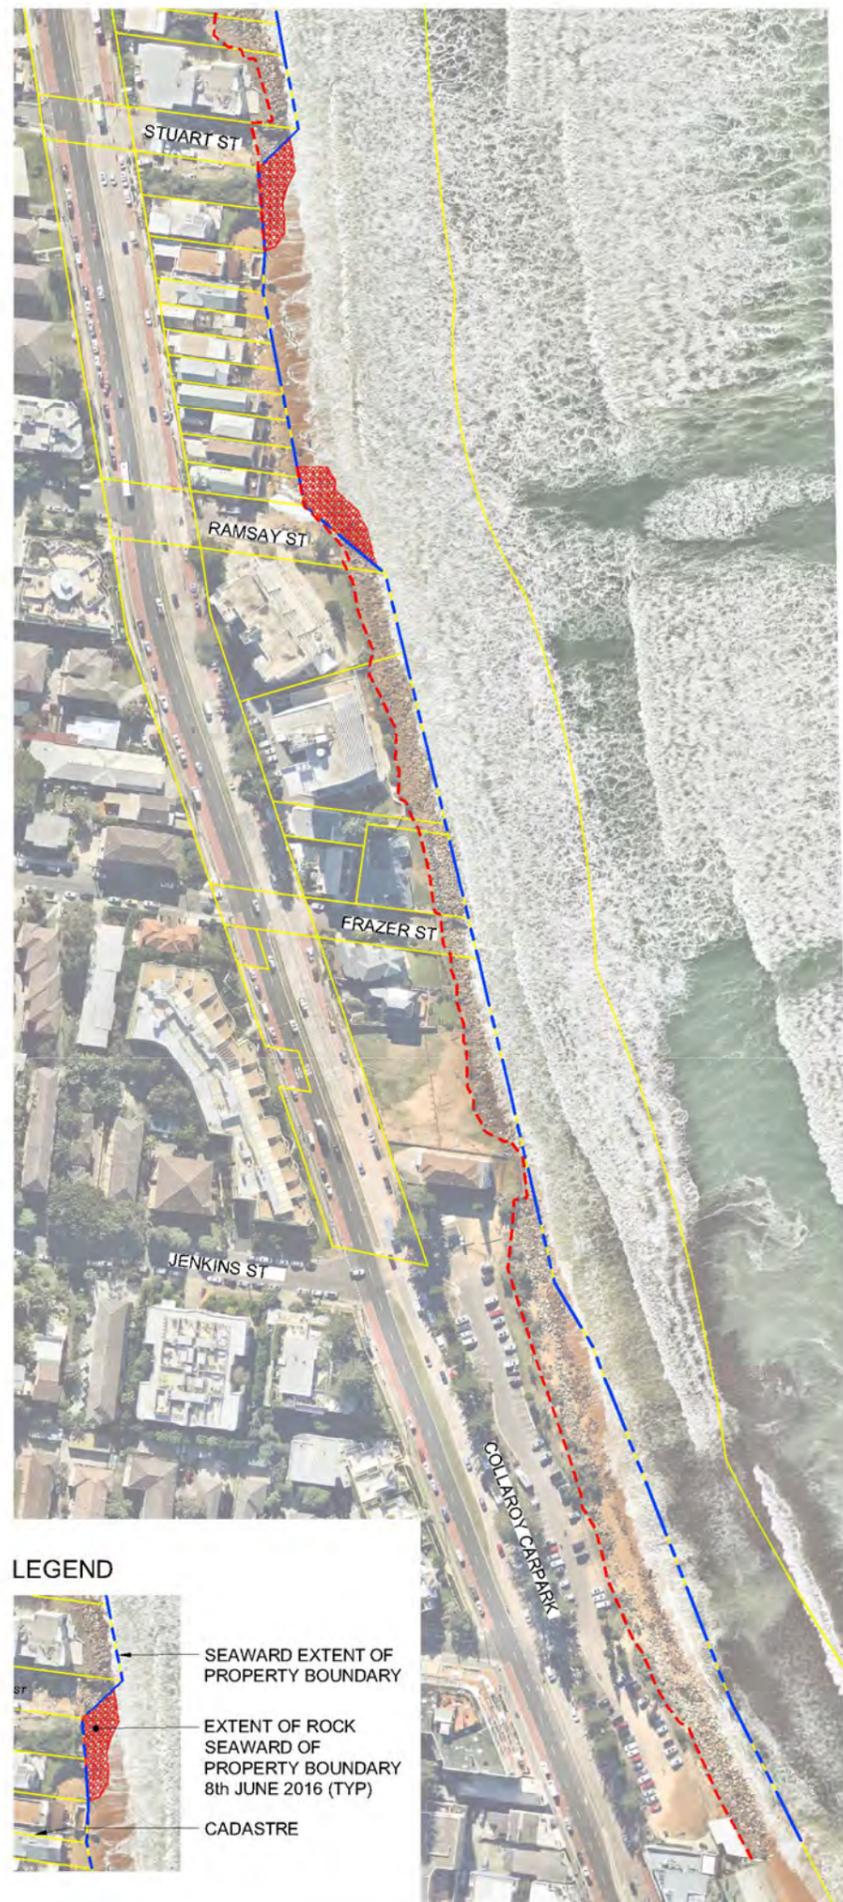
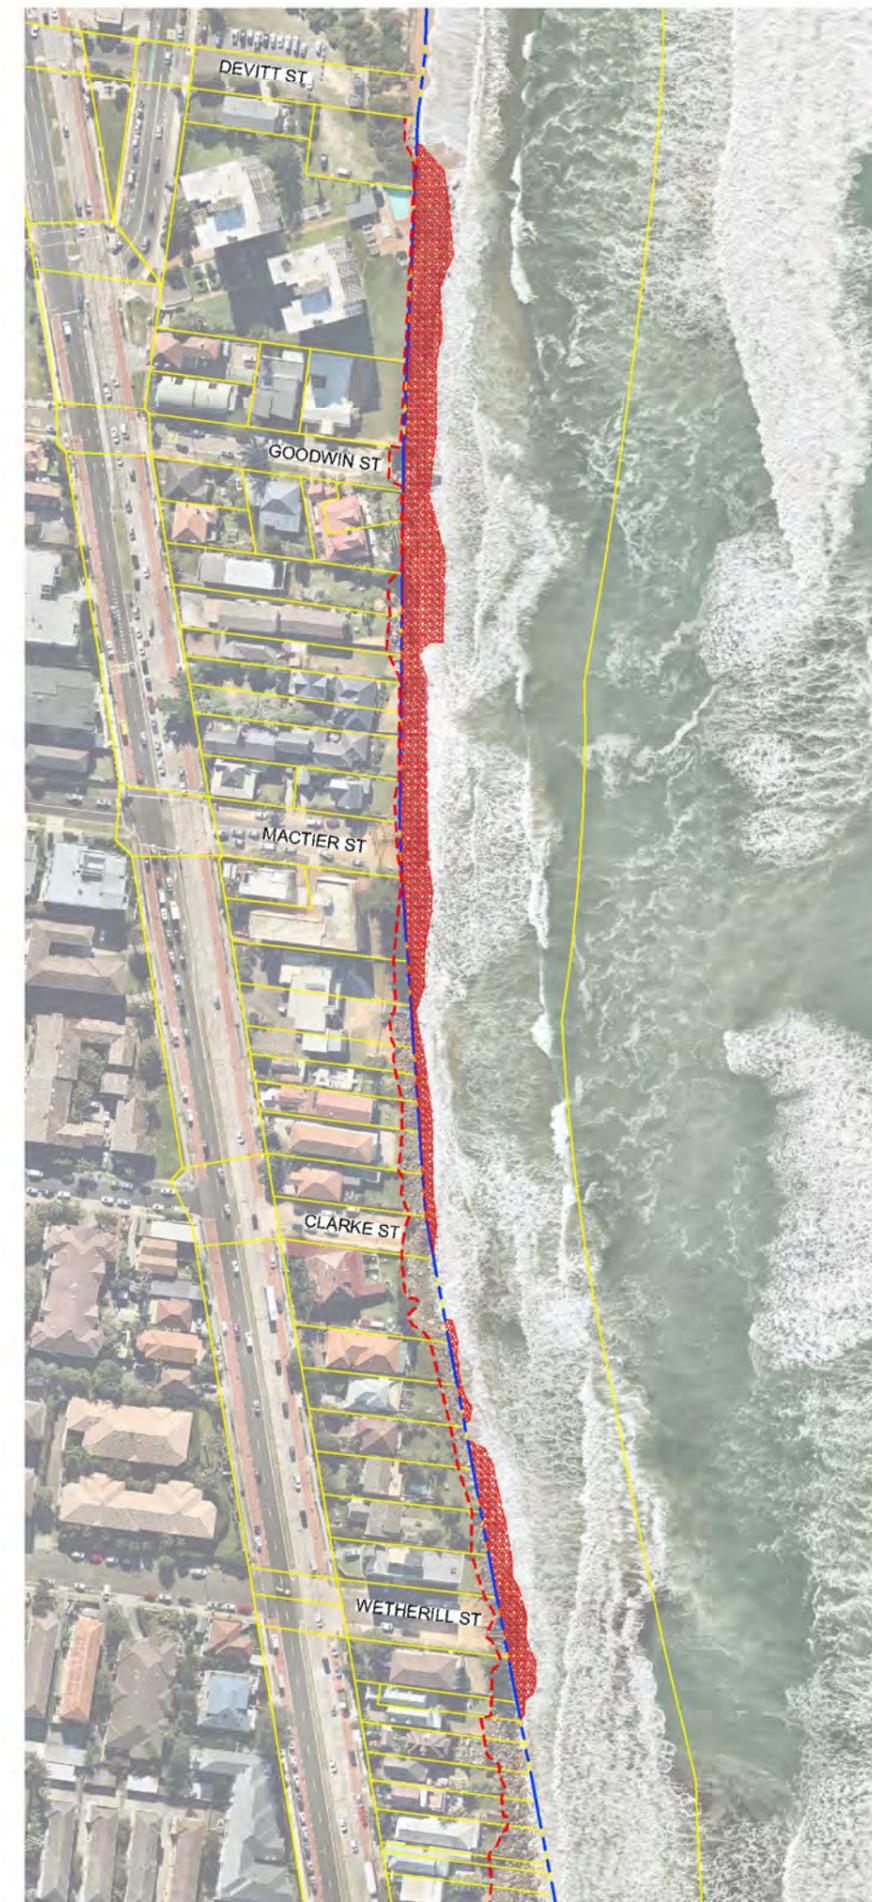
NOTE
MAXIMUM LANDWARD POSITION
OF EXISTING ROCK PROTECTION
AS VISIBLE IN AIR PHOTO
8th JUNE 2016
