Appendix A – Literature on Seawall Impacts and other Human Influences on Beaches

DRAFT COASTAL PROTECTION WORKS
CONCEPT DESIGN AND CONCEPT ALIGNMENT
COLLARROY CARPARK

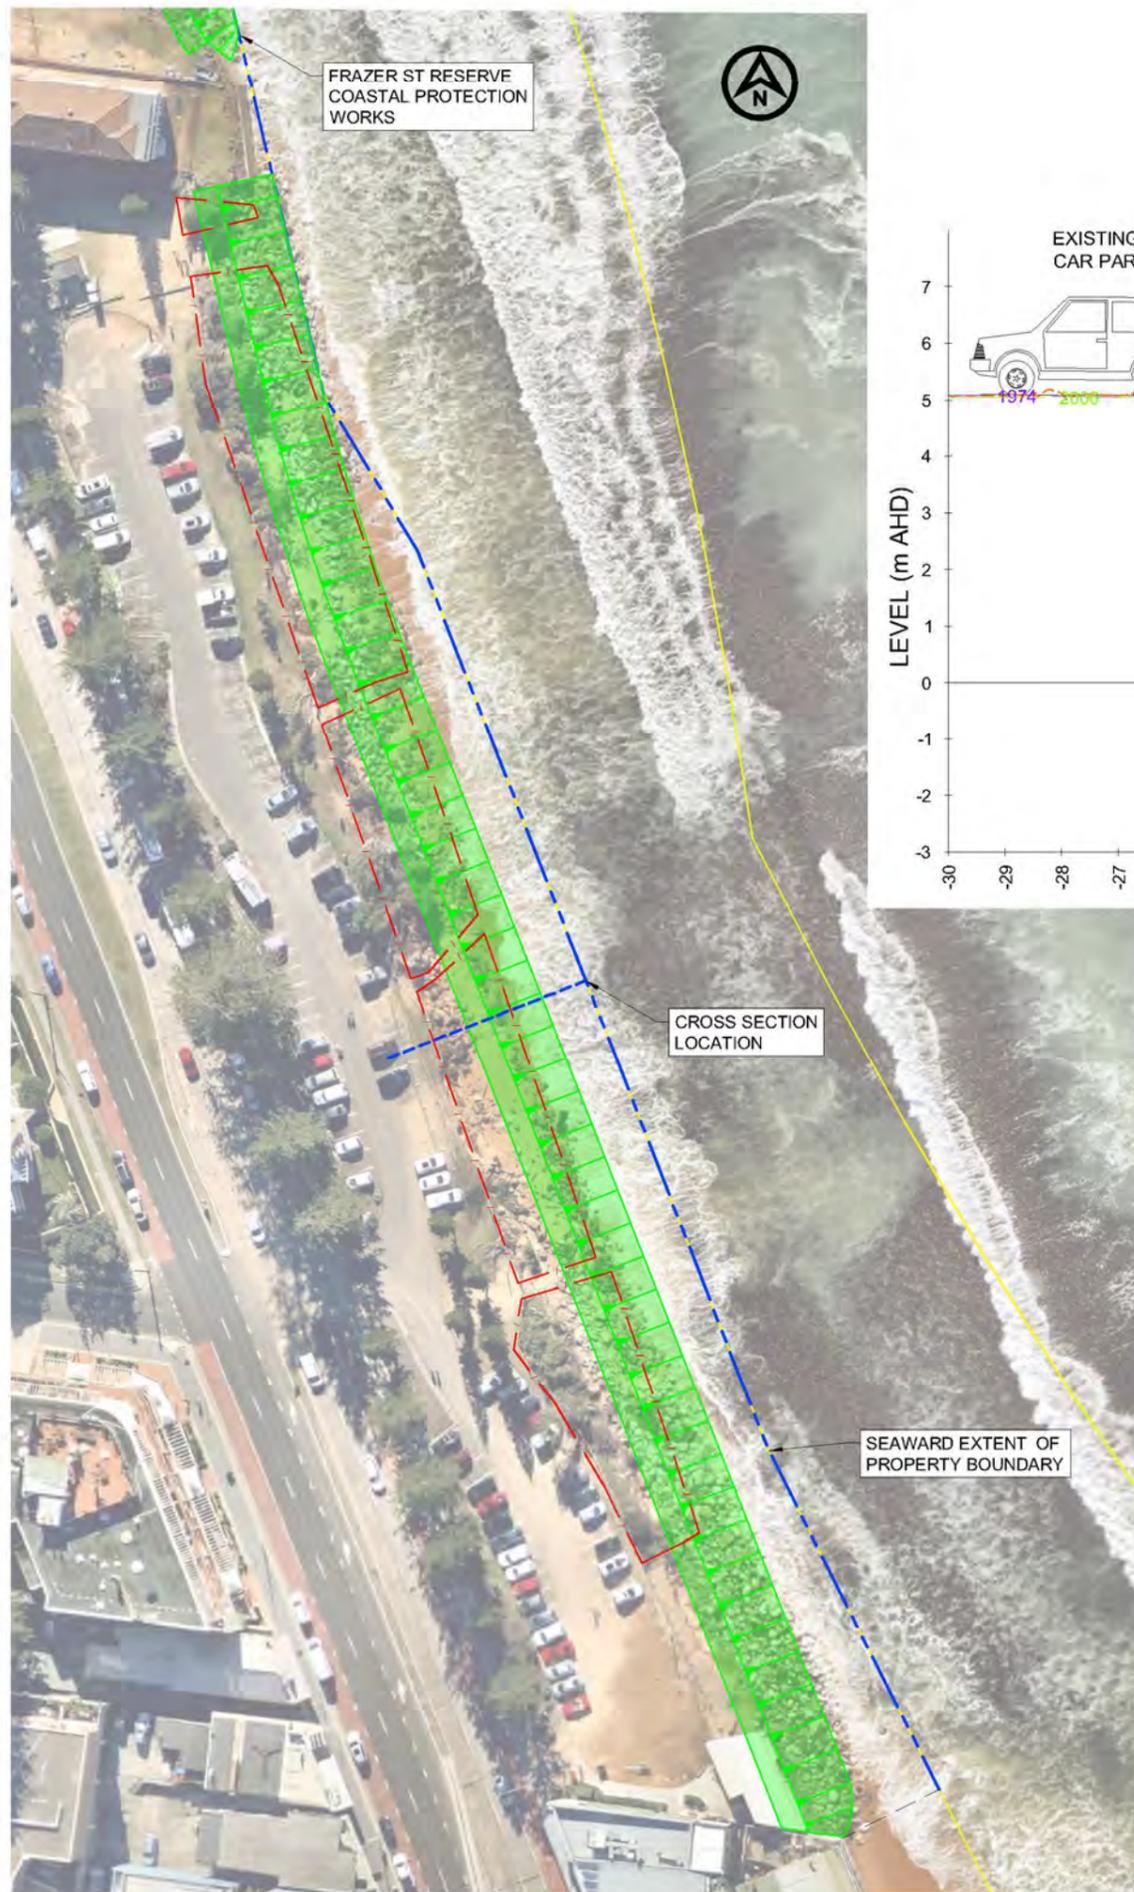
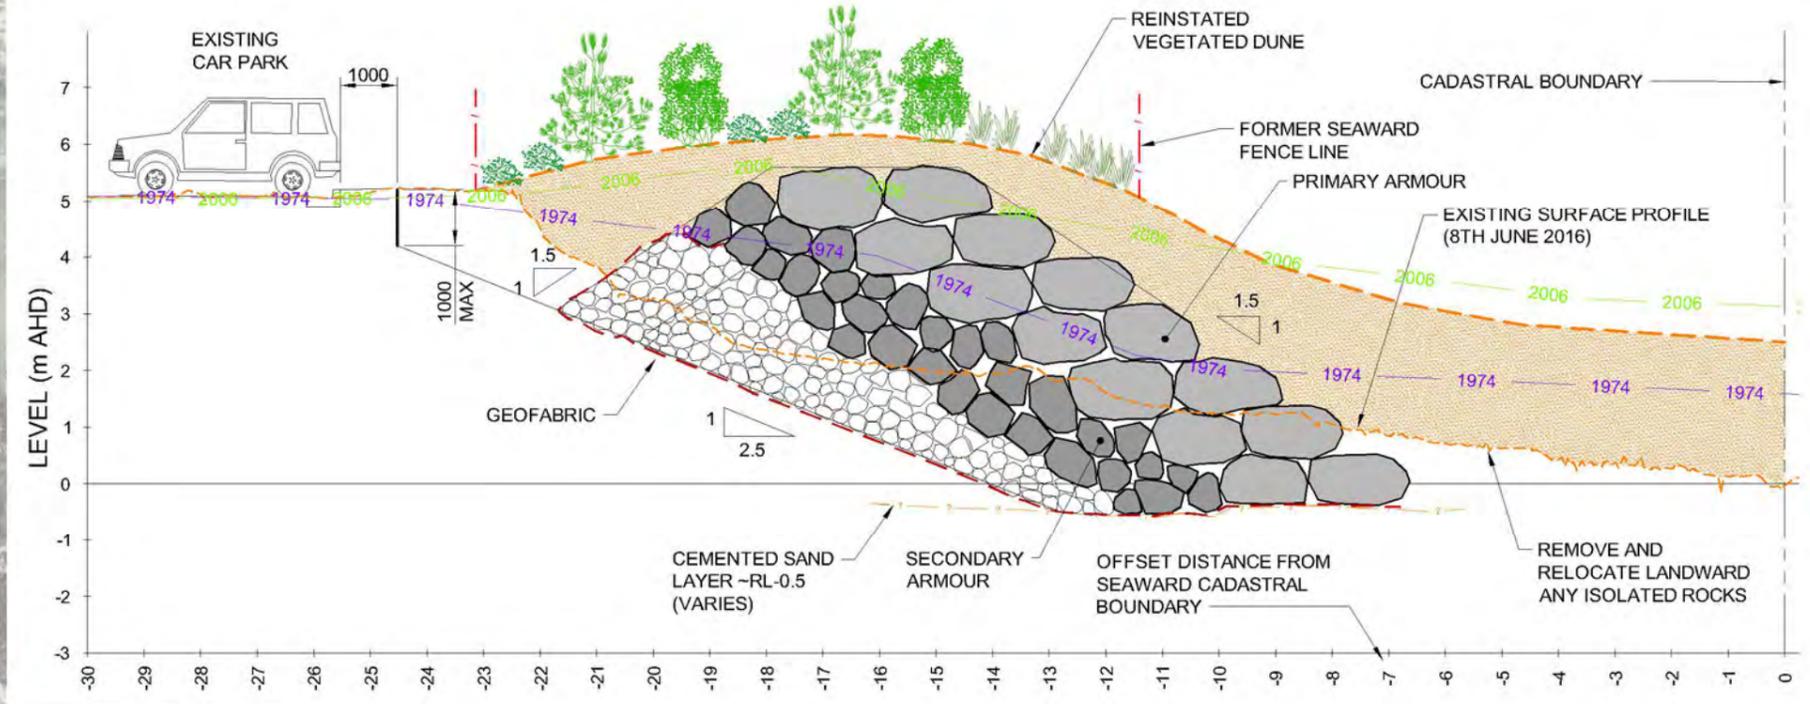
TYPICAL SECTION
1:125

1. ALIGNMENT OF WORKS IS GOVERNED BY CARPARK LOCATION AND EXCAVATION SLOPES. WORKS TO BE LOCATED AS FAR LANDWARD AS POSSIBLE.
2. CONCEPT ONLY, SUBJECT TO DETAILED DESIGN.
3. CREST LEVEL OF WORKS TO BE CONFIRMED DURING DETAILED DESIGN BASED ON CONSIDERATION OF OVERTOPPING RATES, PUBLIC RISK, DAMAGE BEHIND CREST, AND ADAPTION STRATEGIES FOR SEA LEVEL RISE.
4. EXCAVATION SLOPES SHOWN ARE INDICATIVE ONLY.
5. UNDERSIZED ROCK TO BE REMOVED FROM BEACH AND PLACED LANDWARD OF SECONDARY ARMOUR OR DISPOSED OFF SITE.
6. BEACH PROFILES FOR 1974 (ERODED) AND 2006 (ACCRETED) ALSO SHOWN FOR INFORMATION

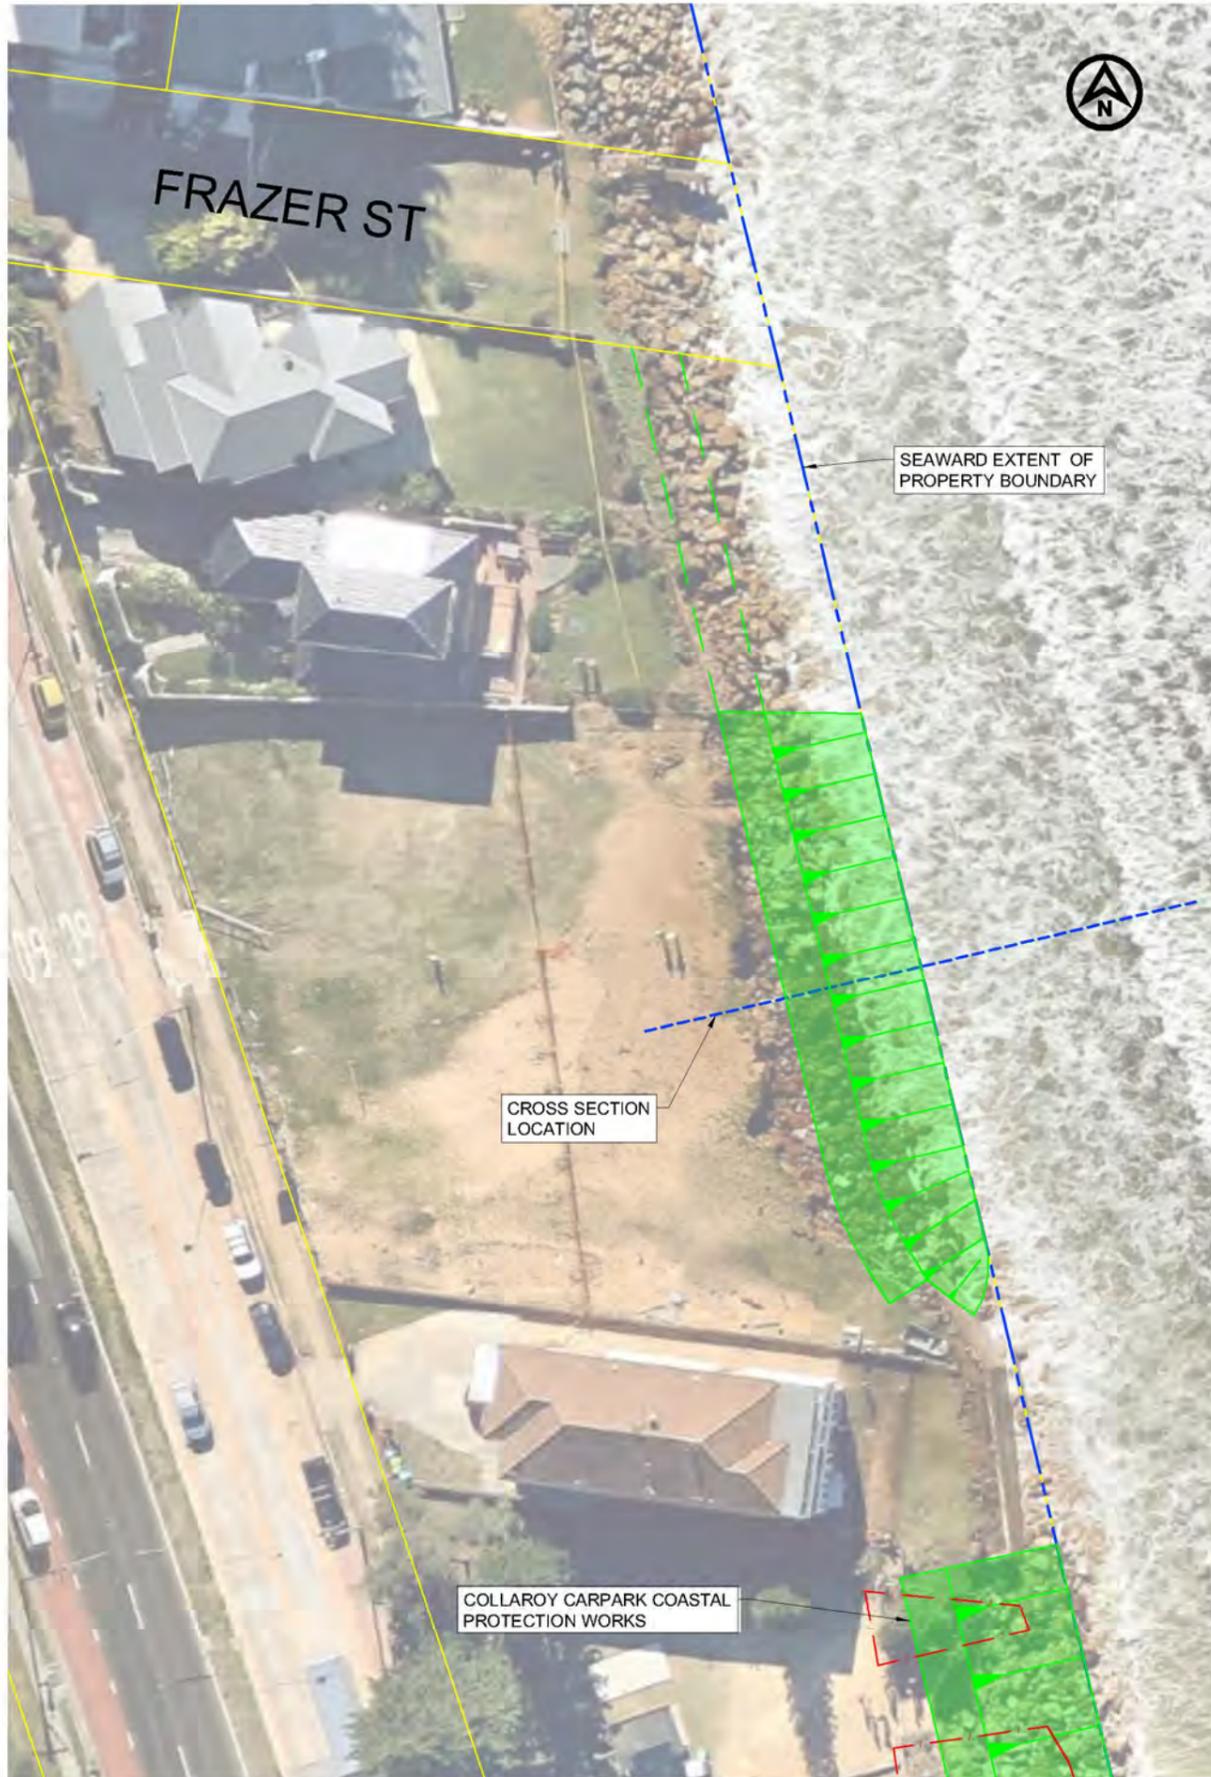
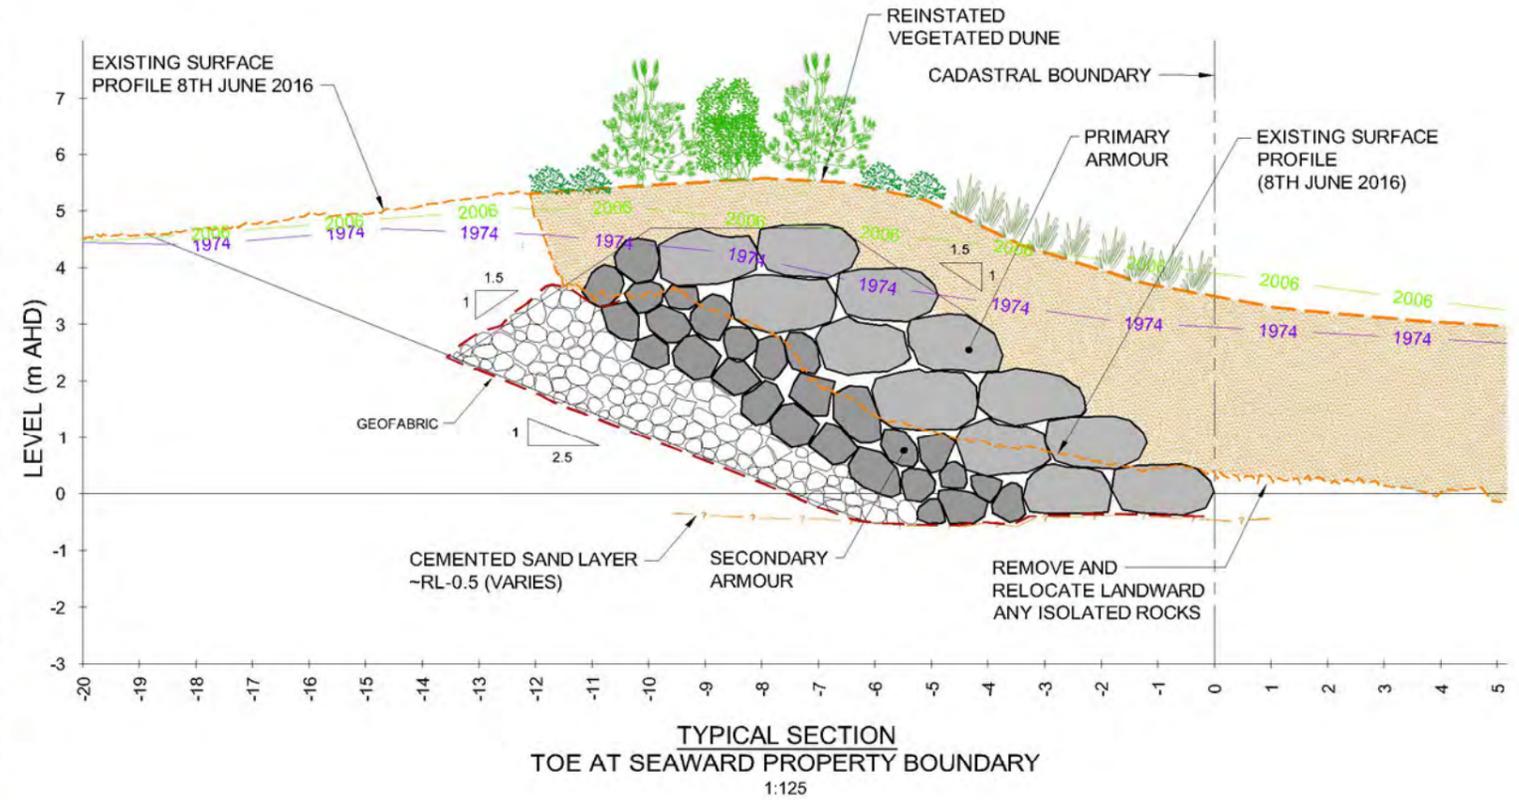
**COASTAL PROTECTION WORKS
CONCEPT DESIGN AND CONCEPT ALIGNMENT
FRAZER ST RESERVE**

1. ALIGNMENT OF WORKS IS GOVERNED BY PROPERTY BOUNDARY. WORKS TO BE LOCATED AS FAR LANDWARD AS POSSIBLE.
2. CONCEPT ONLY, SUBJECT TO DETAILED DESIGN.
3. CREST LEVEL OF WORKS TO BE CONFIRMED DURING DETAILED DESIGN BASED ON CONSIDERATION OF OVERTOPPING RATES, PUBLIC RISK, DAMAGE BEHIND CREST, AND ADAPTION STRATEGIES FOR SEA LEVEL RISE.
4. EXCAVATION SLOPES SHOWN ARE INDICATIVE ONLY.
5. UNDERSIZED ROCK TO BE REMOVED FROM BEACH AND PLACED LANDWARD OF SECONDARY ARMOUR OR DISPOSED OFF SITE.
6. BEACH PROFILES FOR 1974 (ERODED) AND 2006 (ACCRETED) ALSO SHOWN FOR INFORMATION

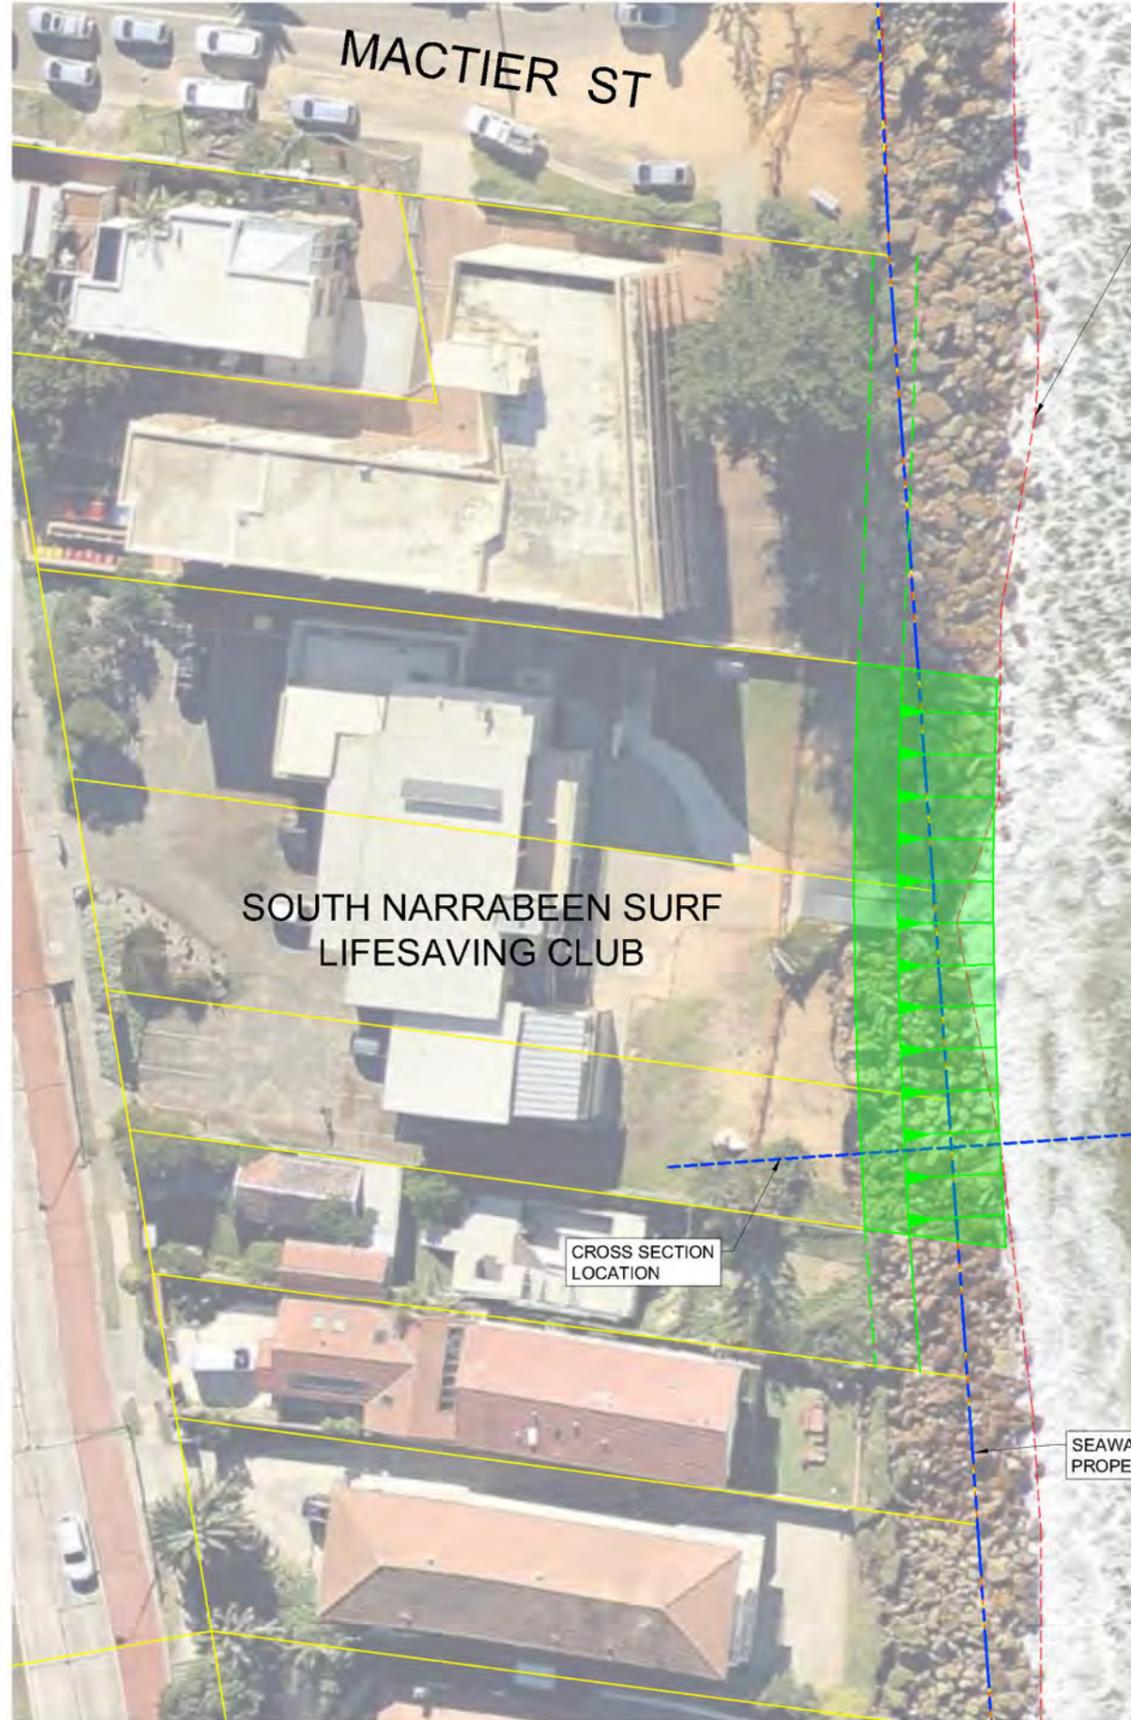
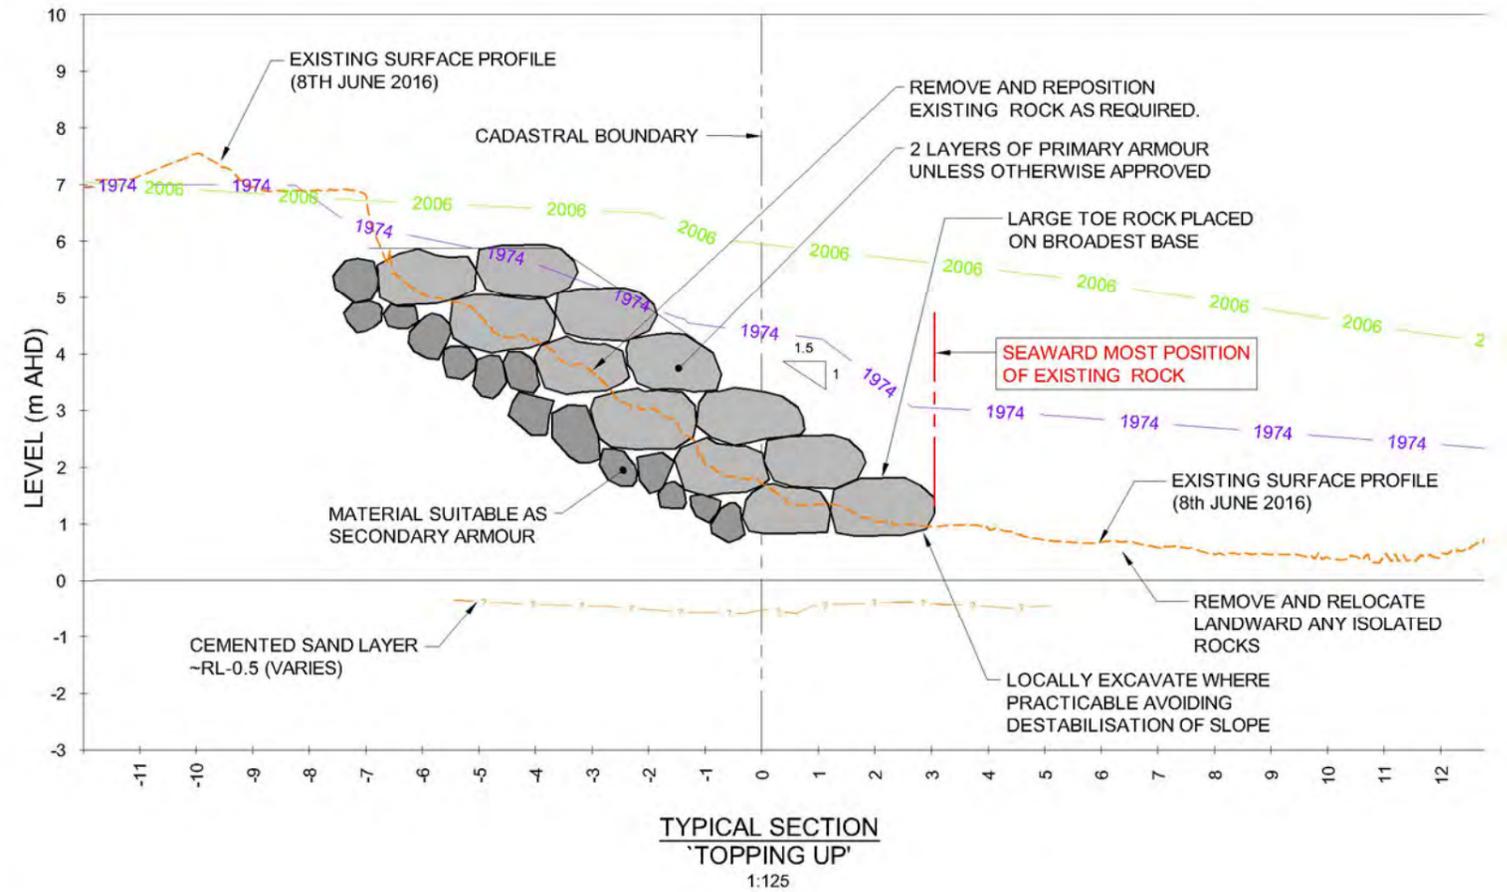
**COASTAL PROTECTION WORKS
CONCEPT DESIGN AND CONCEPT ALIGNMENT
SOUTH NARRABEEN SURF LIFESAVING CLUB**

APPROXIMATE SEAWARD EXTENT OF EXISTING
ROCK PROTECTION (8th JUNE 2016)

1. ALIGNMENT OF WORKS IS GOVERNED BY SEAWARD MOST POSITION OF EXISTING ROCK. TOLERANCE FOR EXTENDING PAST EXISTING ROCK NOMINALLY 2m.
2. CONCEPT ONLY, SUBJECT TO DETAILED DESIGN.
3. CREST LEVEL OF WORKS TO BE CONFIRMED DURING DETAILED DESIGN BASED ON CONSIDERATION OF OVERTOPPING RATES, PUBLIC RISK, DAMAGE BEHIND CREST, AND ADAPTION STRATEGIES FOR SEA LEVEL RISE.
4. BEACH PROFILES FOR 1974 (ERODED) AND 2006 (ACCRETED) ALSO SHOWN FOR INFORMATION
